# Recycling of Road Surfaces with the Roto Trimmer Mobile Rock Processor

Donna McConnaha Sheehy, *USDA Forest Service, Missoula, Montana*

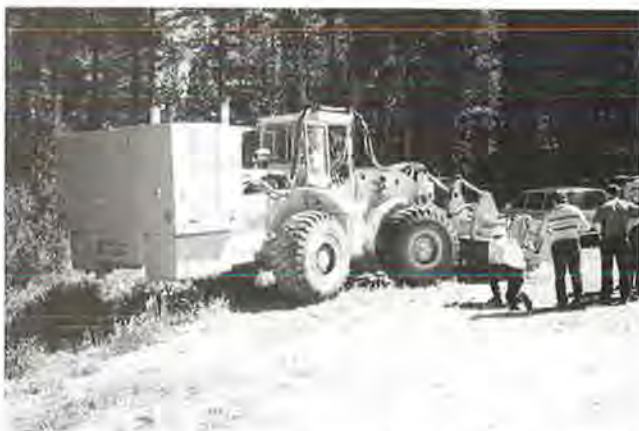
FIGURE 1 Roto Trimmer mounted on a Caterpillar loader (rotary drum on front lift arms and power pack at rear).

The machine, shown in Figure 1, resembles a giant Rototiller and consists of a two-component kit: a front rotary drum attachment and a rear power pack. This kit mounts on any suitable carrier such as a loader, grader, or scraper. It is essentially balanced as the drum and the power pack each weigh approximately 5 450 kg (12,000 lb). The kit components can be mounted or removed from a loader in approximately 12 person-hr.

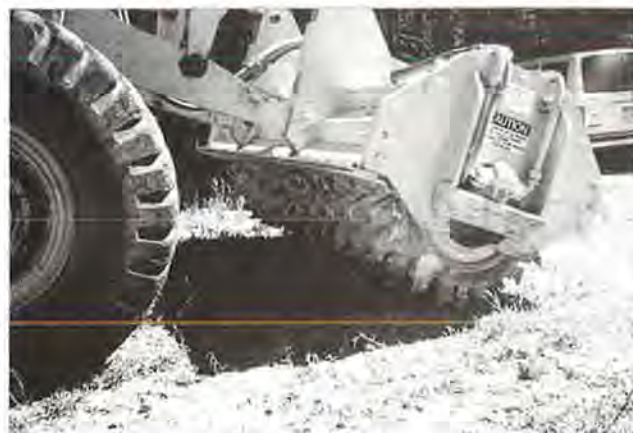
FIGURE 2 Rotary drum attachment with carbide-tipped teeth.

The drum has 184 carbide-tipped teeth in knuckle holders mounted in a spiraled-inward pattern, as shown

in Figure 2. The teeth rotate after every strike to produce even wear. Teeth have an average life of 8 hr and are the only routine replacement item. They are quickly removed with either a forked tool and hammer or an air drill and are easily installed with a tap of the hammer. Teeth cost approximately \$3.20 each in 1993.

A tooth hits every 3.175 mm (0.125 in.) of soil. The teeth crush the rock and rip the material as the drum rotates. The loose rock revolves counterclockwise to the impact plate on which it is further fractured and blended.

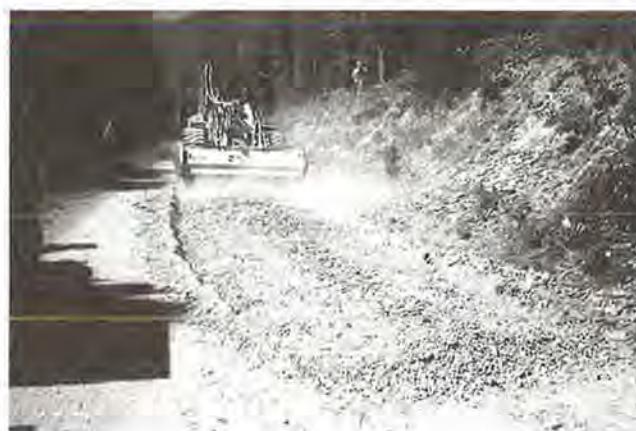
FIGURE 5 Roto Trimmer making first pass.

The optimal procedure has been to operate the machine at idling speed against the grain of the rock. A pass 3 m (10 ft) wide by 100 to 150 mm (4 to 6 in.) deep is made (see Figure 5), followed by another pass alongside for most roads wider than 3 m (10 ft). When attempting to grind to a depth of 150 mm (6 in.), the machine will usually make two passes to obtain full breakage of the rock material. Small sidecast windrows are made, which are ripped to produce material of a smaller particle size. A grader smoothes the windrows, a water truck applies compaction water and controls the minimal dust, and a traditional vibratory roller used in conjunction with an Elliot grid vibratory compactor brings up fines and compacts the soil. The result is a finished road with a hard, smooth, maintainable driving surface.

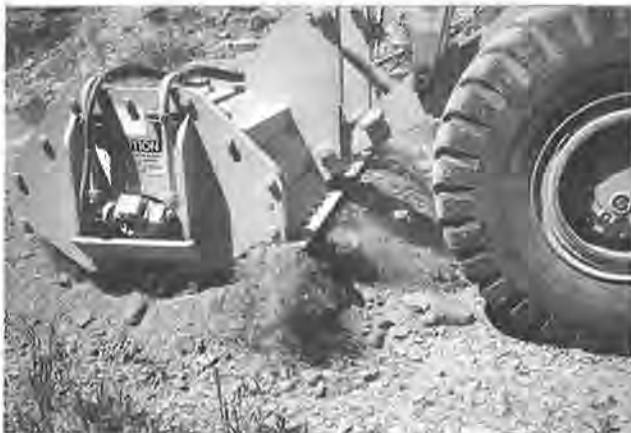
**FIGURE 7** Roto Trimmer in operation; note small amount of dust and sidecast material.

fracture some of the more difficult rock. This allowed the Roto Trimmer to move through the rock sections more easily, resulting in cost savings. The native-surfaced roads were worked to a depth of 150 mm (6 in.) and the chipseal surface was worked to a depth of between 100 and 150 mm (4 and 6 in.). The maximum-size rock allowed in the cushion material was 100 mm (4 in.). Most of the project roads are adjacent to streams or rivers. As the Roto Trimmer did not throw rock or generate excess dust, there was no noticeable impact on drainage during reconstruction (Figure 7).

The recycling of road surfaces eliminates the need for opening new material sources and any associated new road construction. As shown in Figure 7, the actual reconstruction process generates less dust and sidecasting than traditional methods, resulting in fewer impacts on adjacent drainages and any associated fisheries. It utilizes the existing materials in the road surface to build a stable cushion. When the material is compacted with a vibratory roller, a finished product is developed that will last for years without harming the environment.

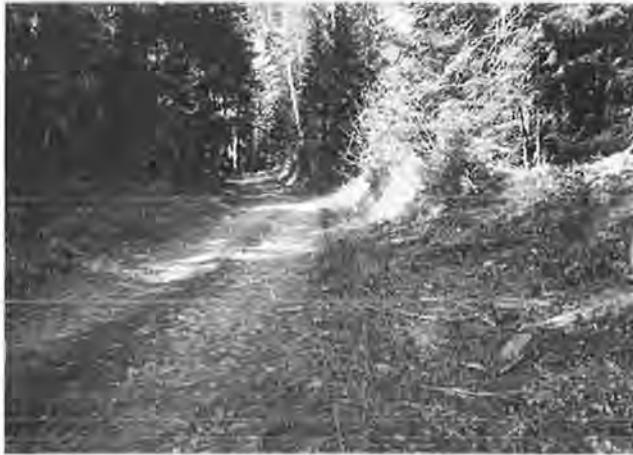
FIGURE 8 Leigh Lake Road: typical section before processing with Roto Trimmer.

The project consisted of reconstruction of 2.7 km (1.7 mi) of a road that had not been maintained but received a large amount of recreational use, primarily by high-clearance vehicles. Over the years, the road had become a trench with no drain dips or open tops and an occasional nonfunctioning culvert. The surface was quite rough—many of the users would walk rather than drive on the road. There were several concerns over the reconstruction: how to maintain the integrity of the road with minimum clearing; what to do with the outside shoulder that was primarily a disposal area for rocks; how to provide adequate drainage; and where to obtain a suitable source for surfacing the road. Figures 8 and 9 show conditions before and after processing of the road surface with the Roto Trimmer.

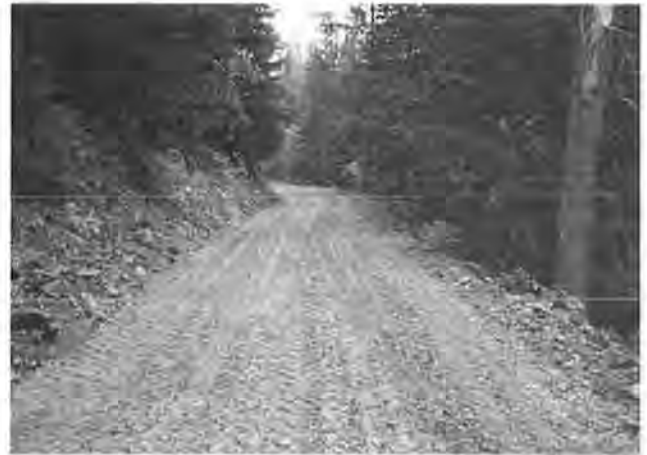
FIGURE 9 Leigh Lake Road: typical section after processing with Roto Trimmer.

The project was considered quite successful. The native-surfaced rock fractured to a fairly uniform 100 mm (4 in.) pit-run surface, eliminating the need for a borrow source. The material in the outside berm was utilized in place, so disposal of oversize material was kept to a minimum. The reconstructed road maintained the integrity of the original location but with a drivable, maintainable surface. The road was shaped to drain with open tops.
