Crash-Tested Bridge Railings for Timber Bridges

Michael A. Ritter, *Forest Service, U.S. Department of Agriculture*

Ronald K. Faller, *University of Nebraska-Lincoln*

Sheila R. Duwadi, *Federal Highway Administration*

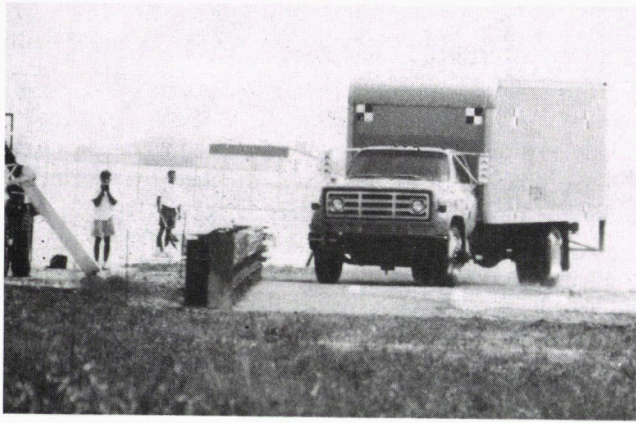
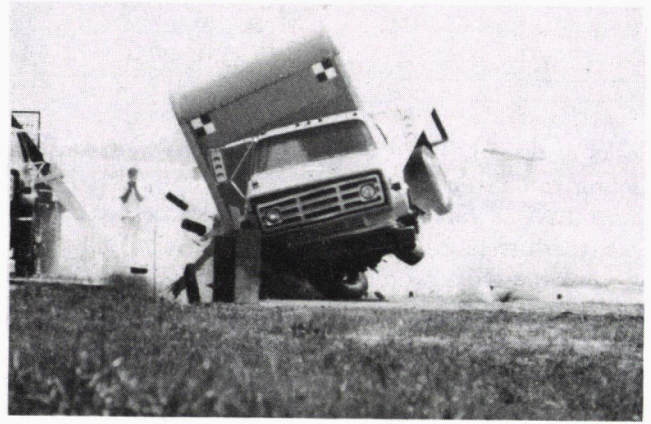
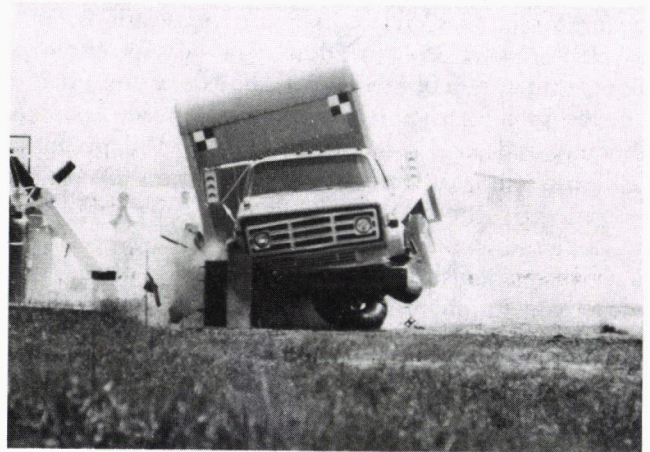
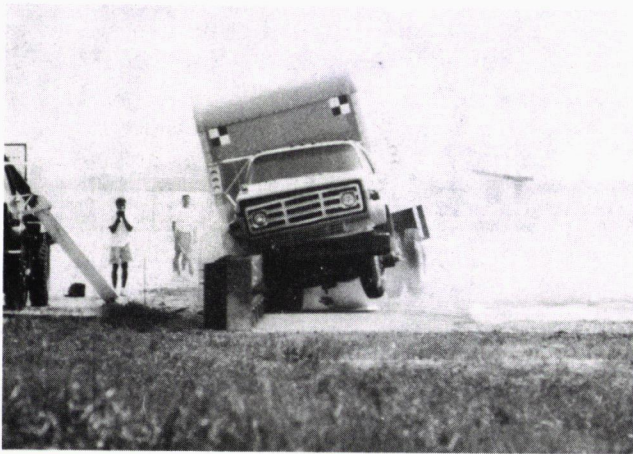
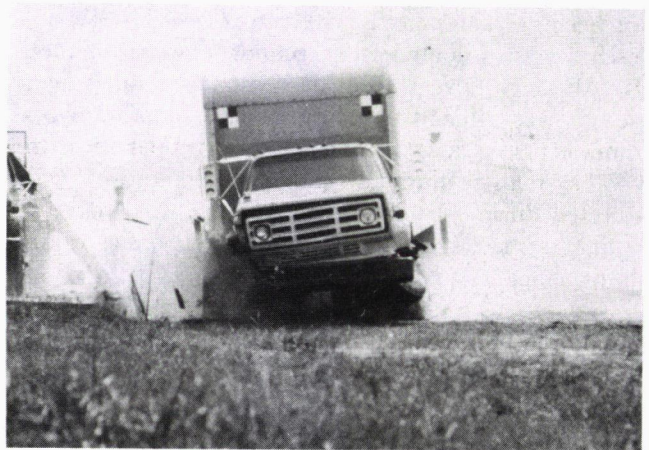
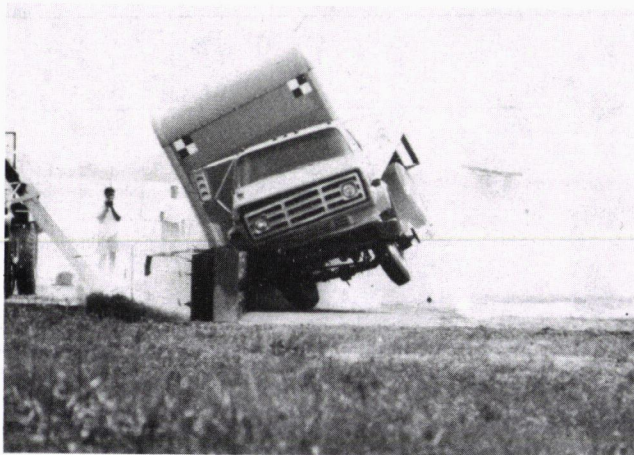
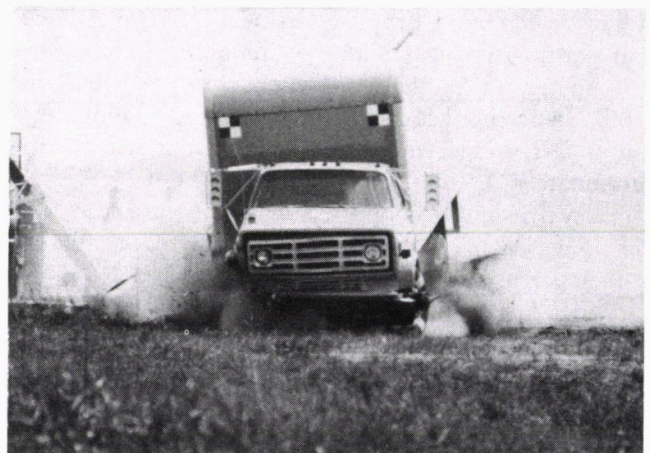
FIGURE 1 Crash-test sequence for 8172-kg (18,000-lb) truck traveling at 80.5 km/hr (50 mph), hitting railing at 15-degree angle to longitudinal railing axis.

Vehicle propulsion and guidance were provided by steel cable configurations. For propulsion, a reverse cable tow with a 1:2 mechanical advantage was used. A cable was attached to the front of the vehicle, routed through a series of pulleys, and connected to a tow vehicle that traveled in a direction opposite to the test vehicle. The unoccupied test vehicle was then pulled by the tow vehicle and released from the tow cable approximately 9.2 m (30 ft) before impact. A vehicle guidance system developed by Hinch was used to steer the test vehicle (9). Using this system, the left front wheel hub is attached to a tensioned steel cable that maintains the vehicle's direction along a designated straight path. Approximately 9.2 m (30 ft) from impact, the guidance connection is sheared off and the vehicle separates from the guidance cable. A crash-test sequence for an 8172-kg (18,000-lb) vehicle is shown in Figure 1.

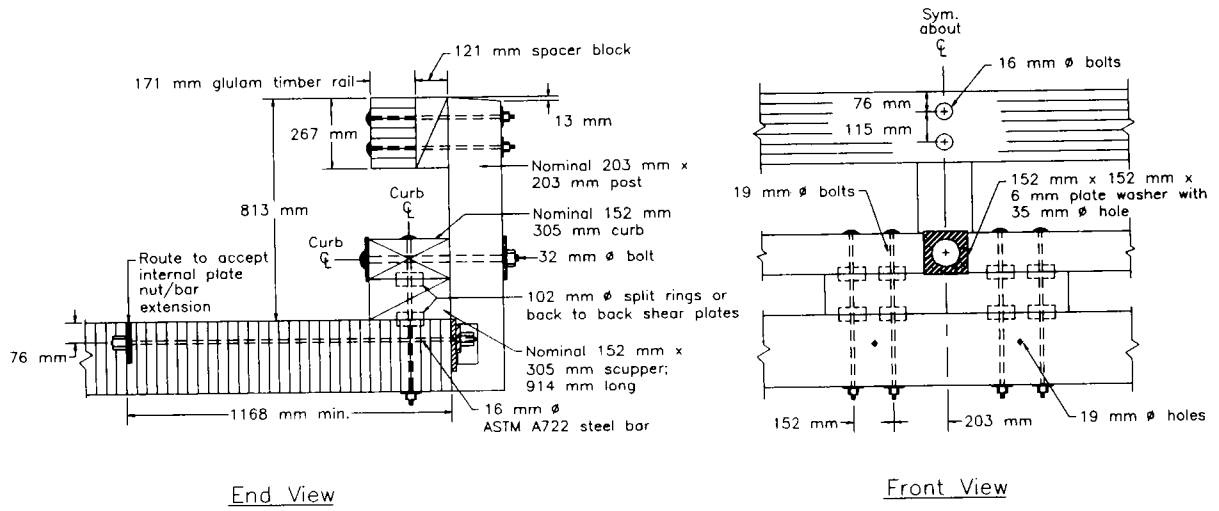
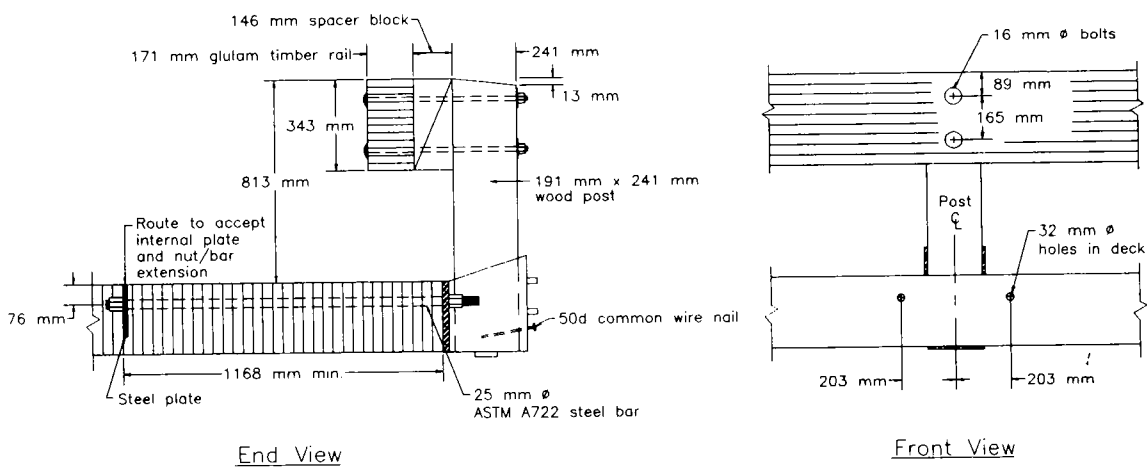
FIGURE 3 Drawings of bridge railings successfully crash tested to AASHTO PL-1: top, glulam timber rail with curb; middle, glulam timber rail without curb; bottom, steel rail.

The three tested PL-1 railings included a glulam timber railing with curb, a glulam timber railing without curb, and a steel thrie beam railing. Photographs and drawings of the PL-1 railings are shown in Figures 2 and 3, respectively.

The glulam timber railing with curb consisted of a single glulam timber railing mounted on a sawn lumber post. The post was connected with a single bolt to a lumber curb that was supported by scupper blocks. The curb and scupper blocks were connected to the bridge deck with bolts and timber connectors.

The glulam timber railing without curb consisted of a single glulam timber railing mounted on a sawn lumber post. The lower portion of the post was placed in a steel box that was attached to the bridge deck with high strength steel bars.

The steel railing consisted of a 10-gauge steel thrie beam railing mounted to a steel, wide flange post. The lower end of the post was bolted to a steel plate that was connected to the bridge deck with high-strength steel bars.
