Candle Power of Rear Lights on Trucks

EDMUND R. RICKER, Traffic Engineer
New Jersey Turnpike Authority

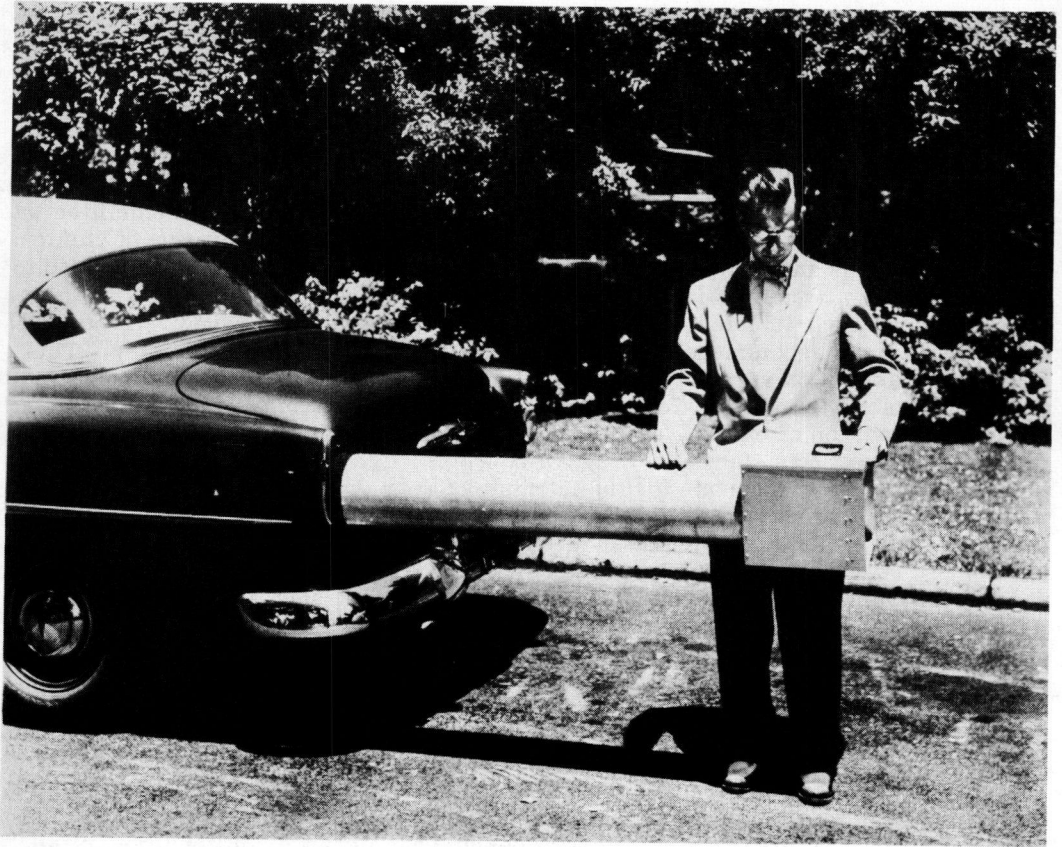
The committee asked the Nela Park Laboratory of the General Electric Company to construct an experimental photometer to make direct measurements of the output of vehicle tail and stop lights. This device is shown in Figure 1. It consists of a baffled photometric tube, lens, barrier-layer cell, microammeter and appropriate switches and circuitry. It is balanced about a carrying handle and the total weight is less than three pounds. The major dimensions of the device are taken up by the hollow tube which is 8 inches in diameter and 4 feet long, for the purpose of providing a constant photometric distance of 4 feet as used in other tail light requirements. The end to be placed against the tail lamp is padded with $1\frac{1}{2}$ inches of sponge rubber with a tapered hole which accepts the tail lamp and allows a 4-inch diameter or smaller source to be measured. At the opposite end of this tube is a plastic fresnel lens which focuses the light from a 10 degree cone onto the face of the barrier-layer cell. Two microammeters with scaled ranges of 0 to 0.8 and 0 to 20 candle power are used to measure the cell current. Two buttons positioned under the fingers of the operator's left hand select the appropriate scale range. A special calibration device was also provided consisting of a red sealed-beam type lamp having a suitable beam distribution and two filaments to simulate tail and stop lamp ranges and distribution. It is operated from a separate six volt DC source.

It must be understood that this device is experimental in nature and does not represent a direct measurement of any existing legal requirements for lamp output. The design is such that the candle power reading is obtained by the integration of light over a 10 degree cone, and all readings reported in later paragraphs are stated in these terms, rather than in light output at specific points. As a very rough relationship to the requirements of the Society of Automotive Engineers, the equivalent integrated candle power is approximately one-half the "on-axis" requirement, which, according to current standards, is 1.5 candle power for tail lamps, 15 candle power for stop lamps,
