# Emulsified Petroleum Oils and Resins in Reconstituting Asphalts in Pavements

B. A. VALLERGA, Vice President, Products Engineering and Marketing, Golden Bear Oil Co., Bakersfield, Calif.

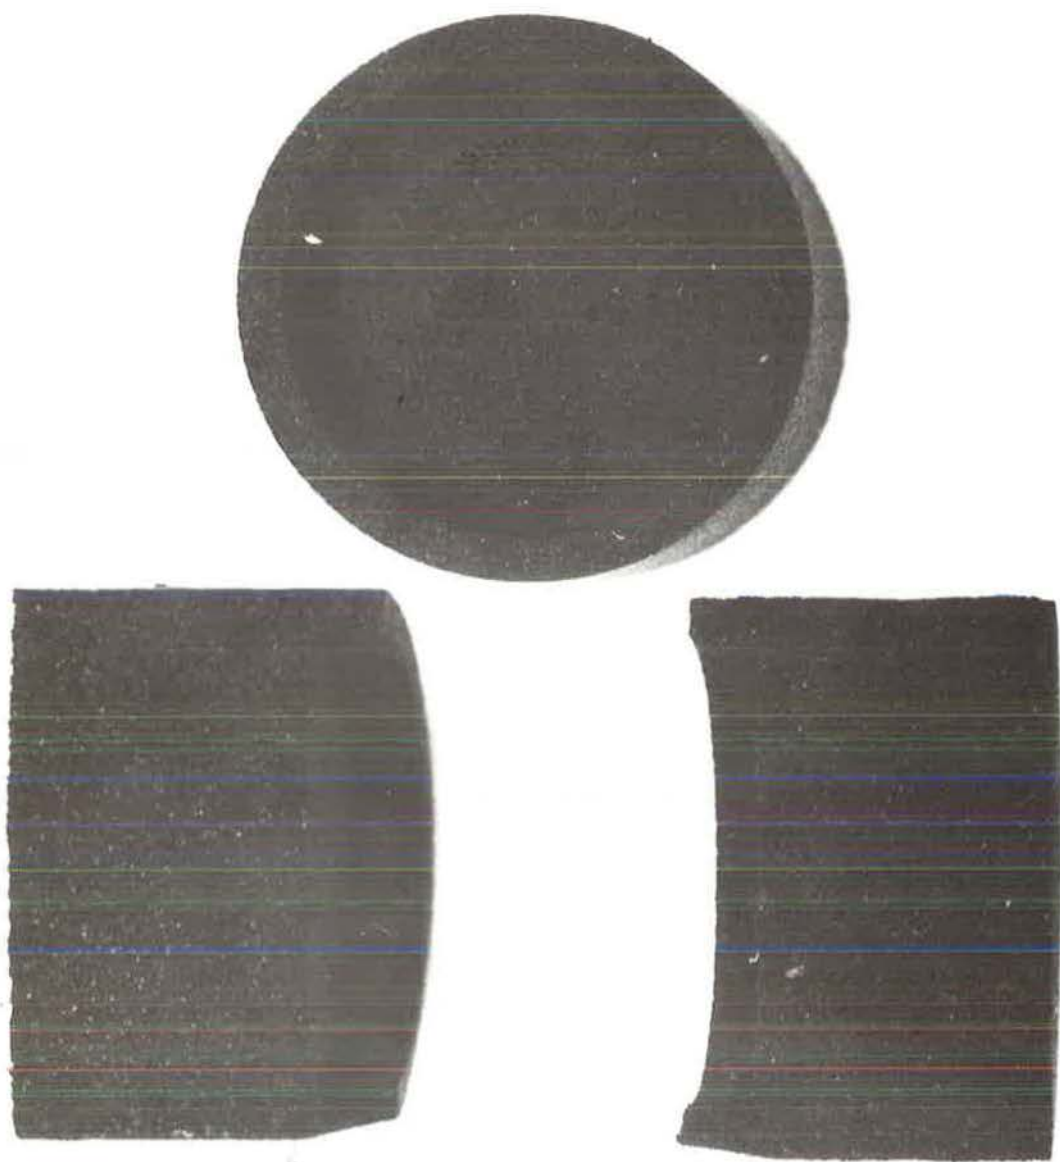
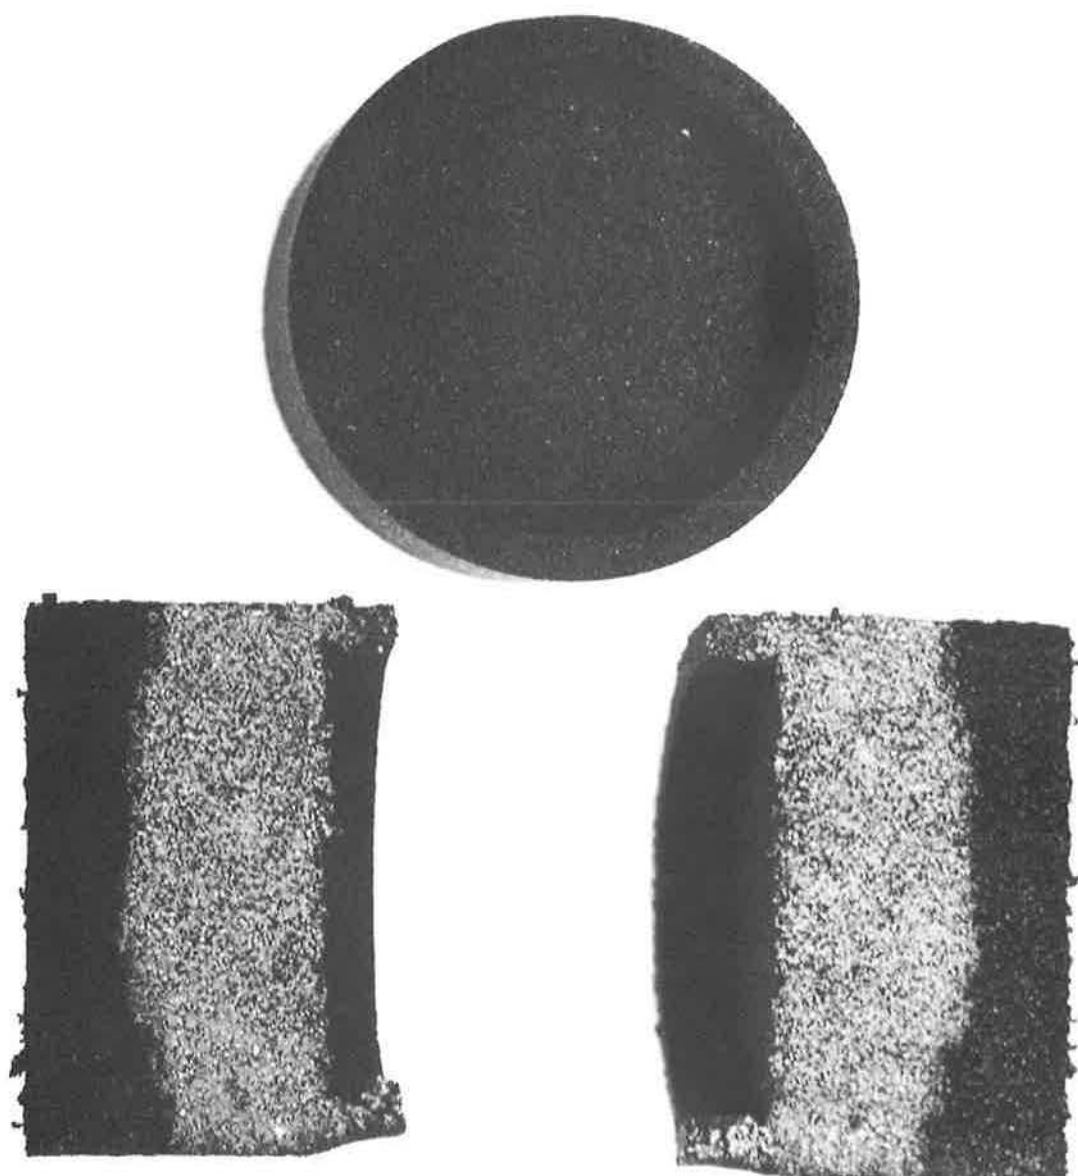
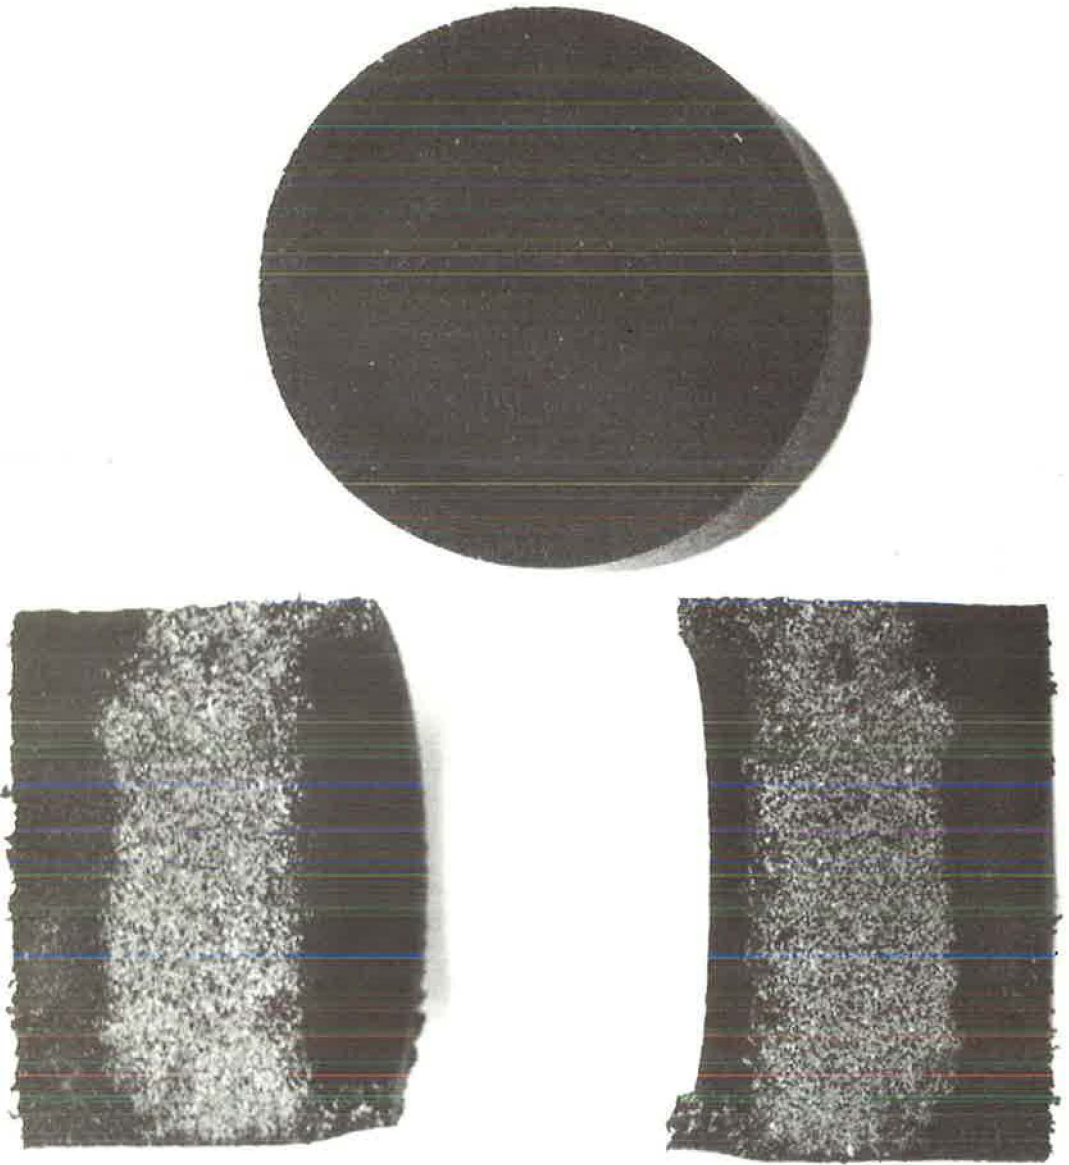
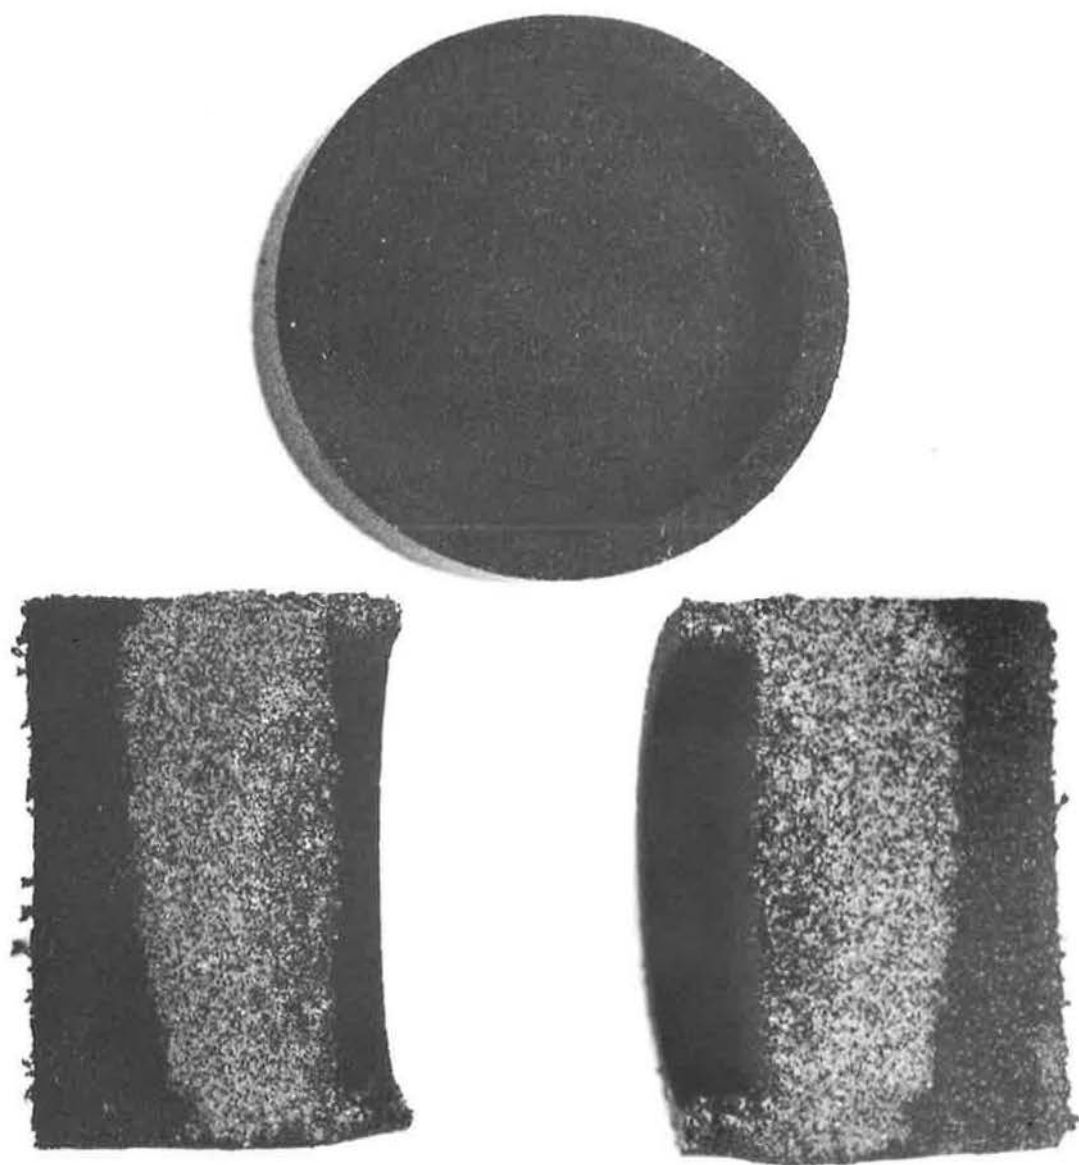
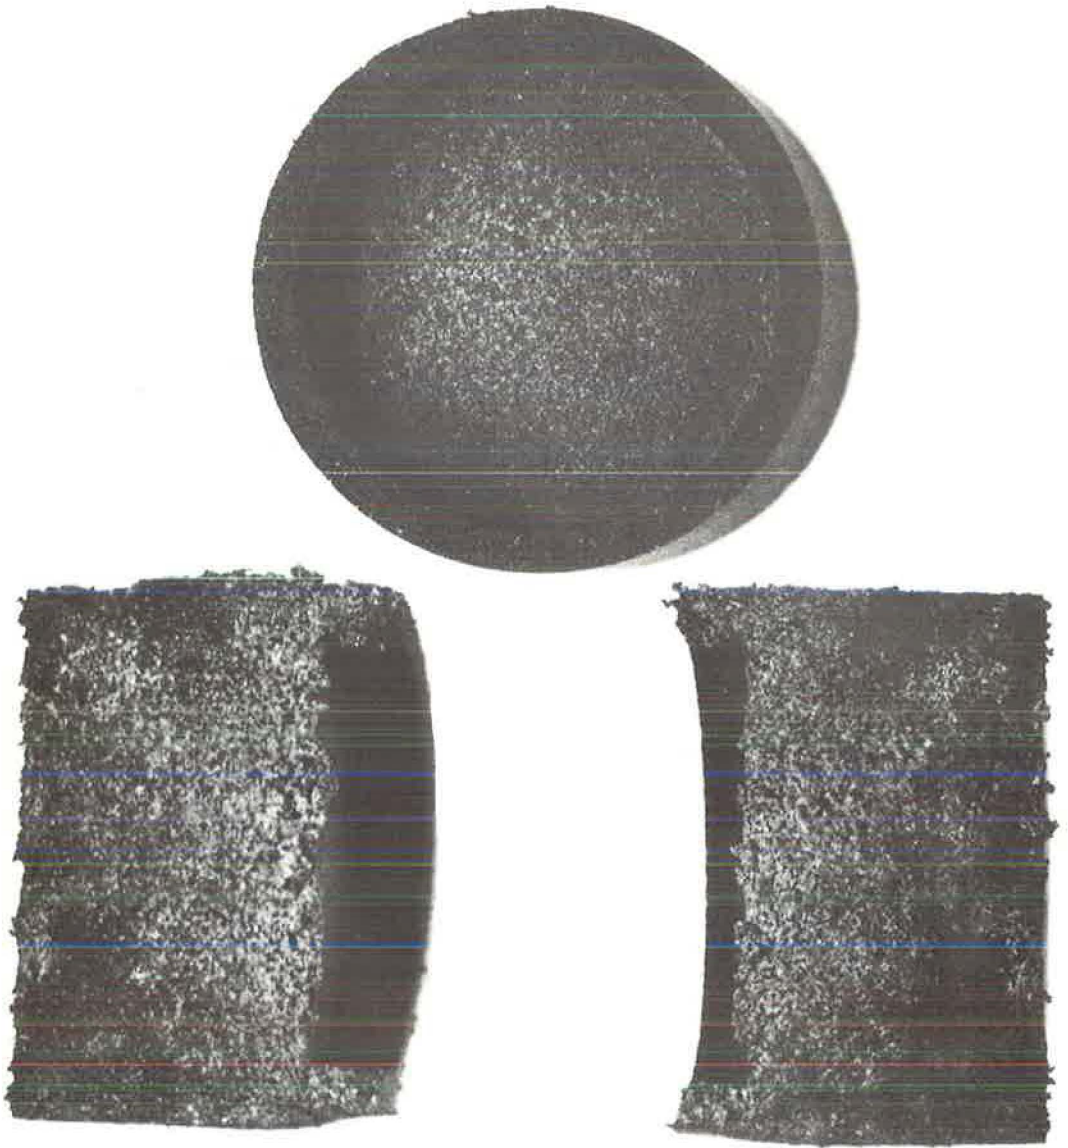
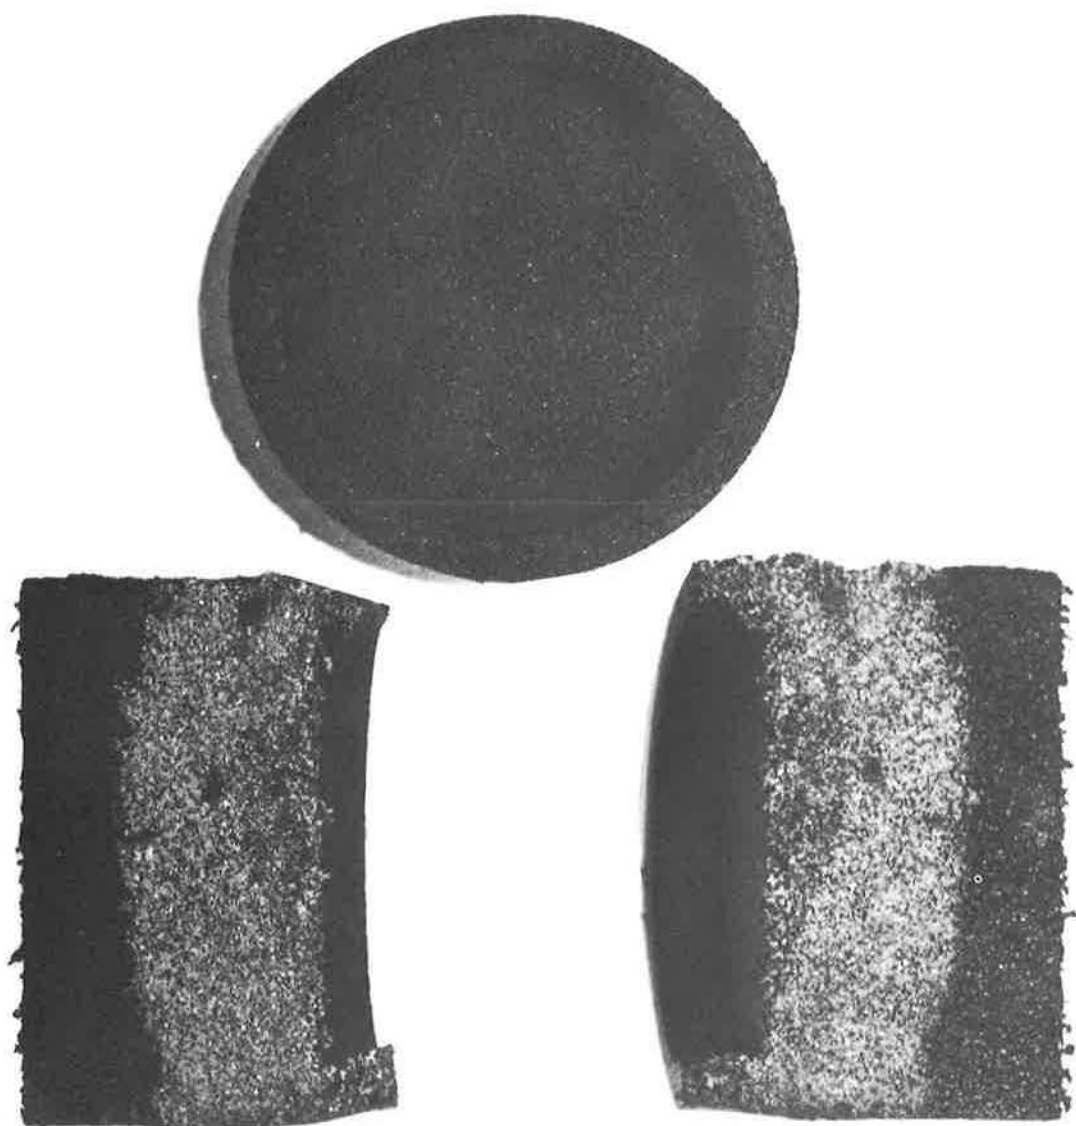
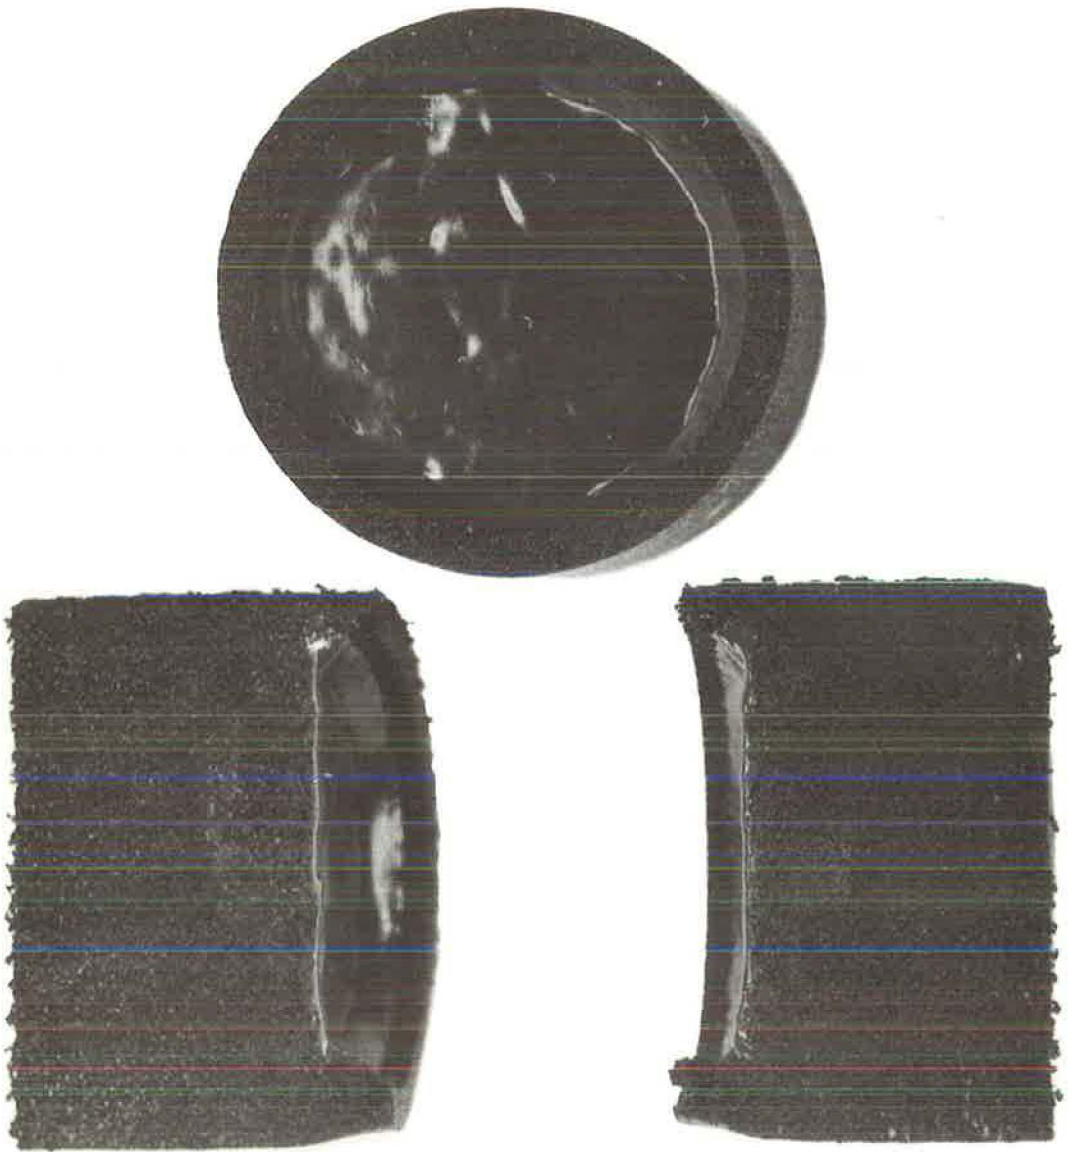
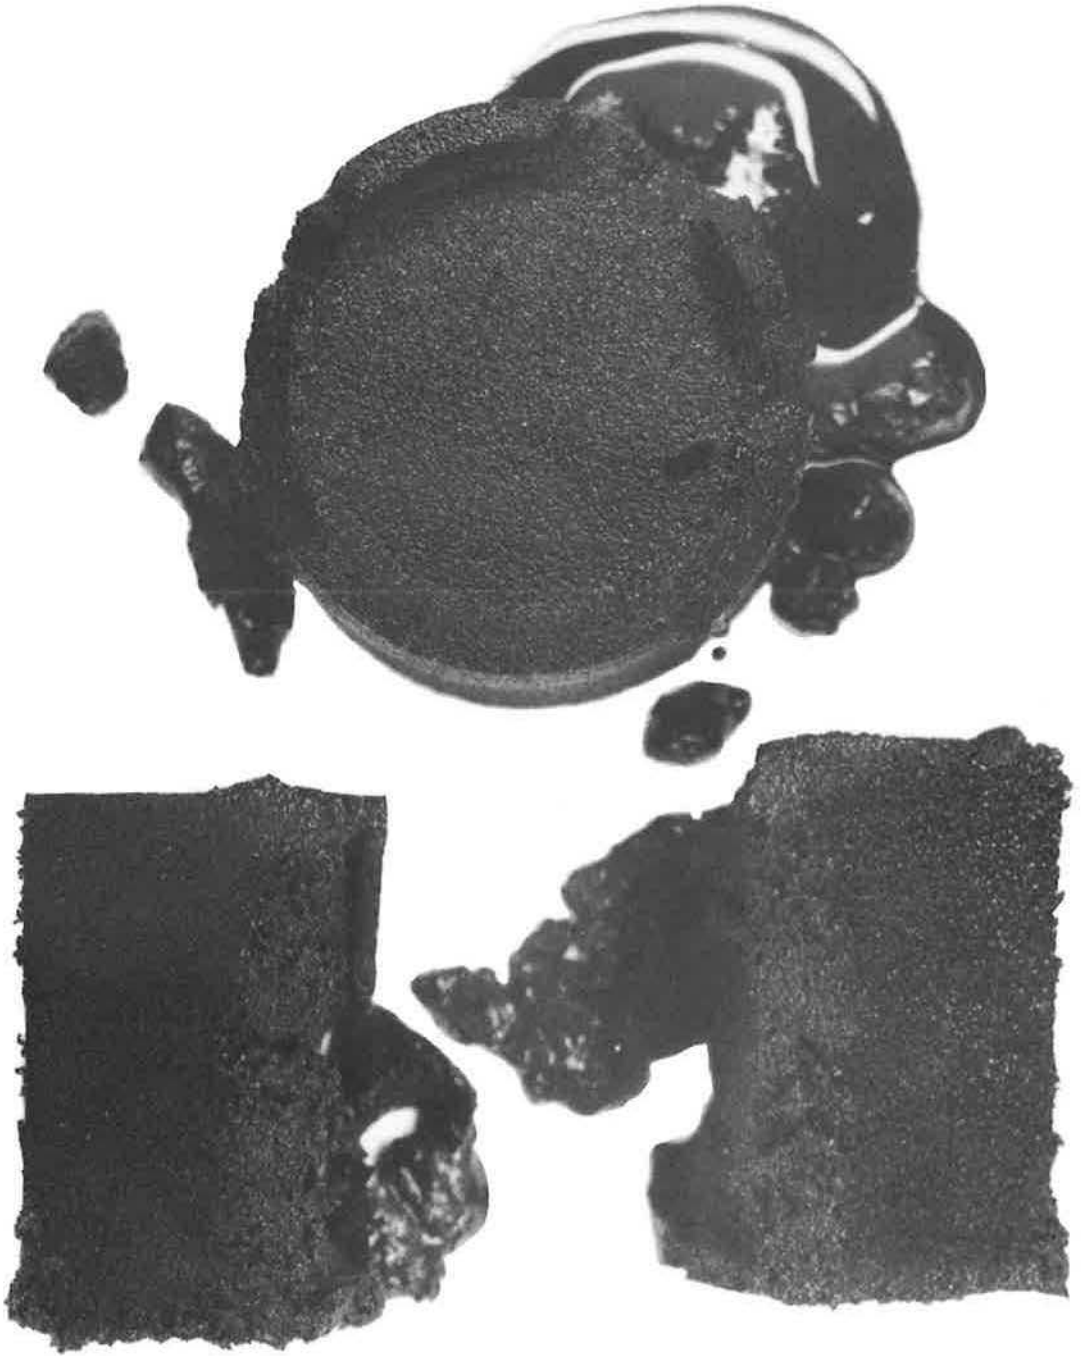
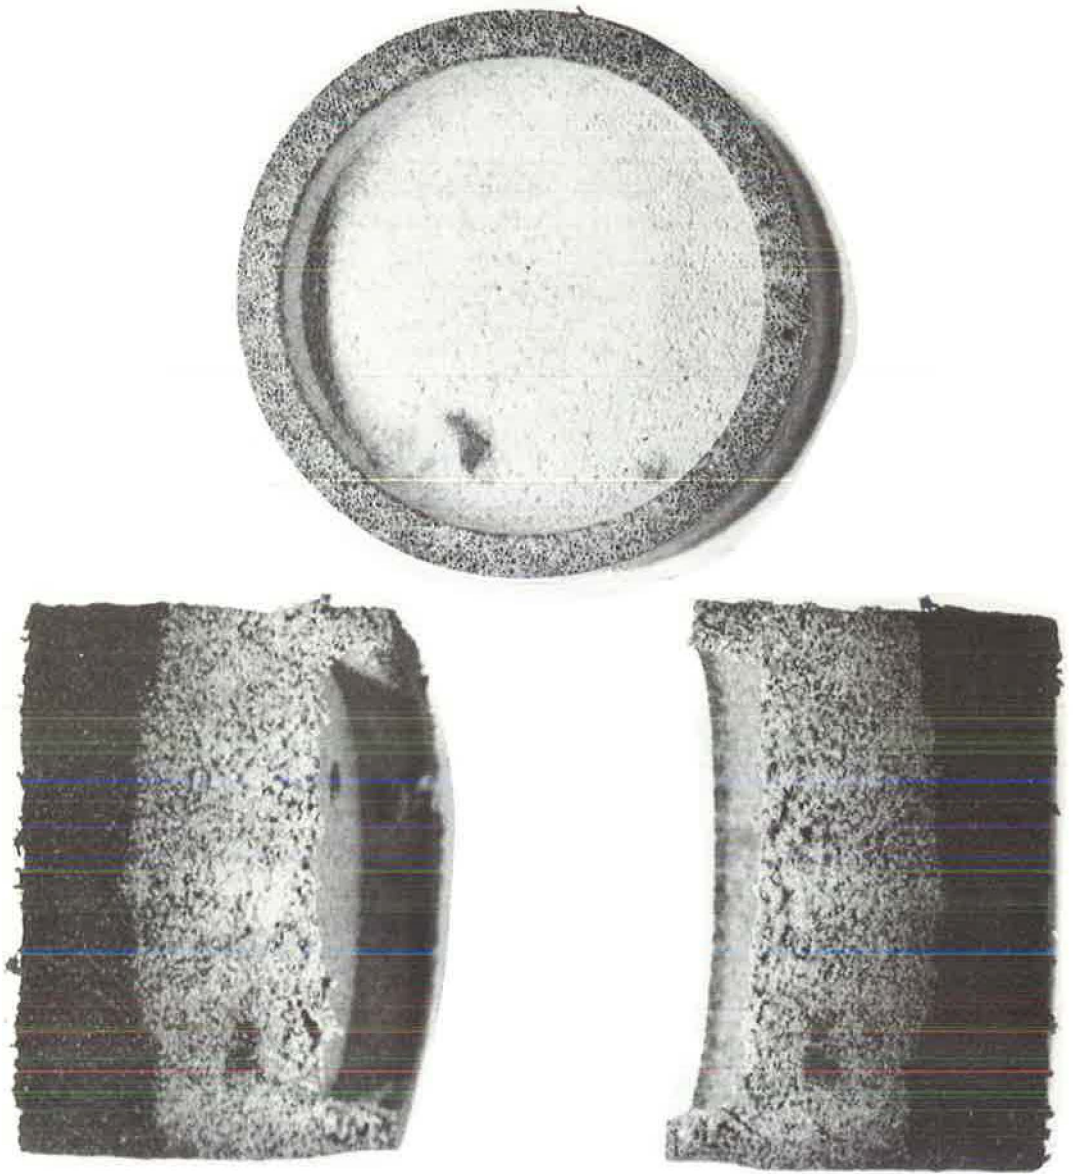
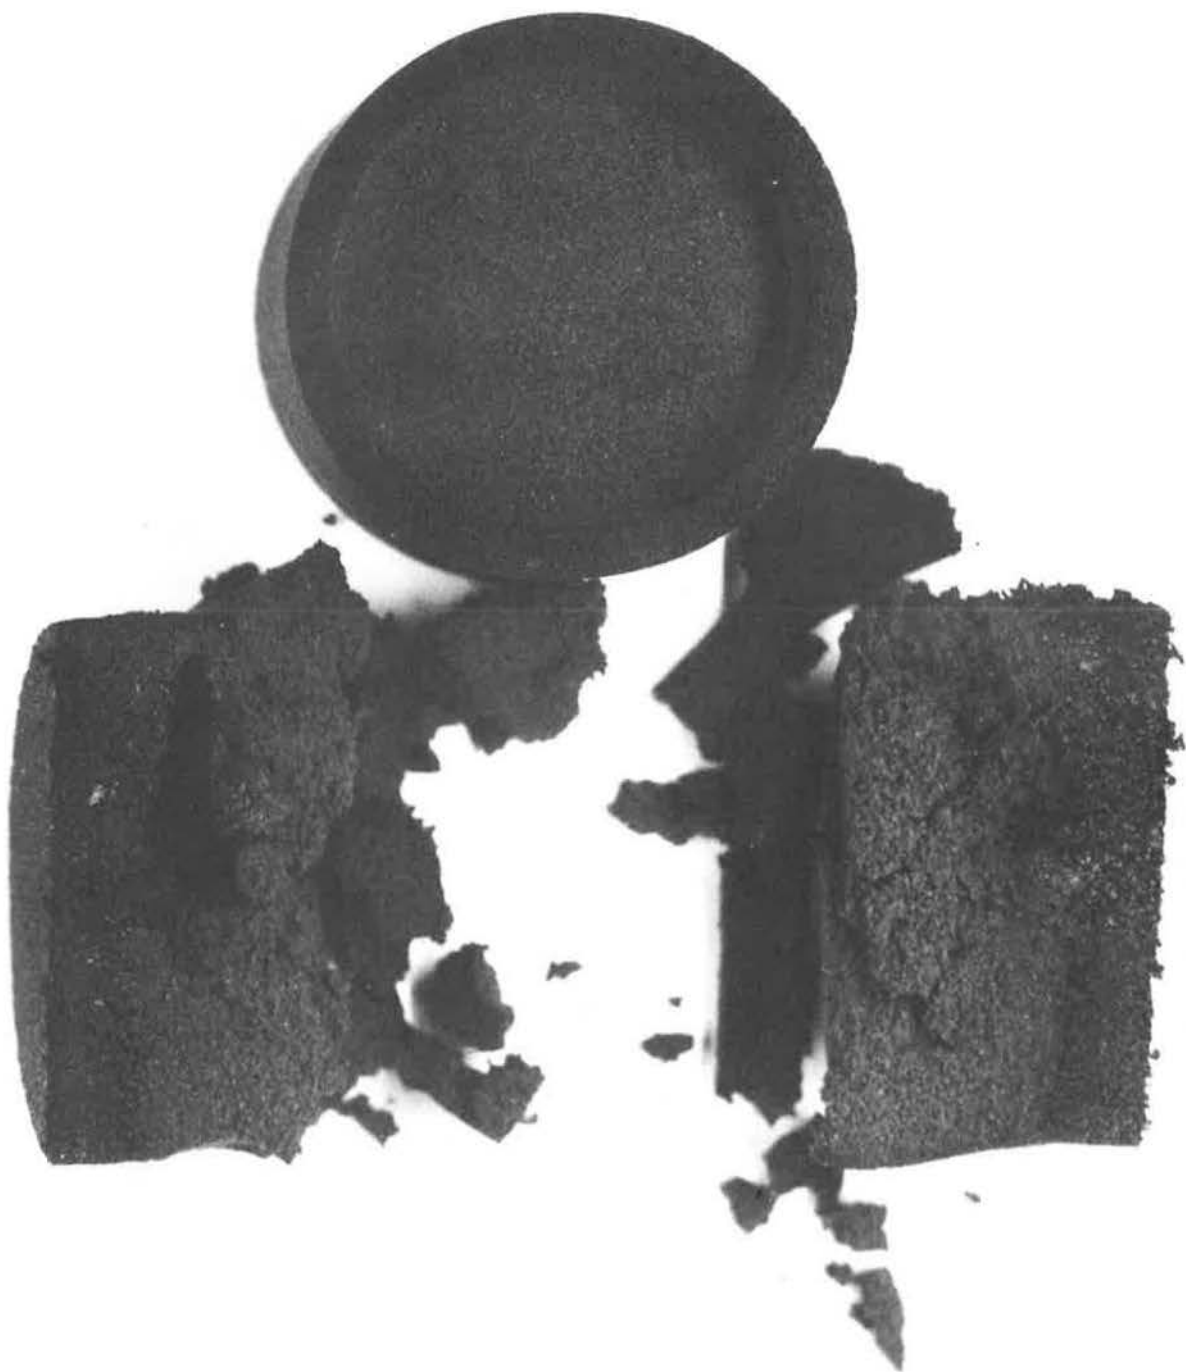
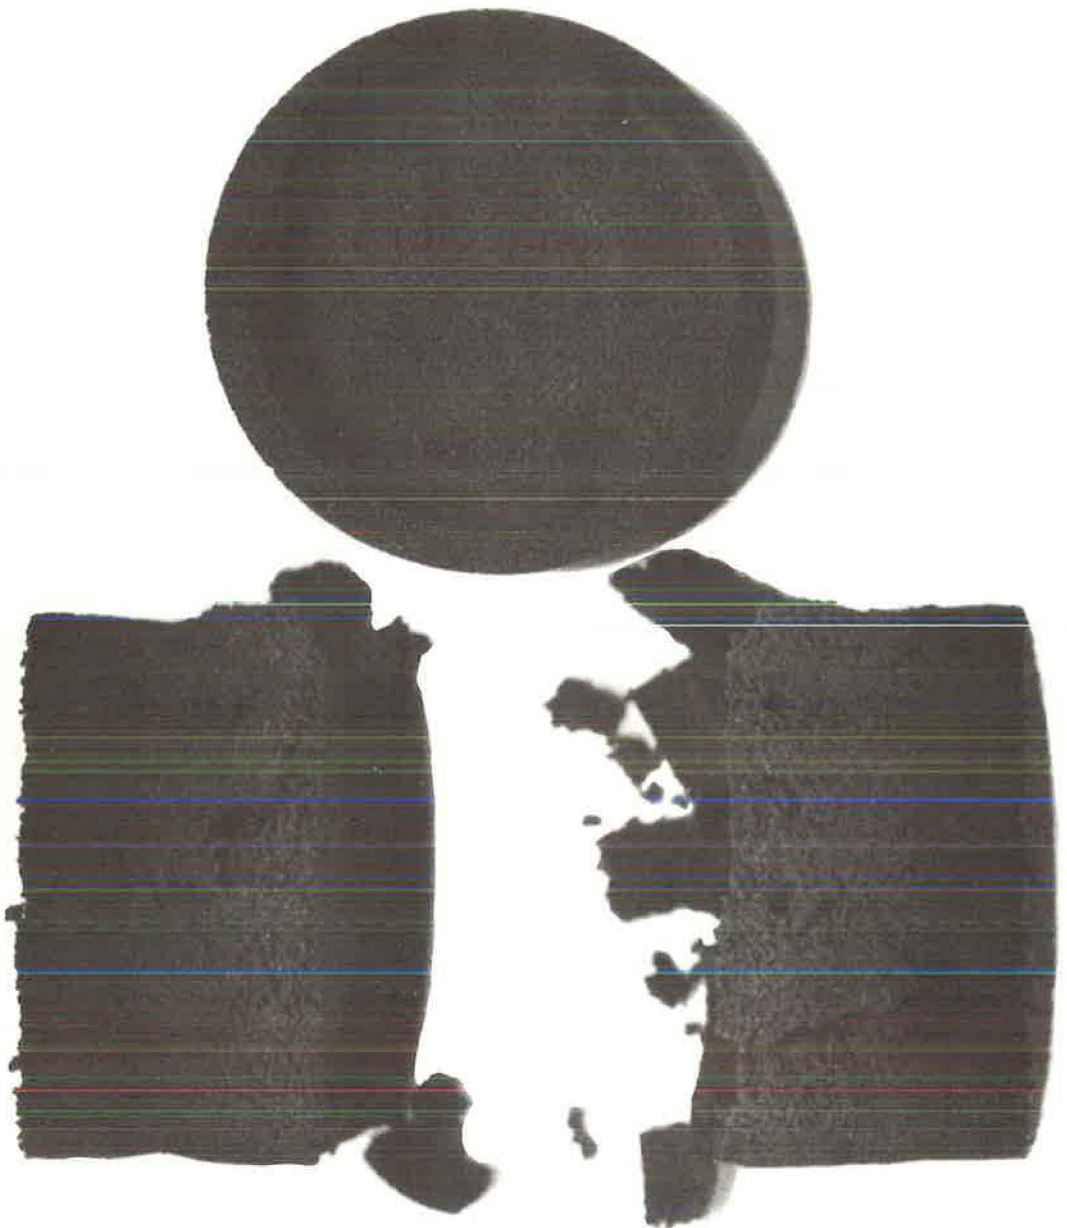
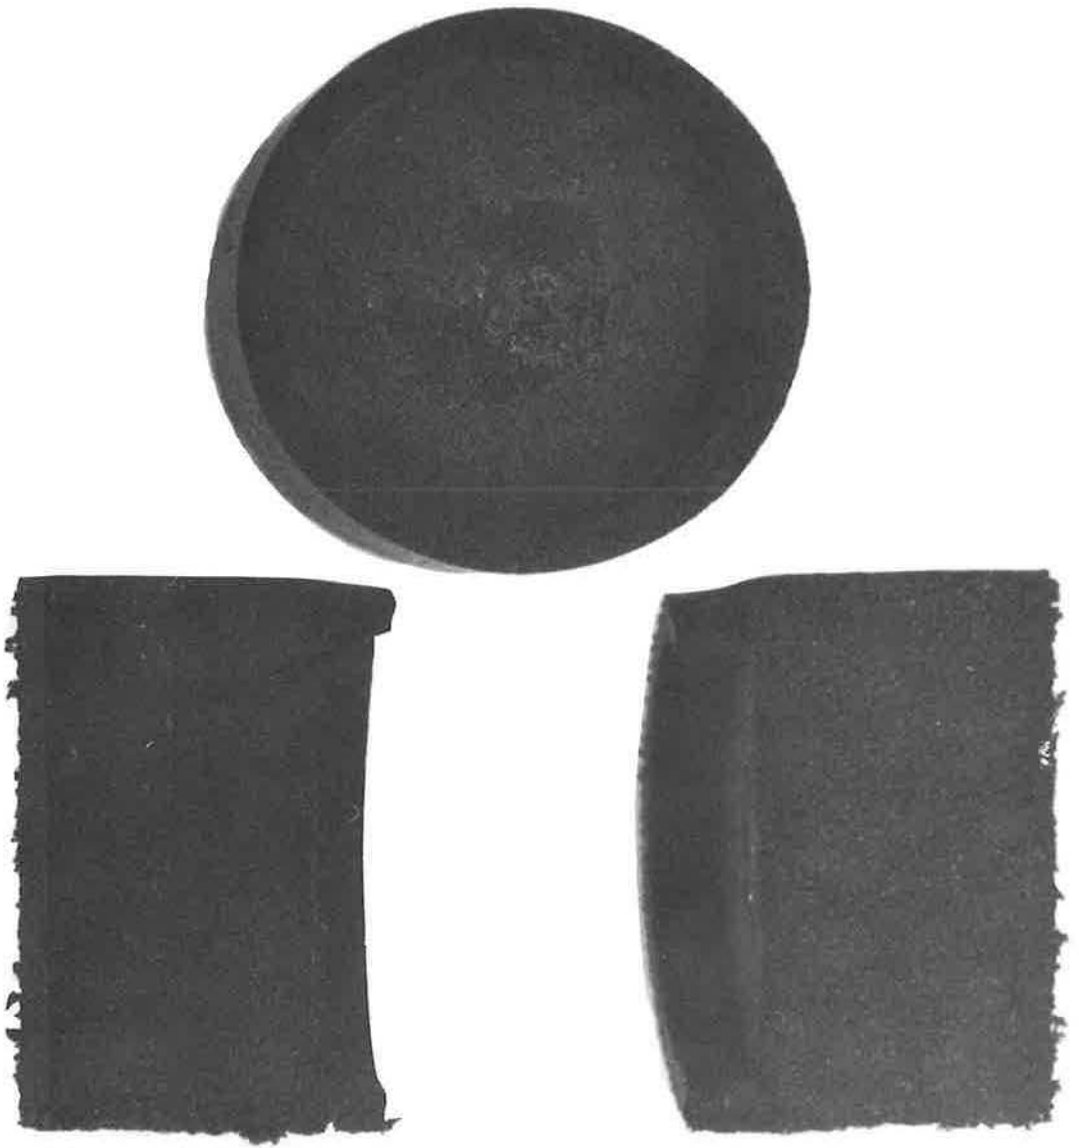
Figures 1 through 12 show the briquets in ultraviolet light used to determine the penetration depth of the fluorescent oils and resins. The procedure was to split one of duplicate briquets and measure depth of penetration to the nearest 0.01 in. As is evident from Table 2, the average depth of penetration for the maltenes in any form of application was virtually the same. The only anomaly was the anionic emulsion that ran through the briquet and out the bottom. This was anticipated, however, because of the repellent nature of the asphalt-coated surfaces to negatively charged particles.

It is evident (Table 2) that a relatively rapid rate of penetration was obtained with all forms of emulsion systems, except the asphalt emulsion (grade SS-1, diluted 2:1 with water) which did not penetrate but formed an asphalt skin at the surface when the water phase evaporated. When applied directly, without a carrier, the oils and resins penetrated very slowly over a 24-hr period. However, the oils and resins, when dissolved in kerosene, also penetrated rapidly.

The briquets were relatively impervious to plain tap water, but with the wetting agent added water penetrated readily. The water with wetting agent even penetrated the treated briquets, but at a much slower rate. This serves as a measure of the relative effect on pavement permeability of these various treatments. The last column (Table 2) indicates that all emulsion systems tested are more effective in decreasing the permeability of an asphalt-aggregate mixture than are the kerosene cutbacks. Moreover, although the SS-1 asphalt emulsion formed a membrane, water still managed to permeate through.

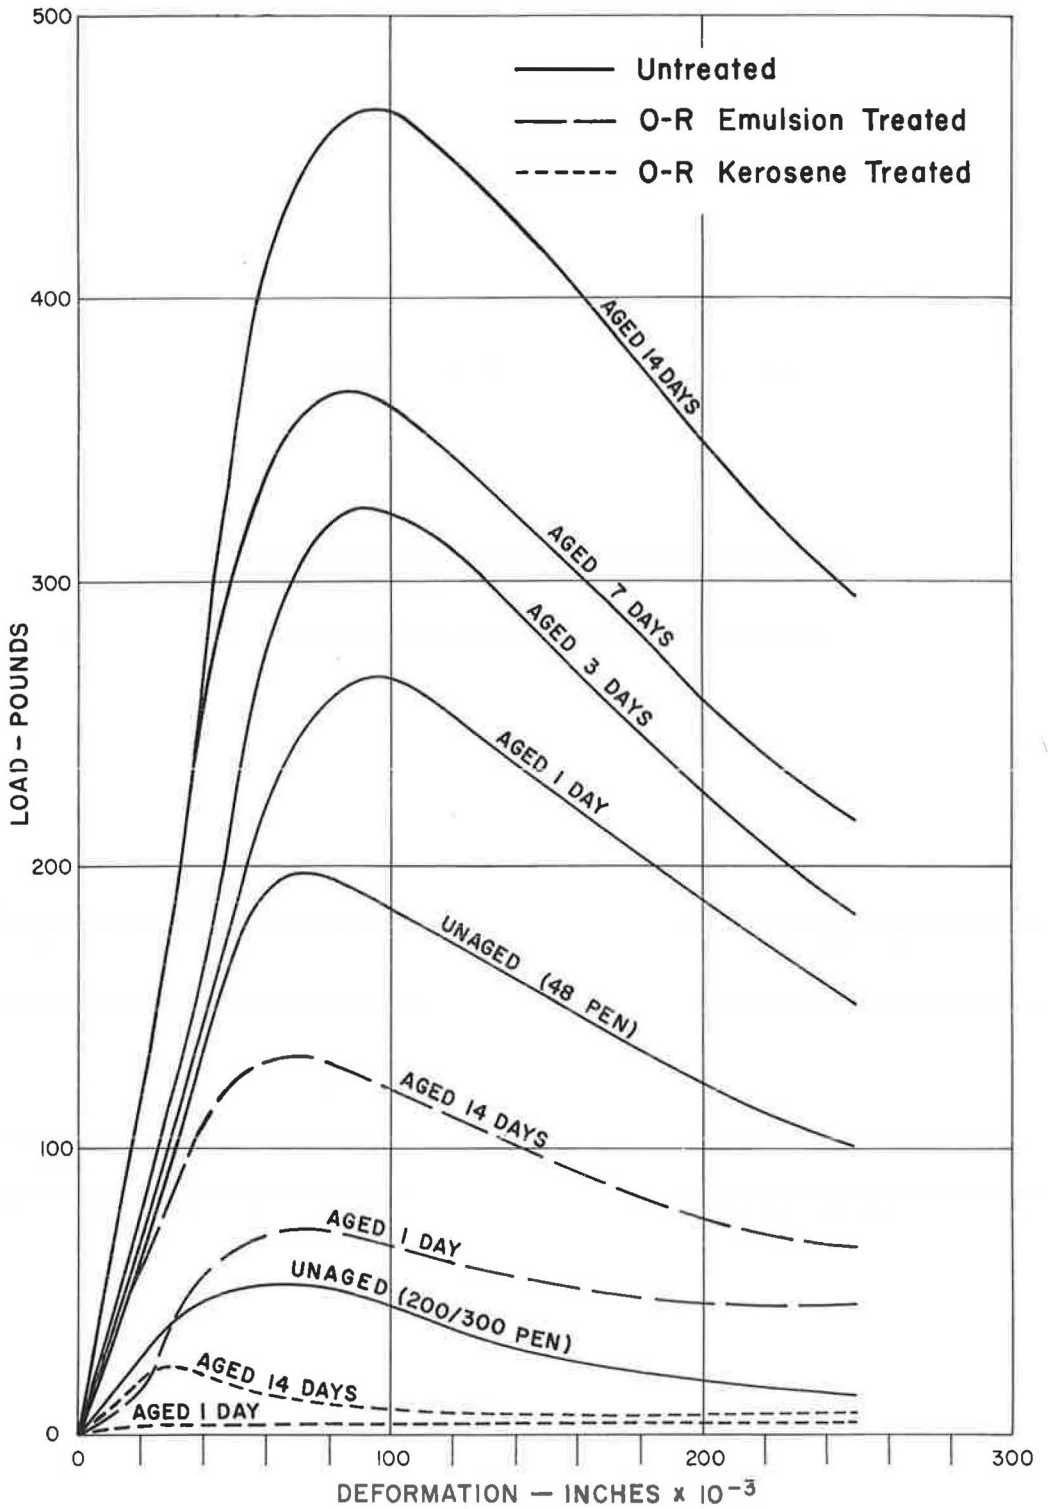
Figure 13. Effect of cationic maltenes emulsion and maltenes solution in kerosene on load-penetration test at various agings in infrared oven.

An improvised load-penetration test was run on the same type of briquet to evaluate the effect of the cationic emulsion of maltenes on the cohesiveness of asphalt as compared to other dilution systems and materials. An apparatus applied load to the treated end of the briquet through a 1.128-in. diameter (1.0 sq in.) piston at a strain rate of 0.25 in. per min to a total deformation of 0.250 in. The data obtained from this test are relative but valid for the series of briquets tested. The apparatus and the test are described in Appendix B. Resulting load-deformation diagrams are shown in Figure 13. A refinement of this test is under development.

To establish reference points, two load-deformation curves are shown for freshly-mixed briquets made with 7½ percent by weight of 48-penetration and 200-

300-penetration asphalts. All other curves represent various treatments of a reference briquet made with 48-penetration asphalt at various ages. The briquets were aged in the infrared oven described elsewhere (2, App. III). The oven is automatically controlled so that the temperature within the briquets is maintained at 140 F during the specified aging time.

Figure 13 indicates that kerosene as a carrier destroys the cohesiveness of asphalt binder and that proper cohesion cannot be regained even after 14-day exposure at 140 F in the infrared oven because the kerosene has dislocated the asphalt-cement between the points of aggregate contact. In contrast, the emulsion system for introducing the maltenes does not displace the asphalt bonding the aggregate particles; in all cases, the briquets resist load penetration exceeding that of 200- to 300-penetration asphalt, although the consistency of the binder has been lowered. Figures 17 and 20 show the difference in behavior.

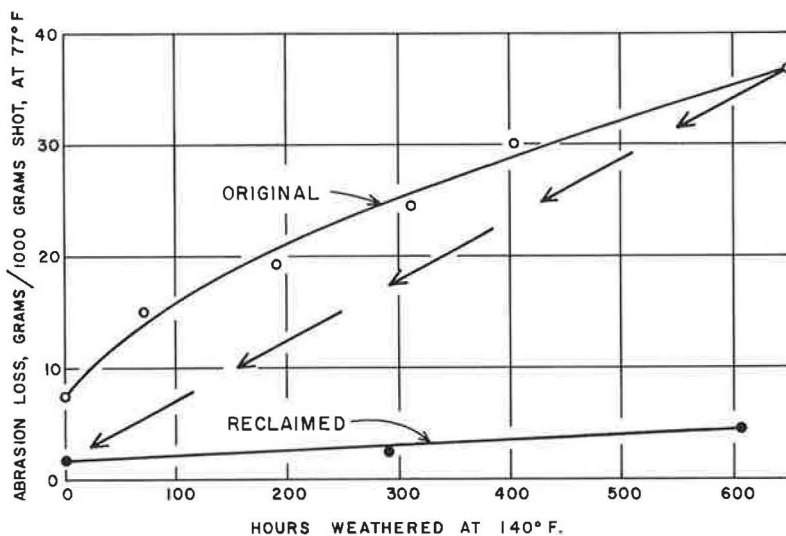
Figure 14. Durability of a 200- to 300-penetration asphalt before and after reclaiming with selected maltenes fraction (2).

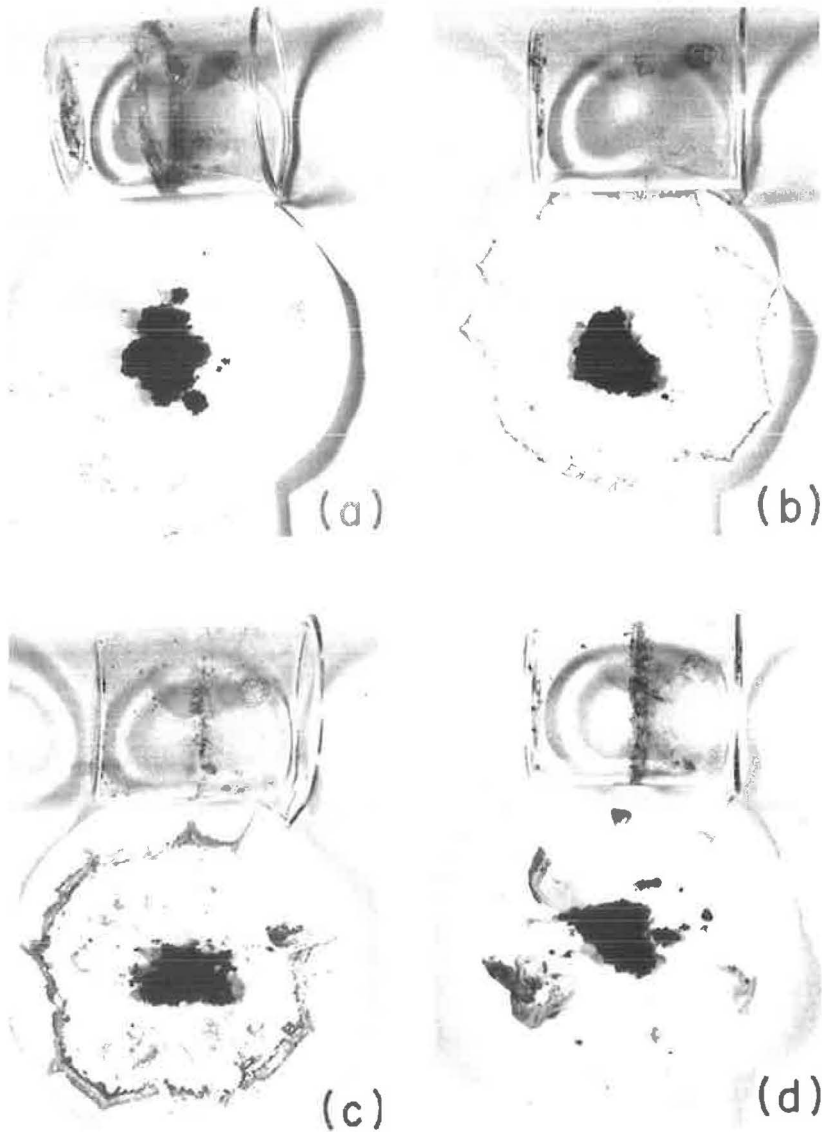
Figure 15. Effect of treatments on stripping resistance of sand-asphalt mixture when exposed to water at boiling point: (a) control, untreated; (b) cationic maltenes emulsion; (c) nonionic maltenes emulsion; and (d) maltenes solution in kerosene.

Figure 15 shows that most of the asphalt was stripped off the sand grains in the untreated control pellet and all of the treated pellets, except the one treated with the cationic emulsion of the maltenes. Although little stripping was noted in the cationic sample, that which occurred came from asphalt at the bottom of the pellet where the treatment did not reach.

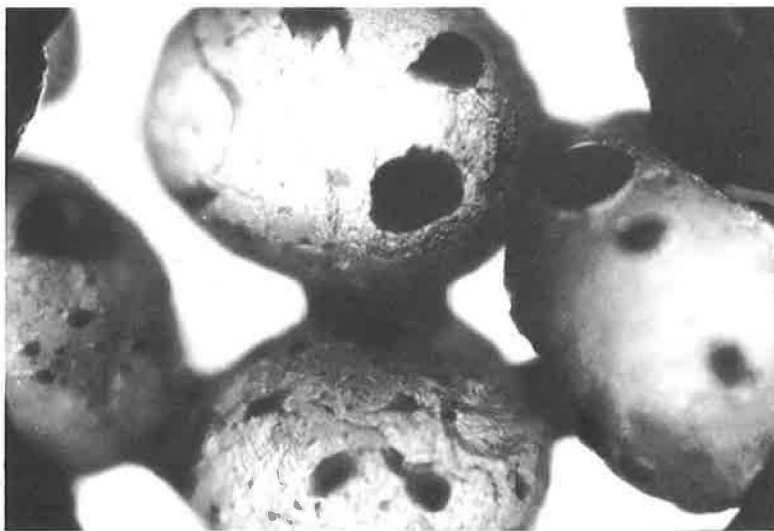
Figure 16. Photomicrograph before stripping test of untreated sand-asphalt mix (see Fig. 15a).

Fragments of the treated pellets were examined under a microscope to observe the effect of the treatment and aging procedure on the asphalt cementing the sand grains in the pellets. Figures 16 to 20 are photomicrographs of the specimens. The control (Fig. 16) shows the type of bond prevailing in such mixes after aging. Improvement in the bonding accomplished by the cationic emulsification system, which causes the maltenes to wet preferentially the asphalt portion of the asphalt-sand mixture, is shown in Figure 17.

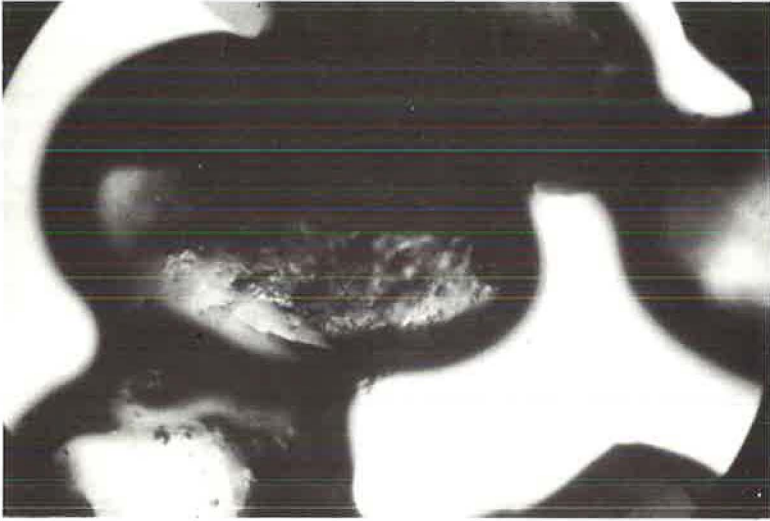
Figure 17. Photomicrograph before stripping test of cationic maltenes emulsion treated sand-asphalt mix (see Fig. 15b).

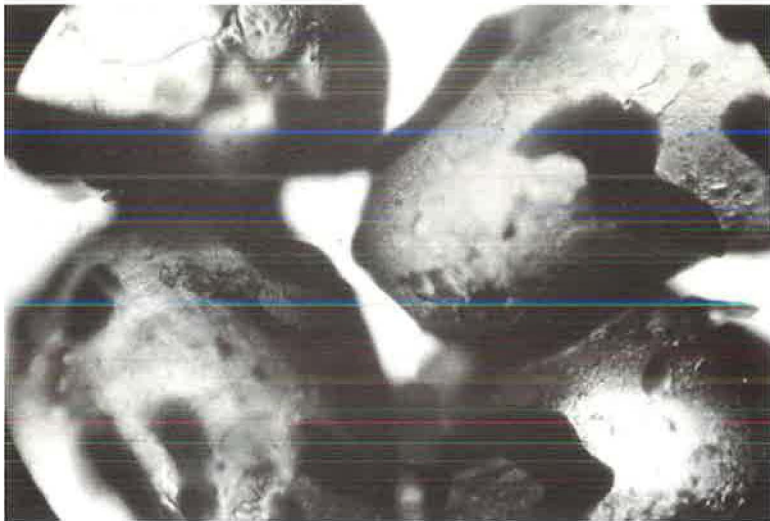
Figure 18. Photomicrograph before stripping test of nonionic maltenes emulsion treated sand-asphalt mix (see Fig. 15c).

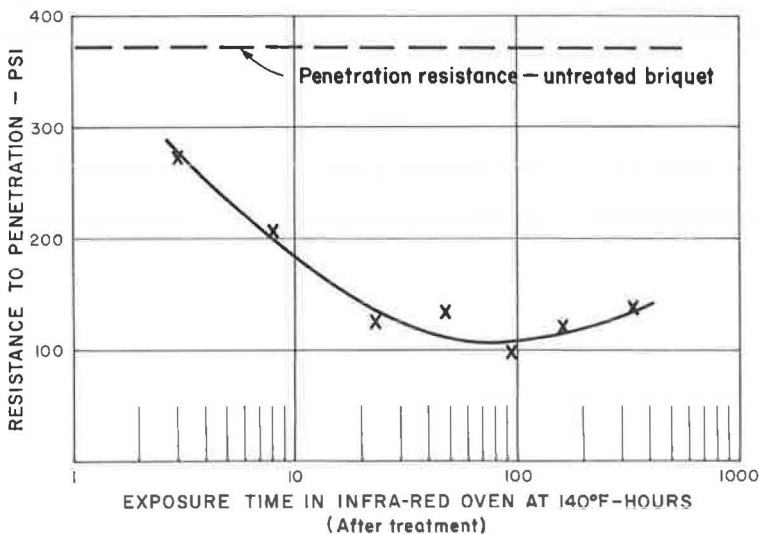
Figure 21. Load-penetration vs aging time as measure of time required for fluxing of maltenes with aged asphalt.

At least 20-hr exposure in the infrared weathering oven at 140 F was needed in this case for the full effect of the cationic emulsion treatment to take place. In terms of field conditions, this would be roughly equivalent to a two-month period under average weathering conditions for the year. Accordingly, the time interval should be considerably less during the hot summer months (1 to 3 days) and somewhat longer in the

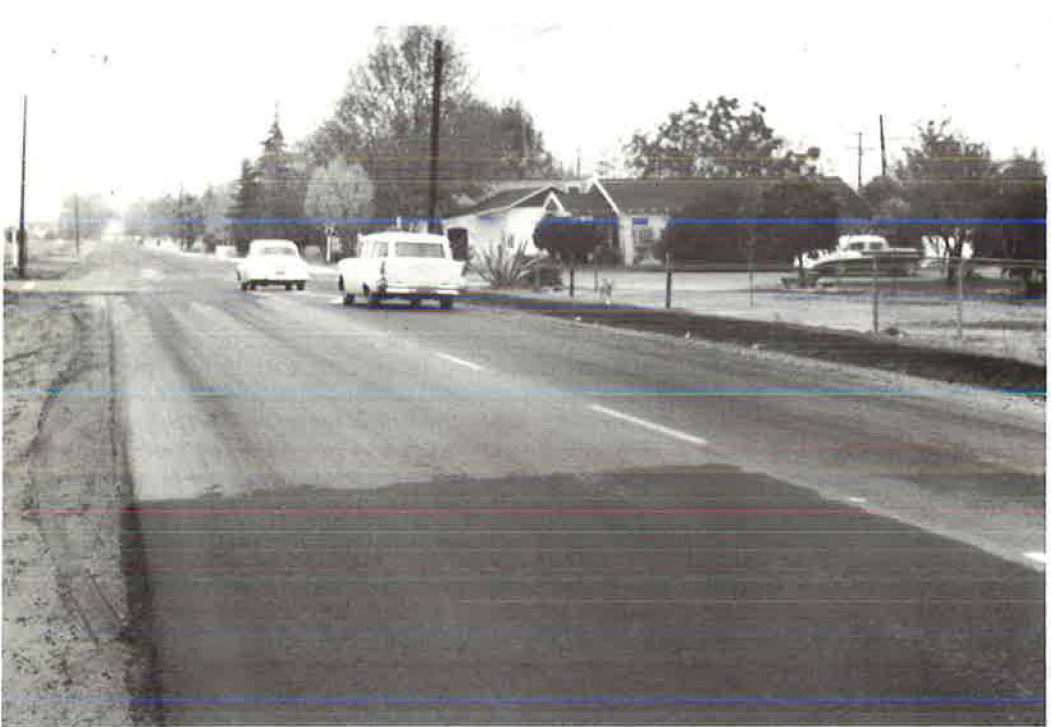
Figure 22. Asphalt section treated with cationic maltene emulsion as construction seal: after rainstorm treated section dried quickly (background); untreated portion retains water in pores (foreground).

In new construction, the object of the treatment is to insure plasticity and improve the durability characteristics of the freshly-placed mix, while providing a construction seal to reduce permeability. This treatment applied after the asphalt paving has been spread and compacted serves two purposes: (a) it penetrates the surface and combines with the asphalt to restore the durability lost in the mixing cycle at the hot plant; and (b) it combines with the asphalt and causes the asphalt to expand and block the pores of the pavement, thereby sealing the pavement to the depth of penetration (Fig. 22).
