# Emulsified Petroleum Oils and Resins in Reconstituting Asphalts in Pavements

B. A. VALLERGA, Vice President, Products Engineering and Marketing, Golden Bear Oil Co., Bakersfield, Calif.

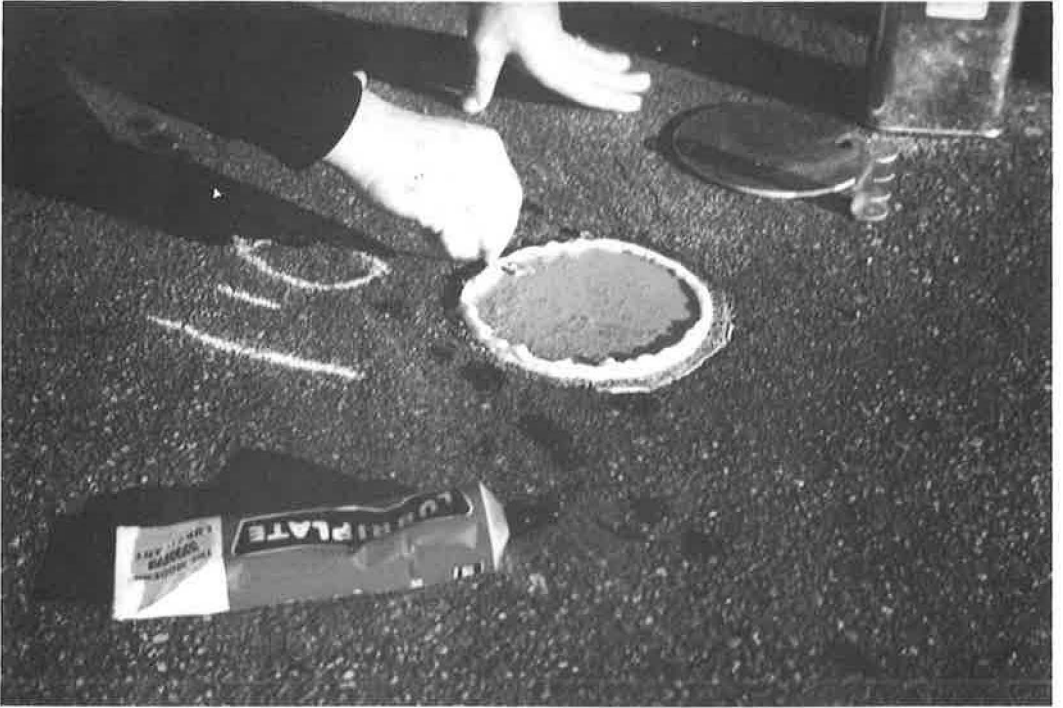
Figure 23. "Grease ring" permeability test.

In the case of preventive maintenance and prime coating, the rate of spread is determined by the "grease ring" permeability test procedure (Fig. 23) described in Appendix C, using the criterion that the minimum spread rate is that quantity which soaks into the pavement in a 15-min period. In new construction seals, a spread rate of 0.2 is generally used for a 2-in. lift or more, and about 0.05 gal per sq yd is used in tack coating.

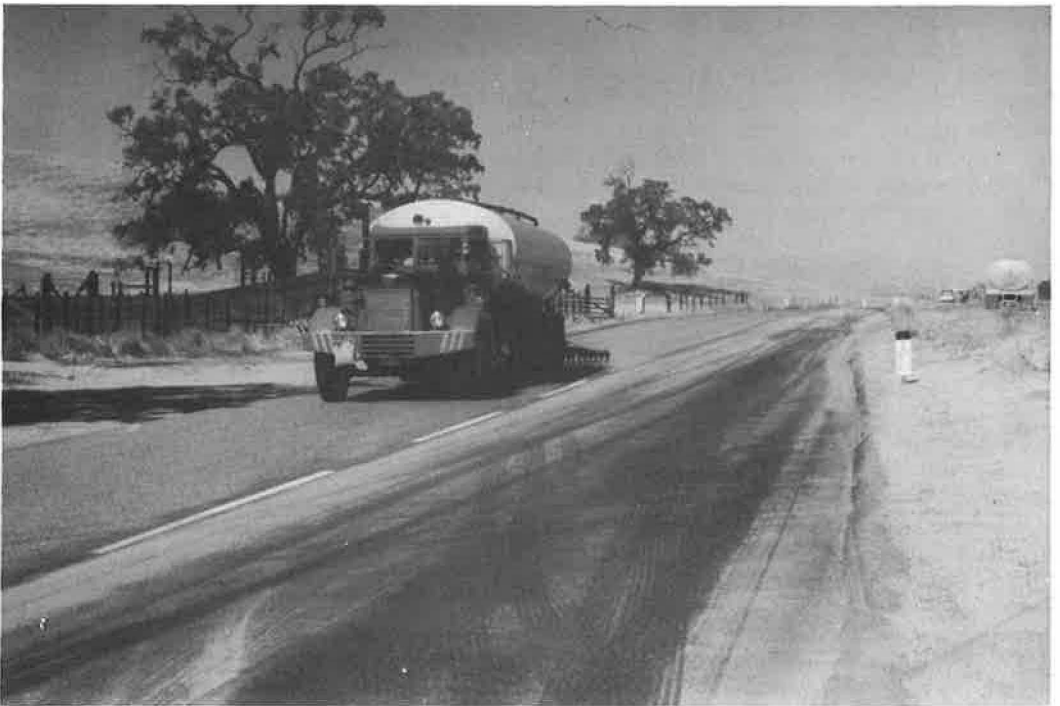
Figure 24. Spraying cationic maltenes emulsion in preventive maintenance; right lane lightly sanded.

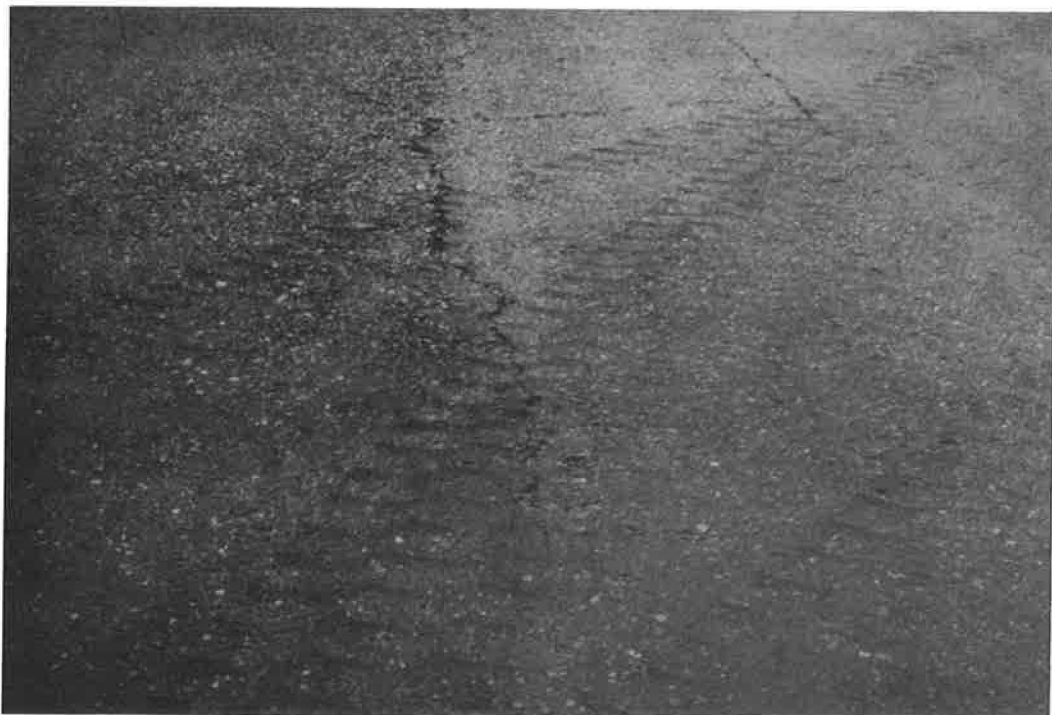
Figure 25. Taxiway at Edwards AFB viewed from treated area toward untreated control section.

In the last 3 ½ years, the surface of the untreated control section has pitted severely, the asphalt has been stripped from the aggregate at the surface and large shrinkage cracks have gradually developed and expanded. A recent survey found that the sides of the shrinkage cracks are breaking off and spalling badly because of extreme brittleness. These cracks meander over to the boundary of the treated area and gradually fade out (Fig. 25). To date, no cracking has started in the treated test areas.

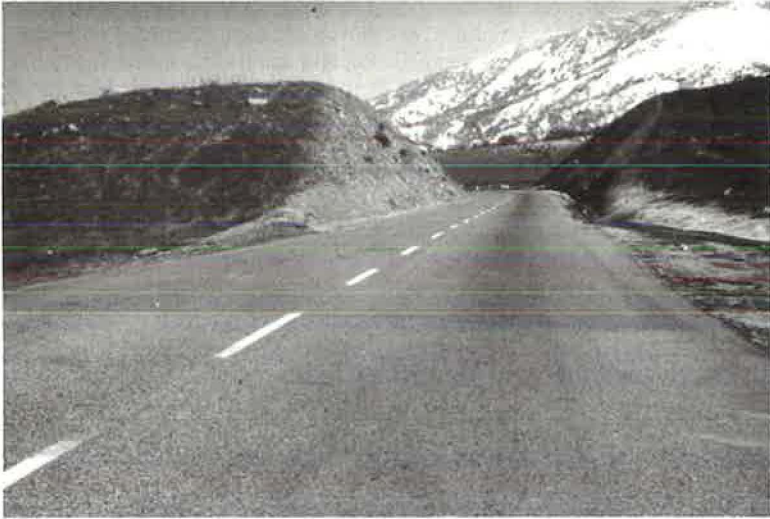
Figure 26. White Wolf Grade section six months after treatment: treated lanes in background; untreated lanes in foreground.

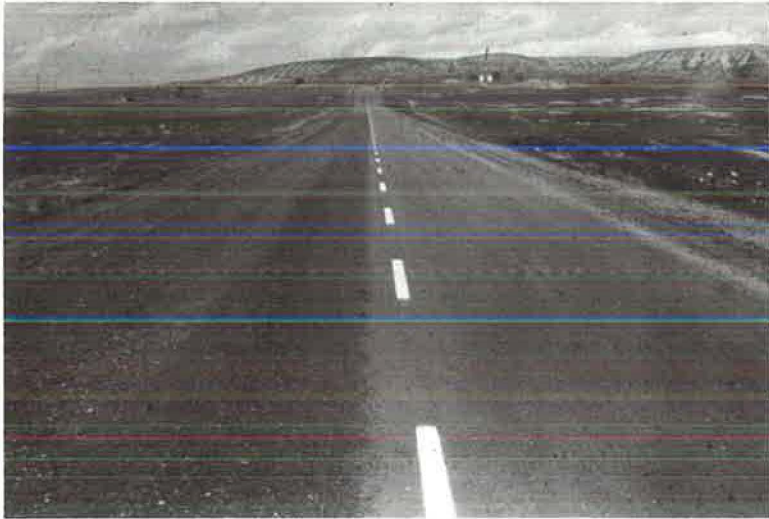
Figure 27. Weathering of road mix more rapid than for asphalt concrete accounting for contrast in surface texture nine months after application: treated lane, right; untreated lane, left.

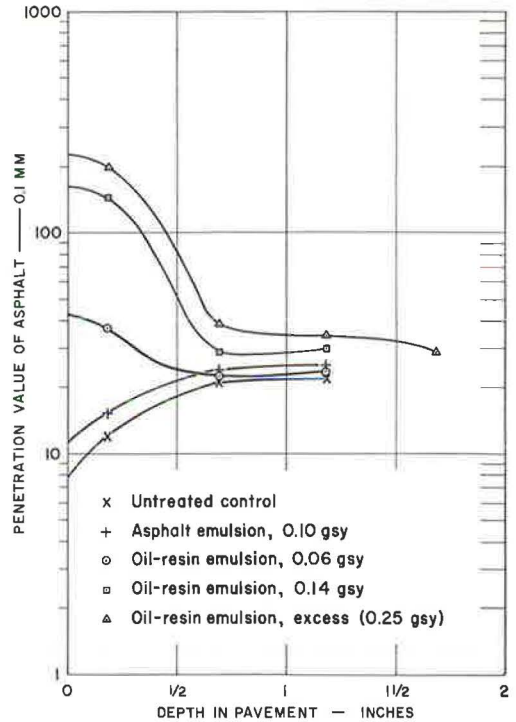
Figure 28. Change in asphalt penetration value with depth in pavement, Lodi Shoulder Project.

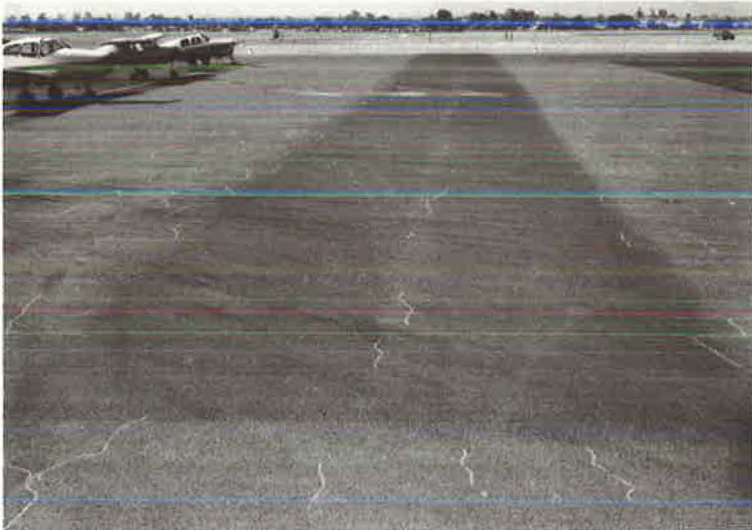
Figure 29. Meadows Field Test Section four months after treatment: absence of shrinkage cracking in treated areas; chalk outlines cracking still existing in surrounding untreated area and in untreated area between passes.

cracks had closed completely in the two treated strips but still remained in the surrounding untreated areas. Figure 29 shows the test area in October 1960 with the two parallel strips with all shrinkage cracks in the vicinity outlined with white chalk. The shrinkage cracks in the narrow strip between the two test sections did not close. Figure 30 shows one of the characteristic shrinkage cracks between the two test strips.

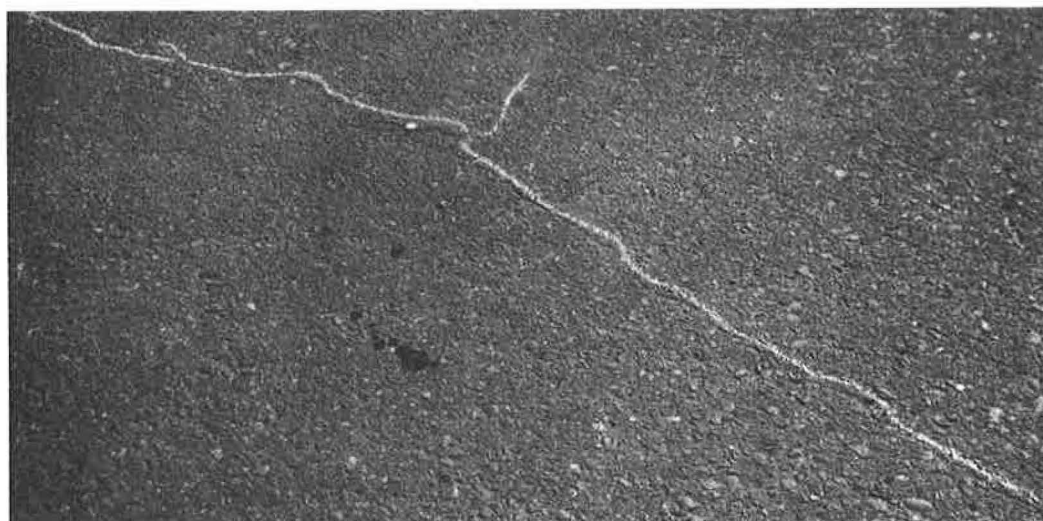
Figure 30. Shrinkage crack between the two test strips (Fig. 29).

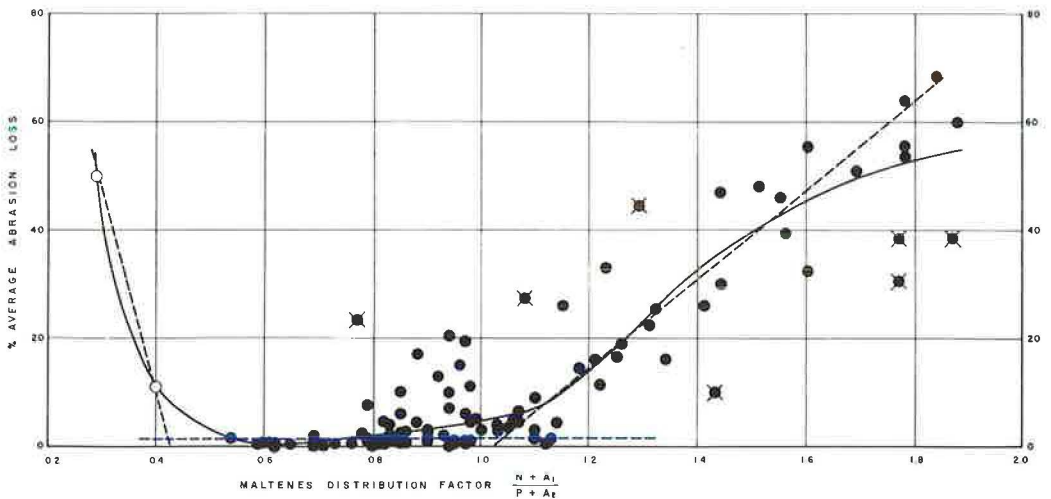
Figure 31. Variation in resistance to abrasion with change in maltenes distribution factor for 101 asphalts (after Rostler and White).

The significance of the maltenes distribution factor as a measure of asphalt durability is shown in Figure 31 (3) which is based on abrasion test data on over 100 samples of 85- to 100-penetration grade asphalts vs their maltenes distribution factor,  $(N + A_1) / (P + A_2)$ . Rostler and White (3) have shown that a maltenes distribution factor of less than 1.14 characterizes an asphalt of excellent durability as measured by abrasion resistance.
