Integrated Microwave Range and Velocity Sensors for Railroad Crossing Warnings

Final Report for High-Speed Rail IDEA Project HSR-08

Prepared by:
David E. Fields and Joe S. O'Conner
O'Conner Engineering, Incorporated

November 2000

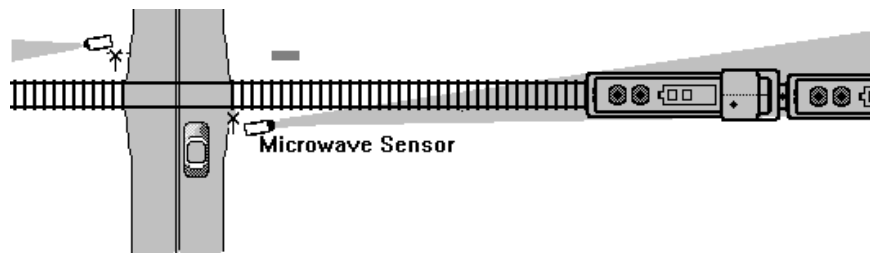
The system design is shown below. Microwave sensors, mounted on railroad signal poles at crossings, detect the trains at extended distances. In theory, this distance can be over a mile away in uncluttered environments. In crossings where extended detection distances may be needed (for example, for higher-speed trains) or where there is significant clutter, then remote detectors placed along the right-of-way with an RF link to the crossing might be required. This system was tested at two active grade crossings, one on the Kansas City Southern (KCS) railroad, and one on the Burlington Northern/Santa Fe (BNSF) railroad. A remote unit was constructed during the project for use at one crossing test site, as extended detection distances were found to be needed. Such remote units might be required wherever there are obstructions to the radar signal or where high-speed trains might be expected.

The basic sensor system observes the velocity and range of an approaching train and determines when it will arrive at the crossing. Warning signals at the crossing are timed such that the warning period is constant for a range of train velocities.

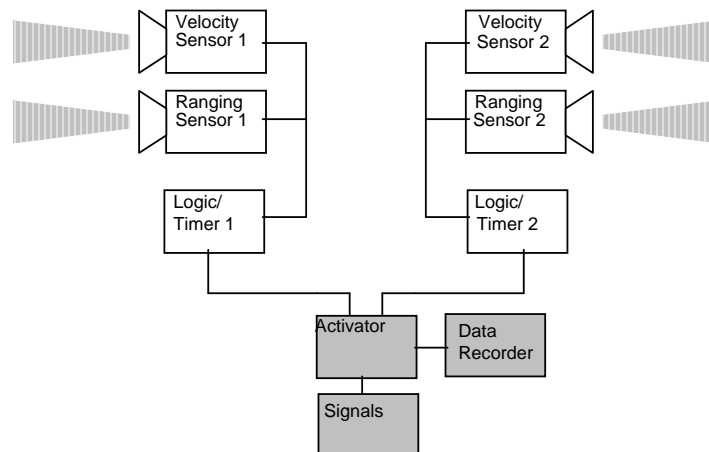
Final System Block Diagram. Shaded blocks denote components added for data collection and remote monitoring.

In the final design, each microwave warning system consisted of one modular sub-system for each direction. A complete sub-system looked in one direction and consists of a ranging sensor, a velocity-measuring sensor, and a microprocessor. The sub-systems acted independently of each other, although future systems may combine functions. A ranging sensor determined the distance to the approaching train. The velocity sensor then accurately measured the speed of the train, sending this information to the microprocessor that calculated the time when the train would arrive at the crossing and the warning time for gate closure. The design concept is that once the microprocessor has determined that the train is a preset time from the crossing it forces a relay closure that activates the crossing lights and lowers the gates. For tests designed here, event types and the associated times were recorded on an event recorder for analysis. The final system design consisted of components configured as shown in the following figure:

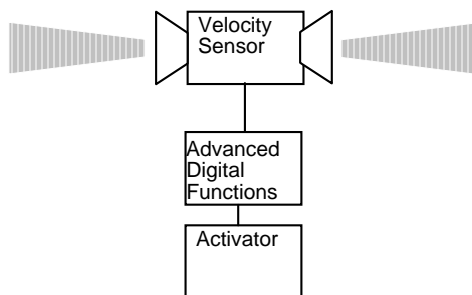
One possible future system design would use simplified digital logic, but include self-monitoring functions.

As a result of this project two systems designs are recommended for further consideration. These systems would not be expected to replace existing track circuit designs in all cases, but could be useful for rural crossings where it is not cost-effective to install track circuit systems. The first design is the system that has been developed and applied here, with the addition of enhanced safety features such as self-monitoring. The second design that should be considered is a simplified design that would be cost effective yet still provide most basic functions. Based on our results, advanced digital logic may be employed for improved control and better reliability. Self-monitoring and reporting are also possible. The second design that is recommended for development is the following:

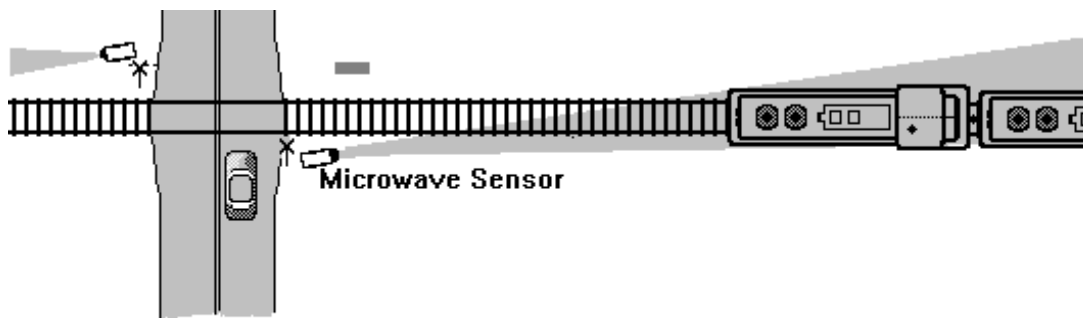
Figure 1. The basic sensor system observes the velocity and range of an approaching train and determines when it will arrive at the crossing. Warning signals at the crossing are timed such that the warning period is constant irrespective of train speed for constant-speed trains.

The system design is shown below. This system was tested at two active grade crossings, one on the Kansas City Southern (KCS) railroad at Furrh Road near Blanchard, Louisiana and the other on the Burlington/Northern/Santa Fe (BNSF) railroad at Knightsen Road near Antioch, California. Microwave sensors, mounted on railroad poles at crossings, may detect trains at distances over a mile away in uncluttered environments. Where extended detection distances are required or where there are overhead wires or other obstructions, then supplementary remote units may be required. A remote unit was constructed for use at the BNSF site, one of two sites chosen for final system implementation.

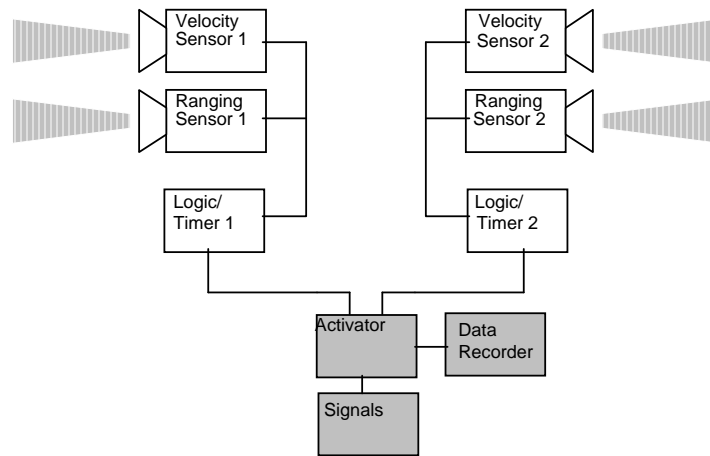
Figure 2. Typical Track Installation Block Diagram. Shaded blocks denote components added for data collection and remote monitoring, plus a hypothetical signal control box.

The final system design as constructed and installed consists of components configured as shown in the following figure:

The six small modules that comprise a system may all be mounted on one of the crossing's signal poles. Each weatherproof steel module is expected to withstand over 10 years of harsh weather.

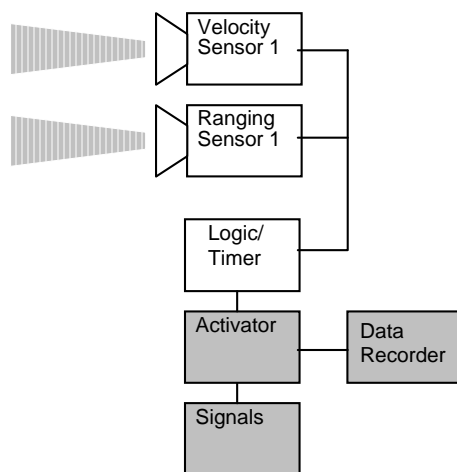
Figure 3. Ranging and Velocity Sensor System Block Diagram. Shaded blocks are components added for data collection and remote monitoring.

- one velocity sensor;
- one ranging sensor;
- one logic controller;
- one 12 vdc power supply (AC/DC converter); and
- cabling, data recorder and mounting brackets.

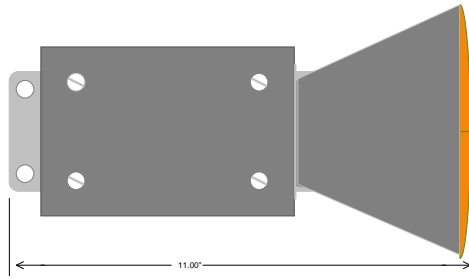
Figure 4. Ranging Sensor external characteristics. The larger horn used on the ranger sensor provides more directionality.

The ranging sensor is a Frequency Modulated Continuous Wave (FMCW) radar operating within a frequency range of 24.35 to 24.7 GHz. It has a power output of 0.005 watts, a range under ideal conditions of 1600 meters, and a range resolution of 0.6 meters. Under normal railroad conditions, trees and clutter reduce sensor range.

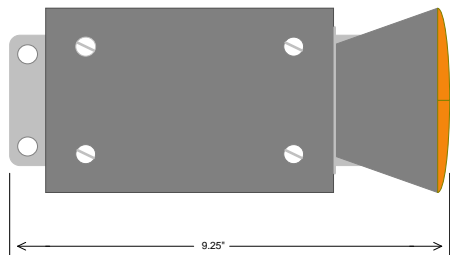
Figure 5. Velocity Sensor external characteristics. Directionality is not so critical with a velocity sensor and a smaller horn may be used, than that required for a ranging sensor.

The velocity sensor is a Doppler radar module capable of detecting closing or receding velocities from 0.5 mph up to 150 mph. However, the sensors for this project are electronically limited to 75 mph for better velocity resolution and to match the distance parameters. Operating at 24.125 GHz, it also has a power output of 0.005 watts and a range of 1600 meters.

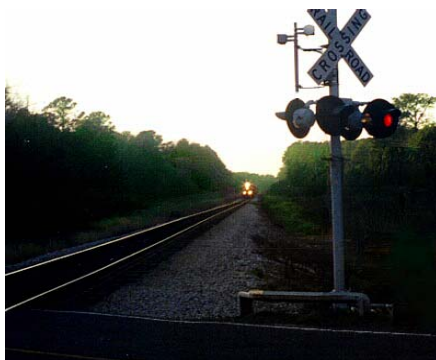
Figure 6. The above photograph shows the system installation at the KCS site with the south looking sensors installed.

Of interest at this site is the close forest cover that rises above the railroad. This posed a special challenge in aiming the sensor units down the tracks, and served as a challenge to the velocity-sensors because the trees can respond to winds. However, no instances of false gate closing signals due to local winds were identified in the data for this site.

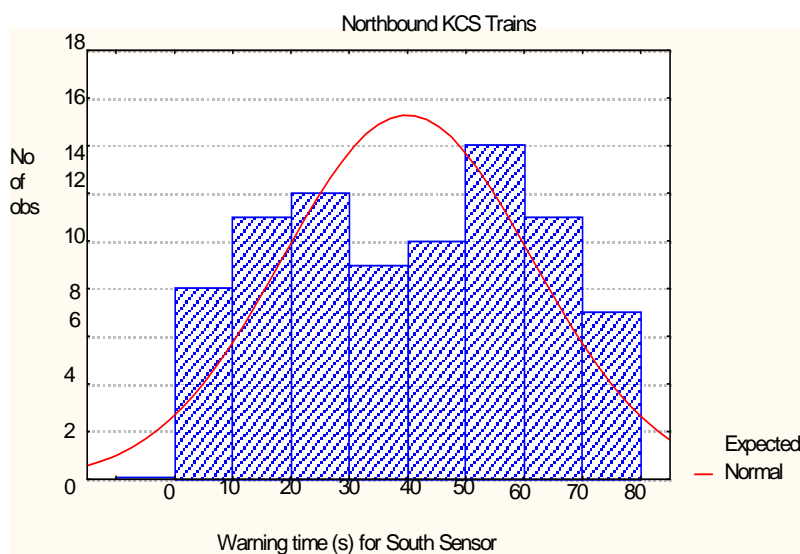
Figure 7. Frequency distribution of warning times are shown in comparison to a fitted Gaussian distribution for Northbound trains at the KCS site (Furrh Road, Louisiana). 23% of the measured values fell below 20 s, while 62% of the values lay above 30 s.

In Figure 7 the frequency distribution of warning times is shown in comparison with the least squares fit to a normal distribution for 92 northbound trains. The warning times are distributed around a mean value of 46 seconds +/- 28 seconds. The data are distributed in a regular manner with the exception of points lying beyond a warning time of 80 seconds. These times exceed the ability of the software to track slow-moving trains, plus some trains presumed to decelerate and stop near the junction. Omitting values greater than 80 seconds leaves 82 trains for which the software was assumed to be capable of tracking. The mean value was 39 seconds +/- 21 s.

The curve is truncated at 0 because of the obvious lack of warning times less than zero (although this could occur if the trains accelerate and the software does not update velocity measurements). The curve was truncated for times greater than 80s for this plot because it appeared that other mechanisms might be causing some variability. The Kolmogorov Smirnov $d=0.061$ implying that one may not reject the hypothesis that the data are normally distributed. The tentative assumption of a log-normal distribution gives a K-S value of 0.153, $p<0.05$, suggesting that one may not reject the possibility that these data may be log-normally distributed. They are closer to normal (Gaussian) than to log-normal in distribution. Thus, of the 82 trains for which the software was assumed capable of tracking, 23% of the measured values were below 20 seconds, while 62% of the values lay above 30 seconds.

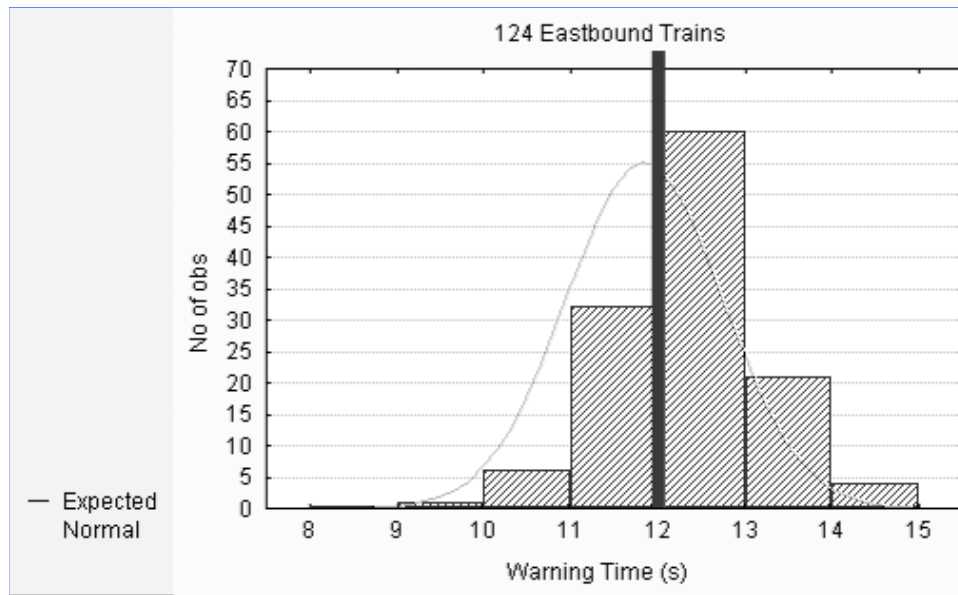
Figure 8. Distribution of warning times for 124 Eastbound trains at the BNSF site, Knightsen Road, California. The data cluster strongly around the design value of 12 s, shown here by the black vertical line.

Figure 8 shows the rank-ordered data for Eastbound trains fitted to a Gaussian distribution. The digital logic associated with the sensor is detecting and calculating warning times correctly for approximately 180 of the trains, as evidenced by the clustering of the data around a target value of 12 s. This value was chosen to evaluate the software at a

To analyze performance of the system in the region where trains were detected sufficiently early to permit software to function as intended, the higher values were truncated. Values of warning times less than 10 s were due to fast trains and these were omitted. The remaining values for 124 Eastbound trains were analyzed. Data were reduced to derive warning times for each train, and analyzed to provide mean value (11.9 s) and standard deviation (0.9 s). For these data, 74% of observations were within +/- 1 second while 94% were within +/- 2 seconds of the mean value. The results are shown in Figure 8, where the data are fitted to a Gaussian distribution.

Figure 8 demonstrates that the digital logic was maintaining a warning time as designed for 12 seconds for roughly one-half of the trains (rank order 6 through 145). Very slow trains, trains stopping near the crossing itself, and Amtrak trains had movement patterns which exceeded the ability of the two-sensor system to follow. Thus for Amtrak trains, the warnings were short, while for slow trains, the warning times were longer than intended, due to software problems. The usual warning time design value is 25 seconds. The software was not designed to continue to update position and speed data, and thus did not work well for slow trains.

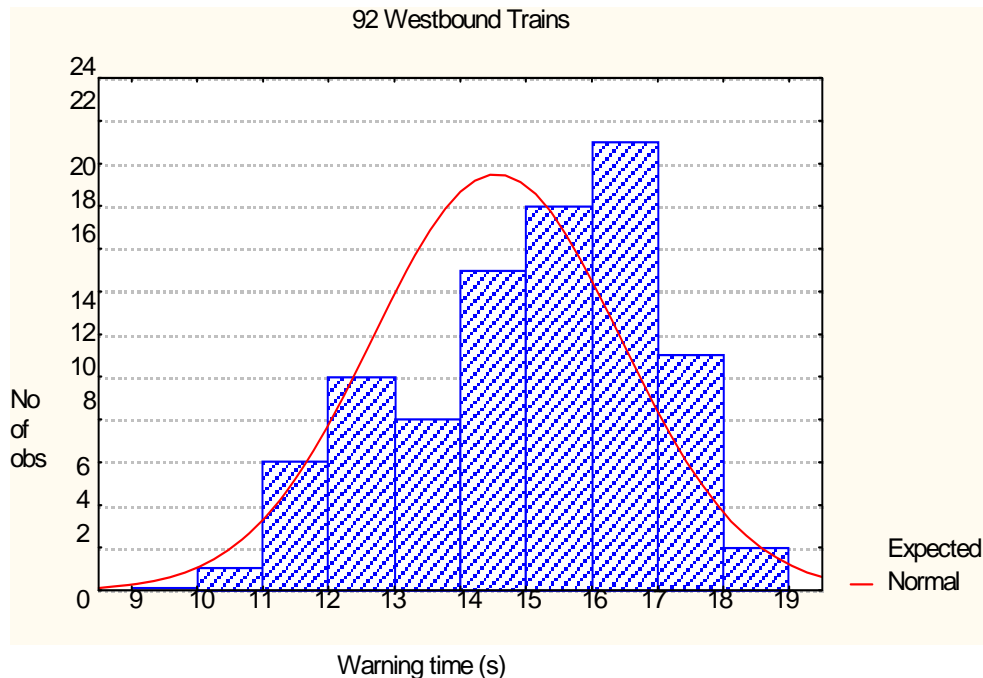
Figure 9. Frequency distribution of warning times for 92 Westbound trains at the BNSF site. This distribution shows an initial region of fast trains, which arrive with short warning intervals; an intermediate region with much more accurate software computation of warning times; and finally, a long-warning time region computed for slow trains

A second digital sub-system, this for monitoring Westbound traffic, was also installed at the BNSF site. Figure 9 shows the frequency distribution of values for Westbound traffic. In the same manner as for the Eastbound traffic, all event data records were examined for the period January 13- February 11, 2000. Very slow trains and trains that stopped inside the crossing area were omitted. This left records for 236 Westbound trains. As seen above for the digital system, the warning times cluster around the 10-18 s warning time, but there is considerably more complexity in the Westbound traffic flow.

Data were selected for the portion of the curve where the software appeared to be functioning properly. For the 92 trains where the warning time was between 10 and 18 s, the mean value was 14.6 s and the S. D. was 1.9 s. These data were fitted to a Gaussian curve and plotted in Figure 9. There was considerable scatter in these points when compared to the values for the Eastbound trains. Partially because of the inability of the software to properly handle slow/stopped trains and partially because of the complex traffic pattern at this site, only 27% of the Westbound trains arrived within +/- 2 seconds of the target warning time of 12 seconds.

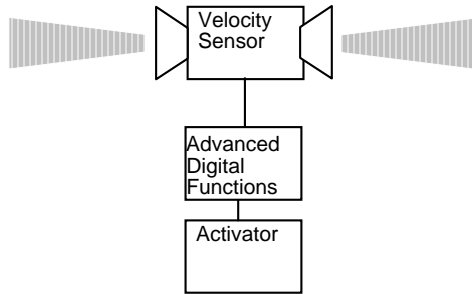
Figure 10. Simplified sensor system block diagram recommended for future implementation. This system would incorporate several advantages including physical simplicity (low parts count and reduced number of sub-modules), advanced digital logic, fault checking and automatic function monitoring.

The second design recommended for future development is the following:
