WIDE-GAP WELDING TECHNIQUES

Transportation Technology Center, Inc. (TTCI)

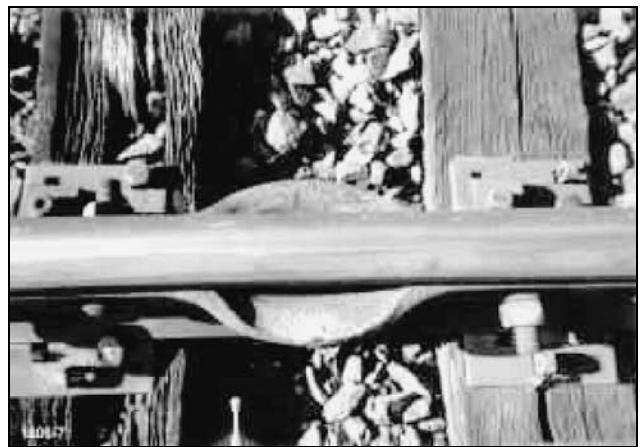
Figure 4. Test wide-gap thermite welds as of December 1, 2000.

Figure 4. (Continued)

Since the April 2000 installation, the welds have been monitored for their integrity through frequent visual track inspections and periodical non-destructive test (NDT) inspections. All 10 test welds were in good service condition as of December 1, 2000. No defects were observed in the welds except for a small (~1.5 mm) slag found on the railhead surface of Weld Number 3. Slag inclusions of that size in

thermite welds are usually not regarded as defects for rejection. Small slag inclusions are often found in thermite welds and can cause failure if located in a critical area (e.g., an area where significant tensile stress occurs). The slag inclusion in Weld Number 3 is located at the running surface. Experience has shown that an inclusion of that size, at such a location, is more likely to wear away than to develop into a sizeable defect. Visual observations did not find any indication of excessive differential wear. The PATCO track supervisor involved in the field inspection believed that the wear of the wide-gap welds was actually somewhat less severe than those of standard thermite welds in PATCO's tracks. Figure 4 shows photographs of all the test welds as of December 1, 2000. Measurements of running surface wear are presented in Table 1 and the results indi-

cate that the differential wear was minimal. Most of the measured differentials were on par with the height variations in other parts of the rail. The comparatively low axle loads of transit traffic and the low accumulated traffic during the test period (6.5 to 10 MGT) did not produce significant wear differences between the weld zones and the rest of the rails. It might take many times more accumulated traffic for a more valid assessment of the differential wear properties of wide-gap welds. This can be achieved if PATCO continues to monitor the test welds.
