**TCRP Synthesis 12**

**Transit Bus Service  
Line and Cleaning Functions**

**A Synthesis of Transit Practice**

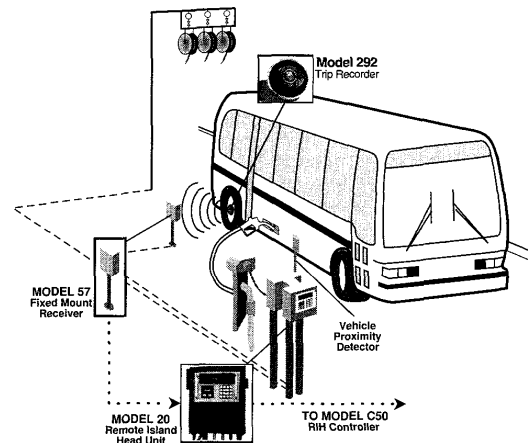
FIGURE 3 Fully automatic bus identification, mileage, fuel, and fluids tracking system (Courtesy of S&A Systems, Inc.)

Transit agencies can upgrade and integrate their data collection systems for increased speed and accuracy. Community Transit in Everett, Washington, for example, has installed a fully integrated and automated system for vehicle identification, mileage, and fuel and fluids dispensing. When a bus pulls into the service line, a receiver mounted on the fuel island interrogates the electronic

hubodometer. The bus number and life-to-date accumulated mileage are transferred via radio signal to a central control unit. The control unit then activates the diesel fuel dispensing pump, as well as the appropriate oil, coolant, ATF, and power steering fluid dispensers. The quantities of the fluids dispensed are automatically recorded and assigned to each bus without manual entry by service line personnel. Figure 3 identifies the features of such a system.

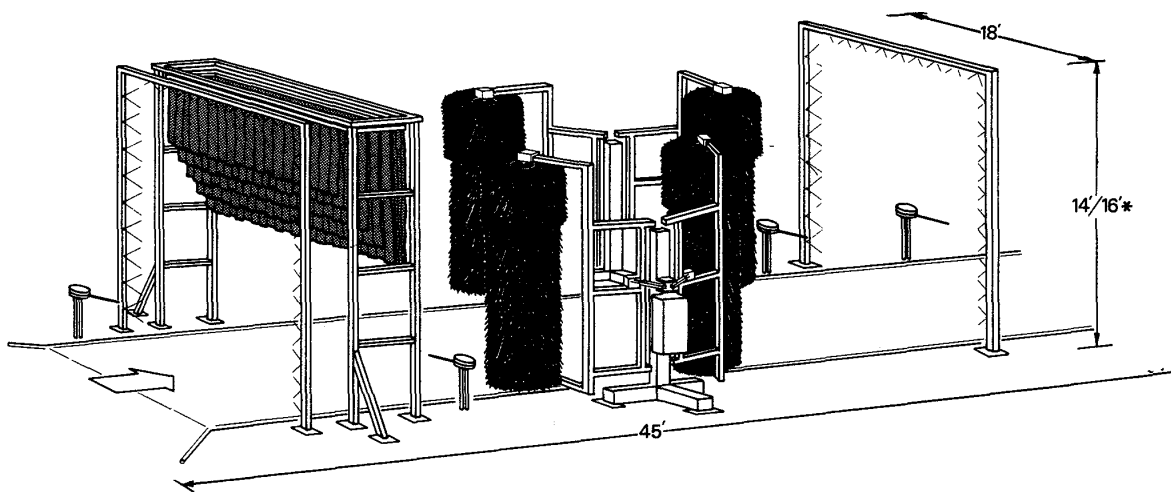
FIGURE 4 Schematic diagram of a typical automated 4-brush washer. (Courtesy of SSI Corp.)

The automated brush washer is the most common washer used in bus transit today (see Figure 4). More than 87 percent of those responding to the survey claim to use some form of automated brush washer. Of those, 66 percent use equipment with four brushes. Automated brush washers with two, three, five, six, seven, and eight brushes were reported on a limited basis. Brush washers typically use a combination of rotating brushes and water/soap spray to clean the bus exterior. Some washers include additional brushes or oscillating or stationary wet mops to clean the roof and front and rear bus sections.

Brush washers generally begin with an application of soap and water to lubricate the brushes, reduce abrasion, and prevent excessive wear on paint and plastic windows. This is followed by the application of more soap and the mechanical scrubbing action of the brushes. A series of electronic actuators provides automatic control of the various wash functions as the bus travels through the

washer. Brush arm movement against the bus is controlled by air pressure. Hydraulic or electric power is used to agitate roof mops and to rotate the brushes. A rinse cycle of fresh water removes dirt suspended in the soap. Most transit agencies allow the buses to drip dry in the storage area.

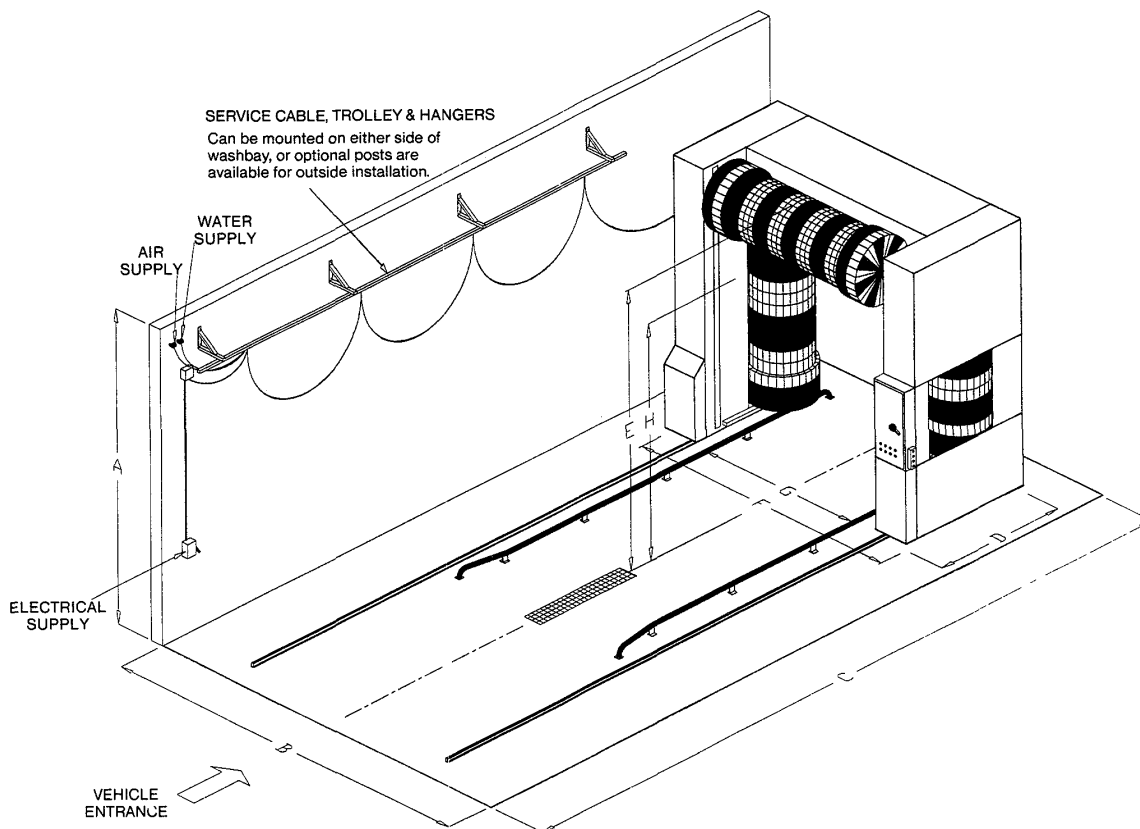
FIGURE 5 Schematic drawing of a typical gantry washing system. (Courtesy of SSI Corp.)

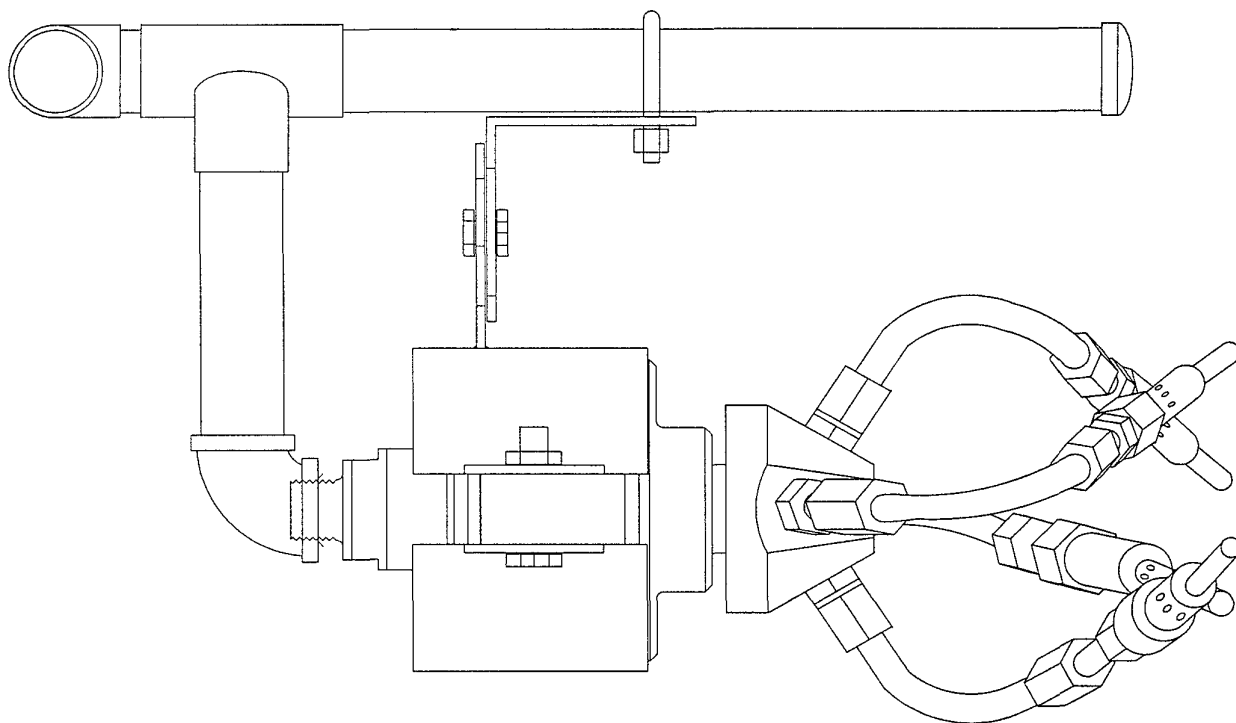
FIGURE 6 Schematic drawing of a high-pressure spinner wheel washer. (Courtesy of SSI Corp.)

Transit agencies have experimented with several types of automated wheel cleaning equipment. The most popular is a high-pressure spinner mounted at specific locations in the wash lane (see Figure 6). As the bus wheel arrives at a certain location, a switch activates water pressure and causes the nozzles to spin in a circular fashion. Water and soap are directed into the wheel at high pressure to dislodge dirt. Because there is no direct physical contact with the wheel surface, this type of washer usually requires additional cleaning during detailed cleaning operations Another type of wheel washer involves a rotating brush that moves into the wheel when the bus stops at a predetermined location.

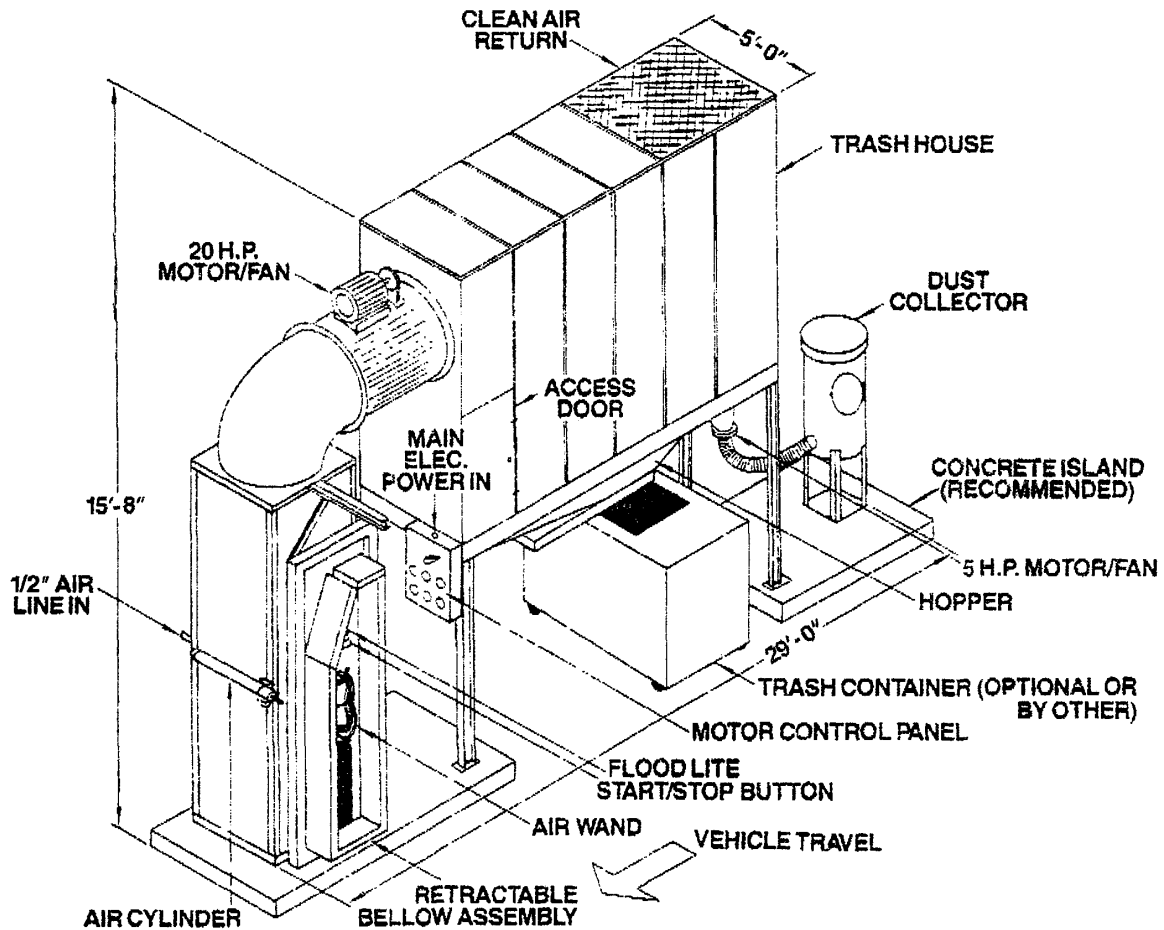
FIGURE 7 Schematic drawing of a typical cyclone vacuum system. (Courtesy of SSI Corp.)

Along with hand sweeping, the cyclone vacuum cleaner is a common way of supplementing the interior cleaning process. This large-capacity vacuum features a main orifice bellows that extends from the service line and fits over the entire front door of the bus (see Figure 7). The hostler opens the rear door or a rear window to allow air drawn into the cyclone to be replaced with outside air. A compressed-air wand is then used to dislodge debris from hard-to-reach areas and direct it to the front door and eventually into the cyclone. The hostler typically starts at the back of the bus and works forward.

Many transit managers are not pleased with the cyclone cleaner because of the excessive noise (up to 100 dBA) and airborne dust it generates. Continuous exposure to noise and dust may create respiratory and hearing loss problems for workers. Additionally, airborne dust created by the cyclone eventually settles on interior surfaces and requires a manual wipe-down to remove. Airborne dust also has become a major concern with sophisticated electronics used in today's transit buses. Electronic systems that operate fareboxes, destination signs, radio communications, wheelchair lifts, and other equipment are much more sensitive to dust compared

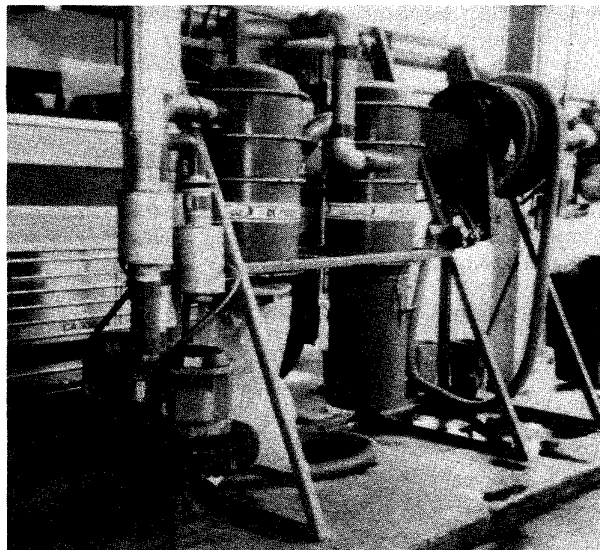
FIGURE 8 Central vacuum system in use at Santa Monica Municipal Bus Lines.

The central vacuum system used by Santa Monica does not use a pneumatic transport system for coarse refuse. Newspapers and recyclable items are removed manually from the bus and placed in ordinary containers on the service line. Except for clean recyclable objects, Santa Monica is concerned about protecting workers from physically touching the refuse left on buses. As a result, a system with larger diameter (3-in.) hoses and more suction power has been specified.

The system is capable of picking up coarse refuse and finer dirt in one operation. Santa Monica was especially concerned with debris lodged between seat cushions and wanted a vacuum system strong enough to pull out any material that workers would normally use their hands to remove. The system also features an automatic-feed hose assembly, making it easy to get the vacuum hose into the bus. When finished, the cleaner leaves the entire length of hose on the bus and pushes a switch on the service line to retract and recoil the hose automatically.

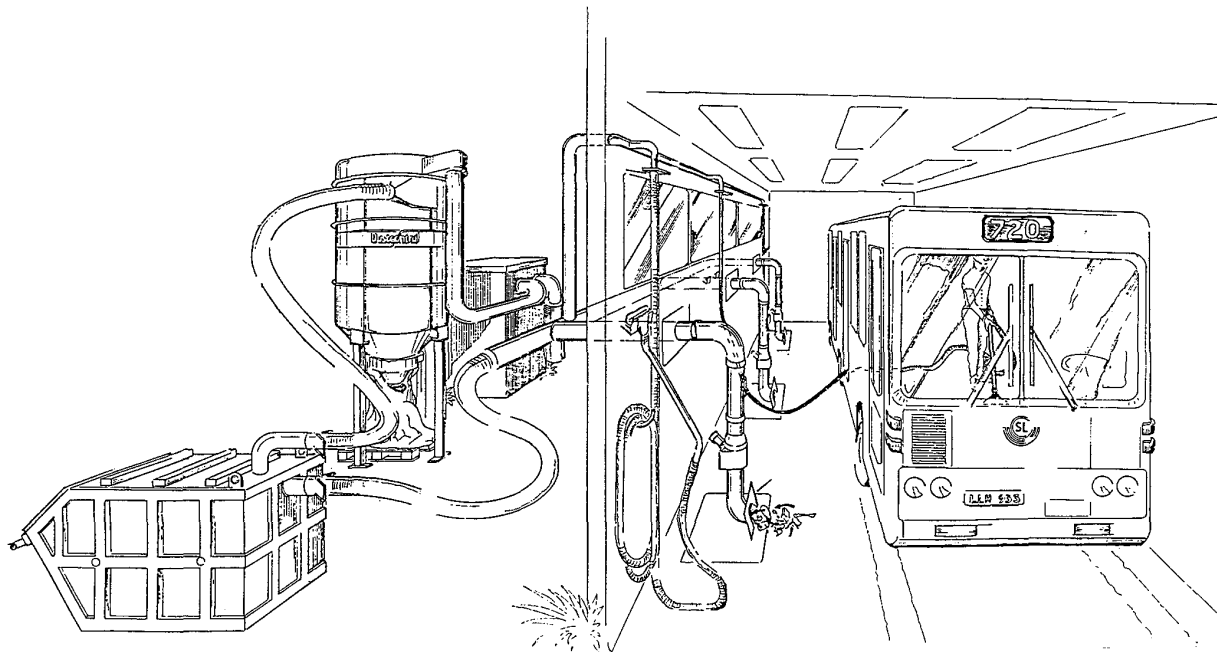
FIGURE 9 Schematic drawing of one example of a central vacuum system for bus interiors. (Courtesy of Transmatic, Inc.)

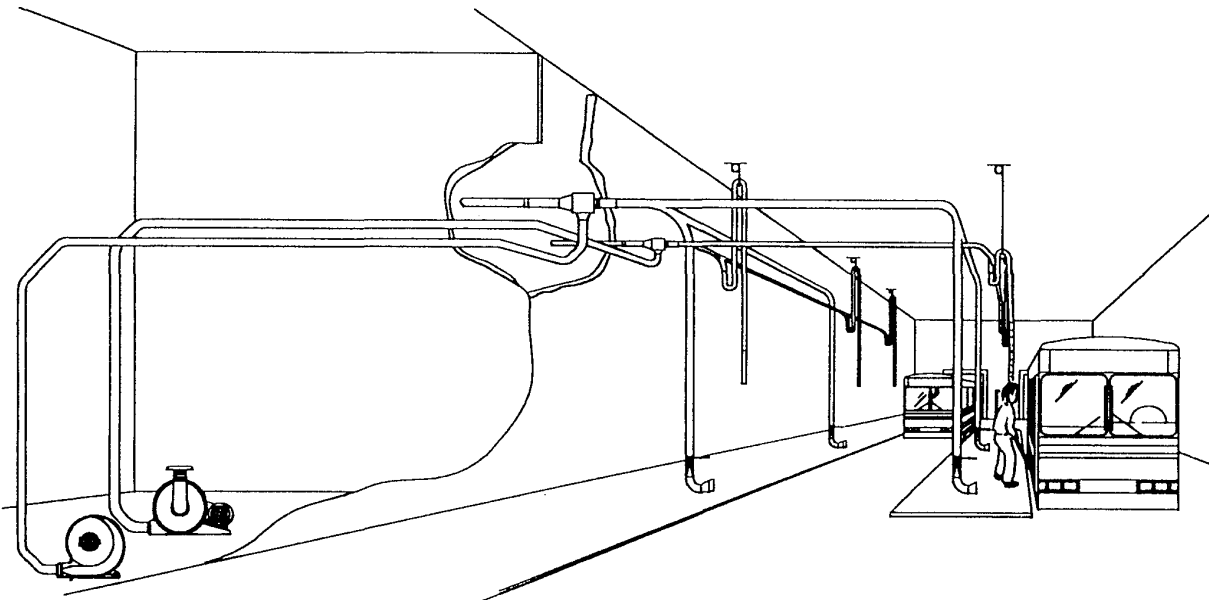
FIGURE 10 Central vacuum system being evaluated by the Toronto Transit Commission. (Courtesy of Eurovac)

Another type of central vacuum system is under development at the Toronto Transit Commission (TTC), which became dissatisfied with cyclone cleaners. The prototype vacuum system being evaluated consists of four pull-down, overhead vacuum hoses and two curb-mounted vacuum collectors (see Figure 10). As the bus stops at a predetermined location at the fuel island, one 2-in. hose is located above the driver's window, while three others are suspended above the front and rear doors.

The approach being evaluated by TTC begins with the hostler removing large debris and sweeping dirt into the step wells before arriving at the service line. Once in the service line, the hostler sits in the driver's seat, opens the side window and pulls in an overhead vacuum hose. While sitting in the driver's seat, the hostler uses the hose to clean difficult-to-reach areas of the driver's compartment.

When finished, the hose is retracted back into the spring-loaded tool retractor. The hostler then uses a broom to sweep dirt and debris from the step wells into the curb-mounted vacuum receptacles. Larger 6-in hoses attached to the curb receptacles are used to transport dirt and debris to a central container.

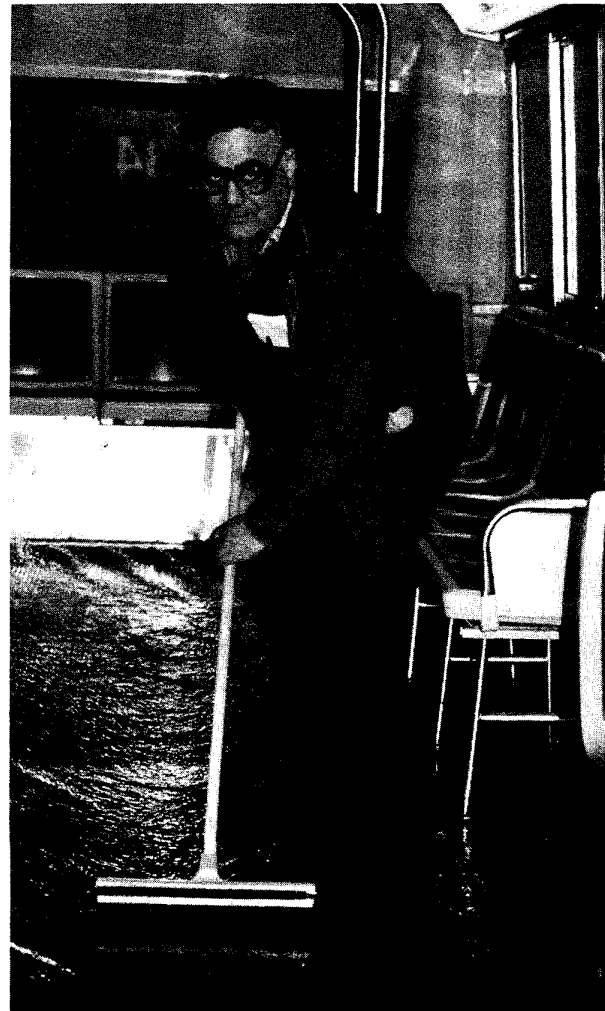
FIGURE 11 Innovative floor washing system developed by the Toronto Transit Commission. (Courtesy of TTC)

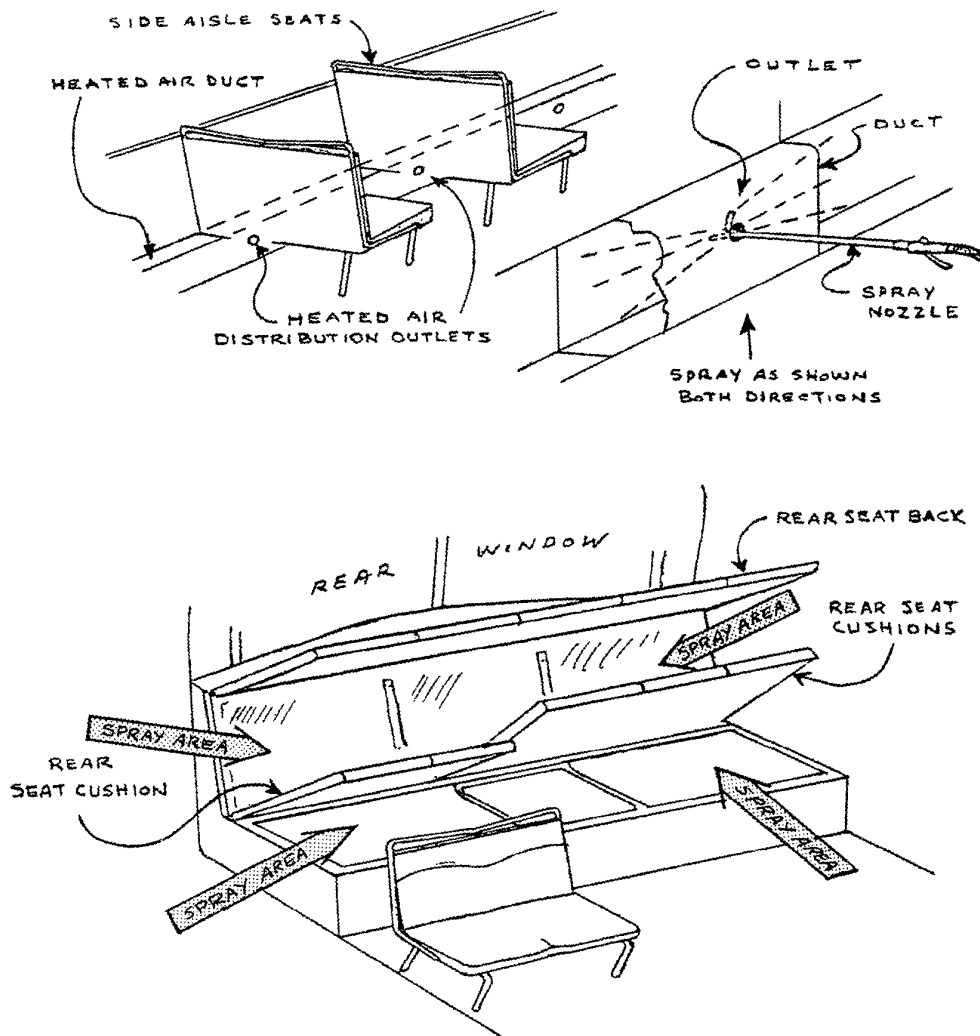
FIGURE 7 Partial illustrated instructions for fumigation procedure (Detroit Department of Transportation).
