REPAIRS WITH HIGH-PERFORMANCE MATERIALS MAKE BRIDGES STRONGER, LAST LONGER

Georgia Researchers Test Carbon Fiber Composites

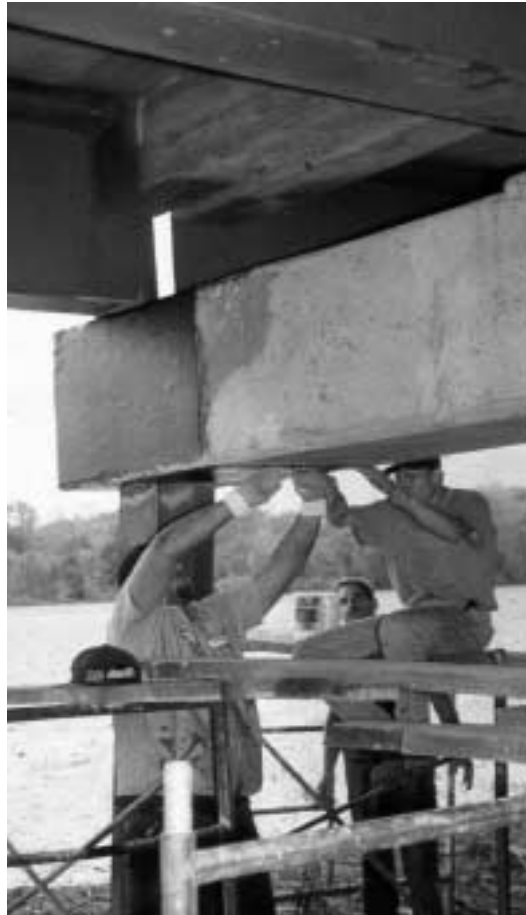
Carbon Fiber Fabric, SR 2 application.

Two contractors repaired six of the pier caps in the spring of 1997 using field-manufactured composites. One contractor used carbon-reinforcing fabric that weighed 9 oz/yd², and the second contractor used a thicker, mechanically epoxy-impregnated, carbon-reinforcing fabric that weighed 18 oz/yd². After surface preparation of the concrete, some epoxy injections, and spall repairs, the first coat of epoxy was applied, and the carbon fiber fabrics were mounted by hand.
