Reducing the Illegal Passing of School Buses

Video Footage Assists in Documentation, Training, and Raising Public Awareness

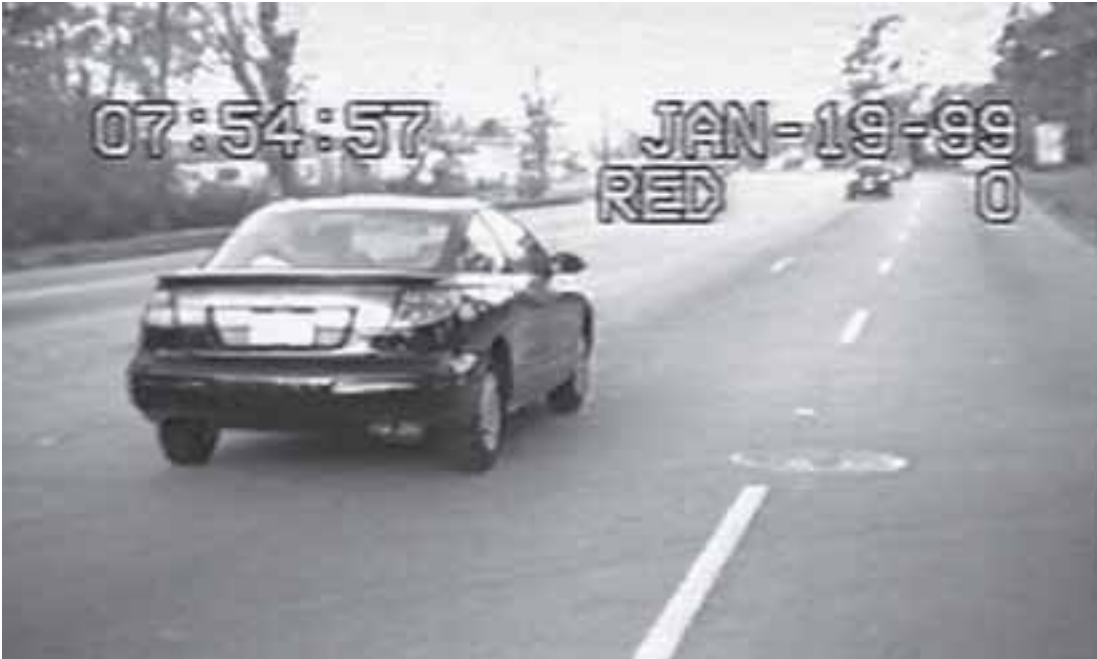
Video footage snapshot documents a passing violation while the school bus was stopped (vehicle speed is 0) and the stop arm was deployed (red warning lights were activated).

To address questions about the school bus stop arm deployment procedures, the project team conducted a study using video cameras. The Onslow County project team mounted weatherproof video cameras outside the bus near the stop arm of selected school buses operated by drivers who had reported frequent illegal passing. The video cameras recorded the date, the time, the speed of the bus, the activation of the amber warning lights, and the deployment of the stop arm.

least one or two vehicles illegally passing while the stopped bus was loading and unloading school children. Because the footage documented that the school bus was stopped and that the stop arm was deployed, the violations were easily verified.

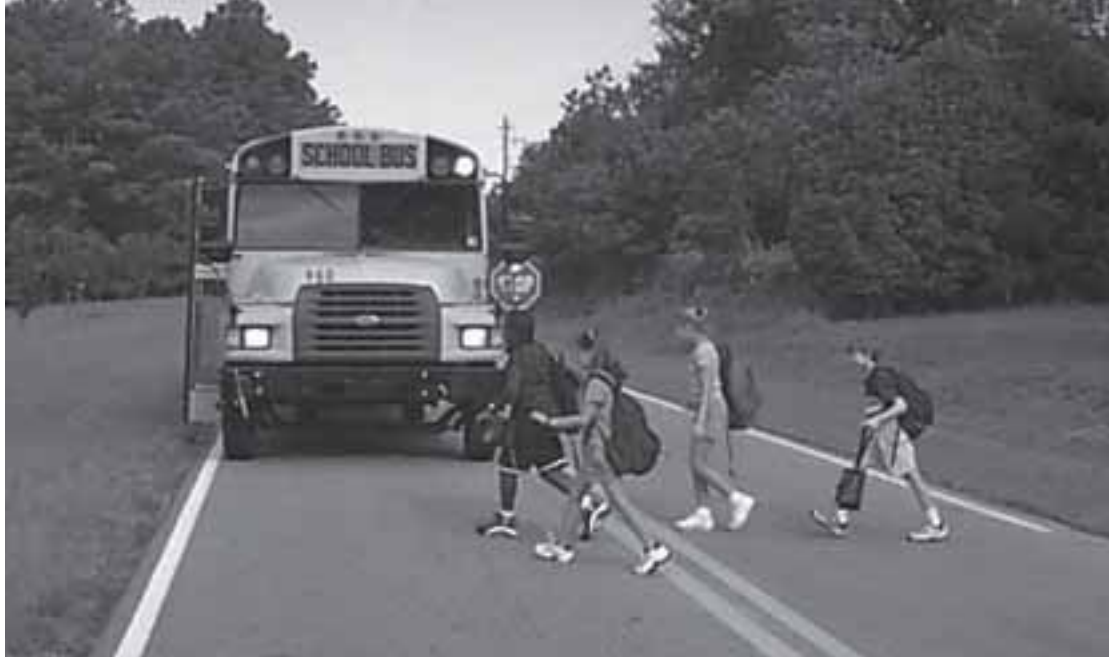
Frame from school bus driver reinforcement training videotape, produced by the North Carolina Department of Public Instruction and the Institute for Transportation Research and Education, North Carolina State University, with funding from the National Highway Traffic Safety Administration.

Training Drivers

The focus on stop arm violations and the implementation of the video technology brought the school system transportation staff and law enforcement agencies together to work toward a common goal. The time and motion study revealed that drivers may not have followed consistently the procedures for making passenger stops.

After the reinforcement training in Onslow County, the average daily number of reported violations of the no-passing law filed by the 203 bus drivers dropped. The one-week tally declined from 22.6 to 15 violations per day.
