Construction of a Fill by a Mud Displacement Method

WILLIAM G. WEBER, JR., *Associate Materials and Research Engineer, Materials and Research Department, California Division of Highways, Sacramento*

A highway fill was constructed across an open water cove on the west side of San Francisco Bay by displacing the underlying soft mud to depths of as much as 60 ft by the weight of the placed fill. Various construction methods were attempted and a method of obtaining reasonably uniform mud displacement developed. The fill failures were analyzed and the factors affecting these failures evaluated. The measured settlements and pore pressures are presented and evaluated. The performance of the highway after three years of use is given.

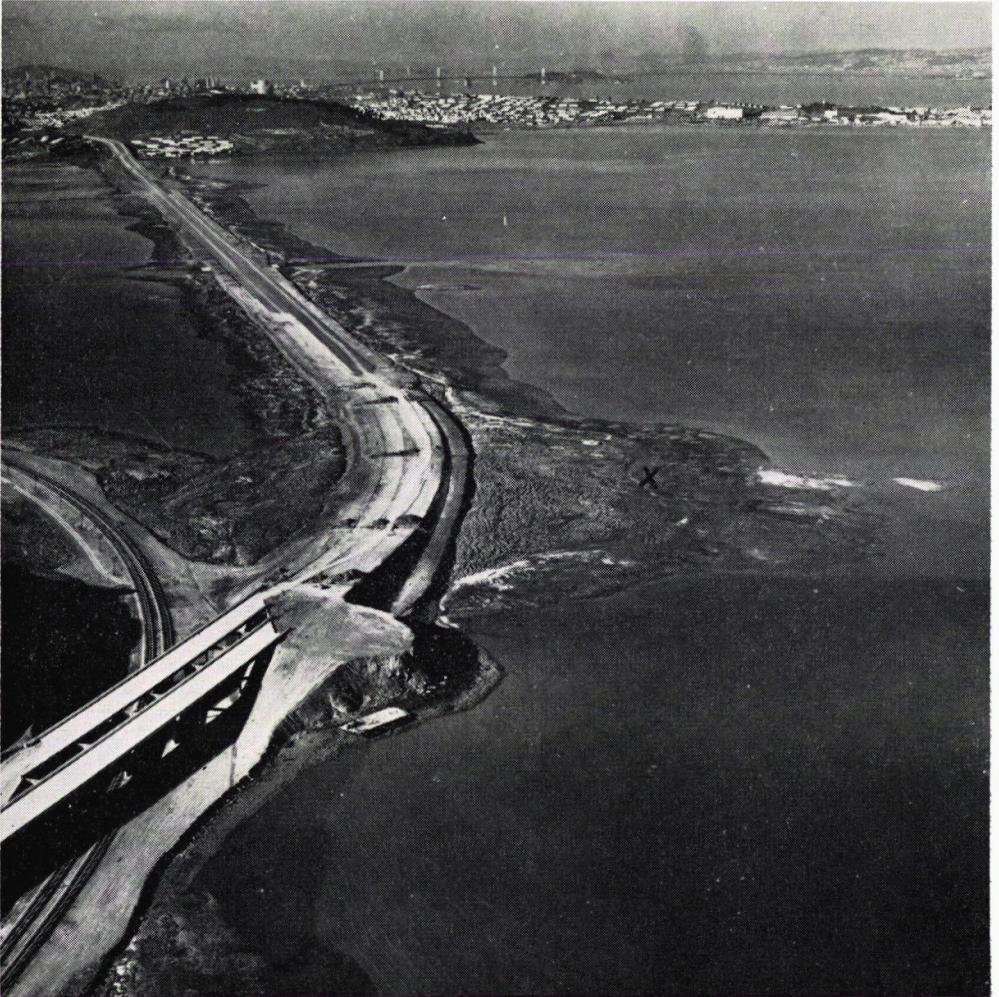
Figure 1. General view of open water fill, final grading operations in progress.

ized in 1952 the construction of an experimental fill southward from the north end of Candlestick Cove to determine the feasibility of constructing an open water fill by end dumping methods. This was successfully accomplished for the conditions at this location. In June 1953, a contract was let to construct an experimental fill where a greater thickness of soft mud existed to study construction techniques further. The remaining portion was then constructed under normal construction contracts. Figure 1 is a general view of the area.

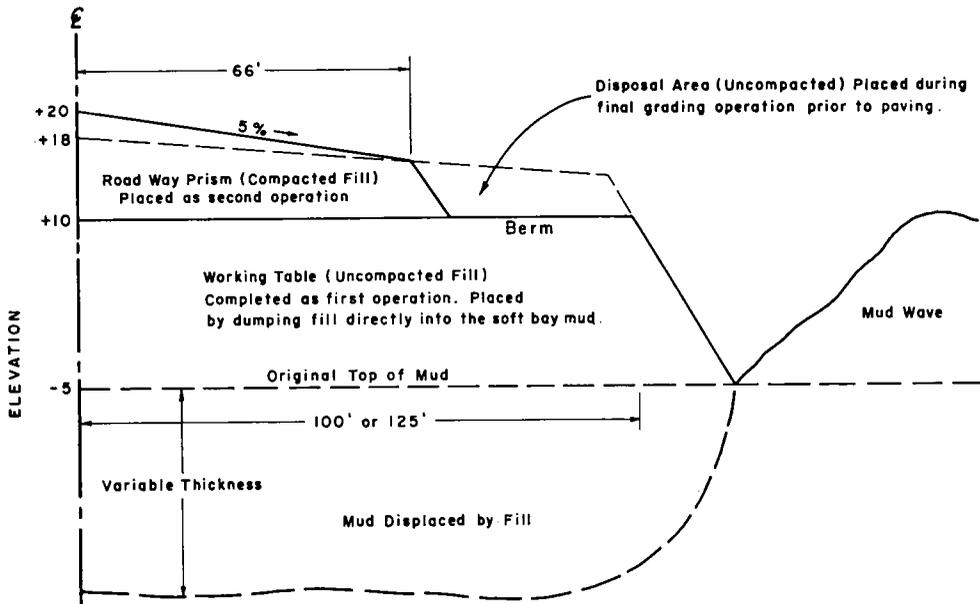
Figure 2. Typical cross-section of fill.

The fill as constructed consisted of two parts, as shown in Figure 2. A working table was placed by end dumping methods and was in the uncompacted condition. A smaller compacted prism was placed on the working table and referred to as the roadway prism.

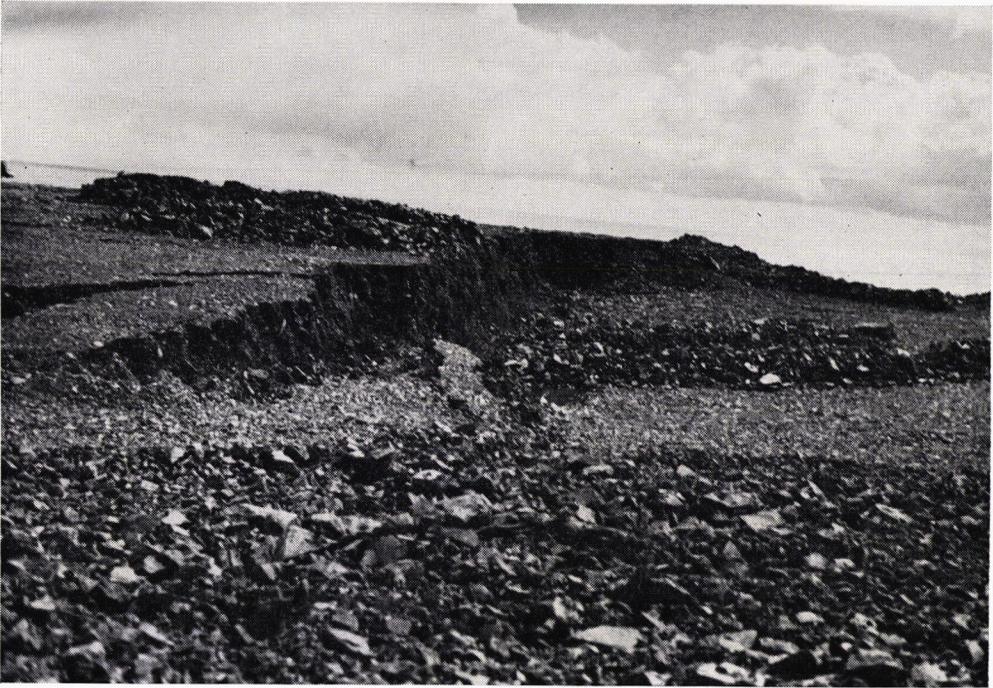
Figure 3. Nose of fill dropped about 7 ft (see Fig. 4).

As the nose of the fill was advanced from the stable portion of the working table, a crack would develop near the stable portion as shown in Figure 3. Regardless of how far the fill was advanced past this crack, movement would continue to occur at this location until the nose had become stable. Then the cracking would

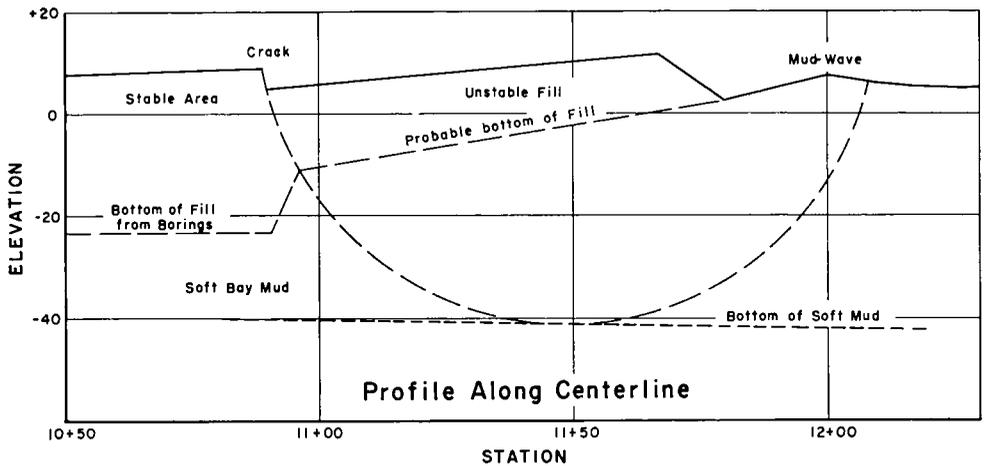
Figure 4. Typical shear-type failure.

advance to the point where the fill was again unstable. Studies were made on the failures by measuring the surface movements and running shear circles. From these measurements two primary types of movement were found to occur: (a) shear type—a rotary movement where the fill would have a large drop at the crack and little or no movement at the edge of the fill, as shown in Figures 4 and 5a; (b) squeeze type—a movement where the drop would be uniform over the failed area with a small horizontal movement occurring, as shown in Figures 5b and 6. The normal type of failure was the shear type. The mud was forced up about 20 to 40 ft from the fill and appeared to move in a vertical direction. The surface of the crest of the mud wave had a rough appearance. Occasionally a vertical face appeared on the side of the mud wave away from the fill. These shear failures appeared to follow a rotational movement.

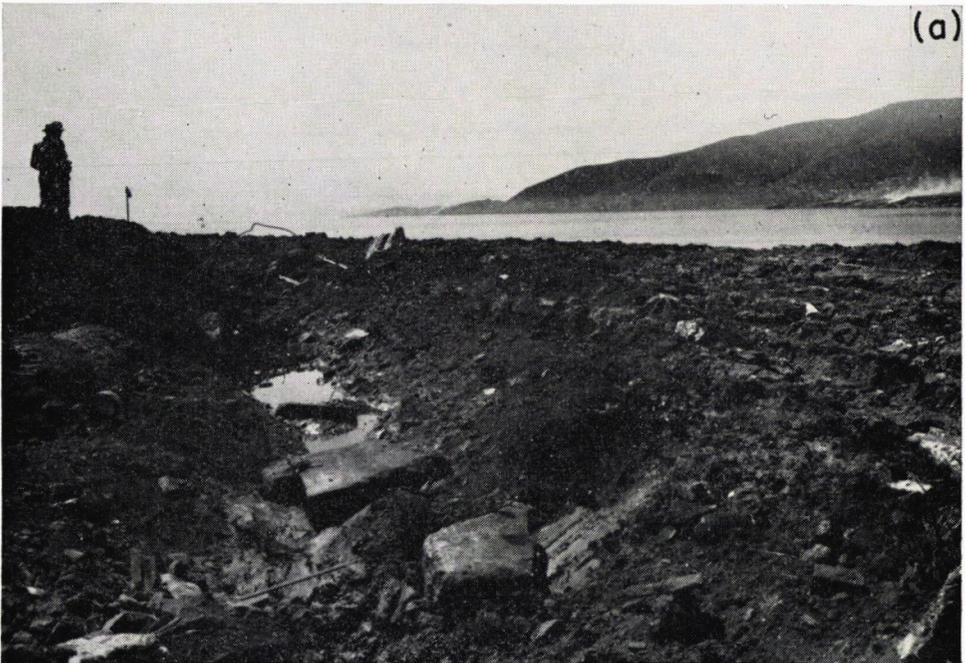
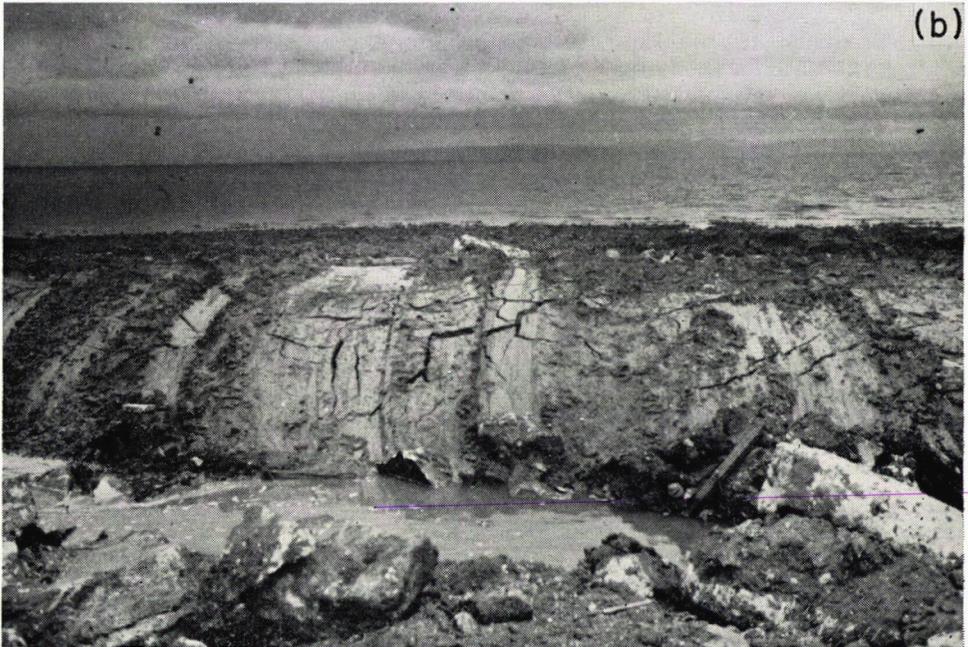
Figure 5. Type of mud wave produced by failures: (a) shear-type failure;
(b) squeeze-type failure.

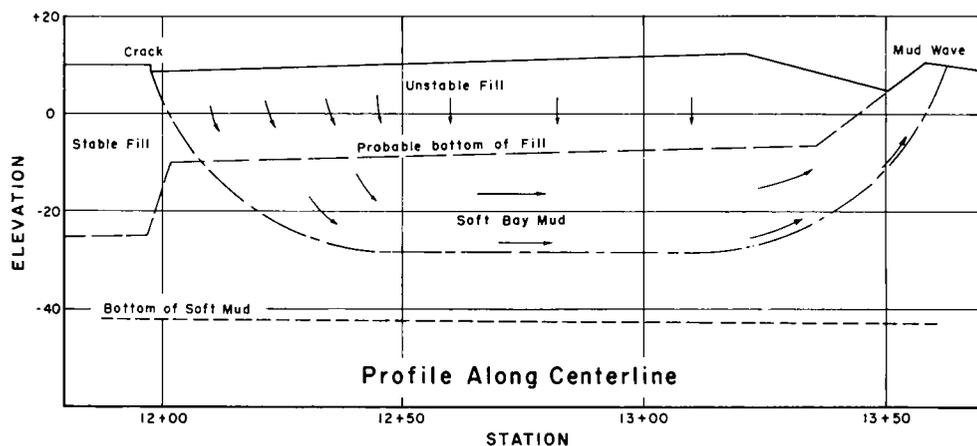
Figure 6. Typical squeeze-type failure.

On the few occasions that the fill was rapidly advanced, with small mud displacement, an unusual type of failure occurred that has been referred to as a squeeze-type failure. Generally, some factor (such as an extremely

large build-up of the mud wave, a period of high tides, or an extended period where the nose of the fill was not advanced and then rapidly advanced) caused this condition to occur. The failed portion of the fill would crack in all directions and the settlement would occur rather uniformly. The failed area tended to settle at a slow, steady rate. The mud was pushed out from under the fill at an angle with a smooth appearance, and a high mud wave was not built up with this type of failure. When the soft mud was displaced to elevation -20 to -30 , the movement would cease with the fill becoming stable. In analyzing this type of failure it was assumed that a sliding action occurred in the soft mud.

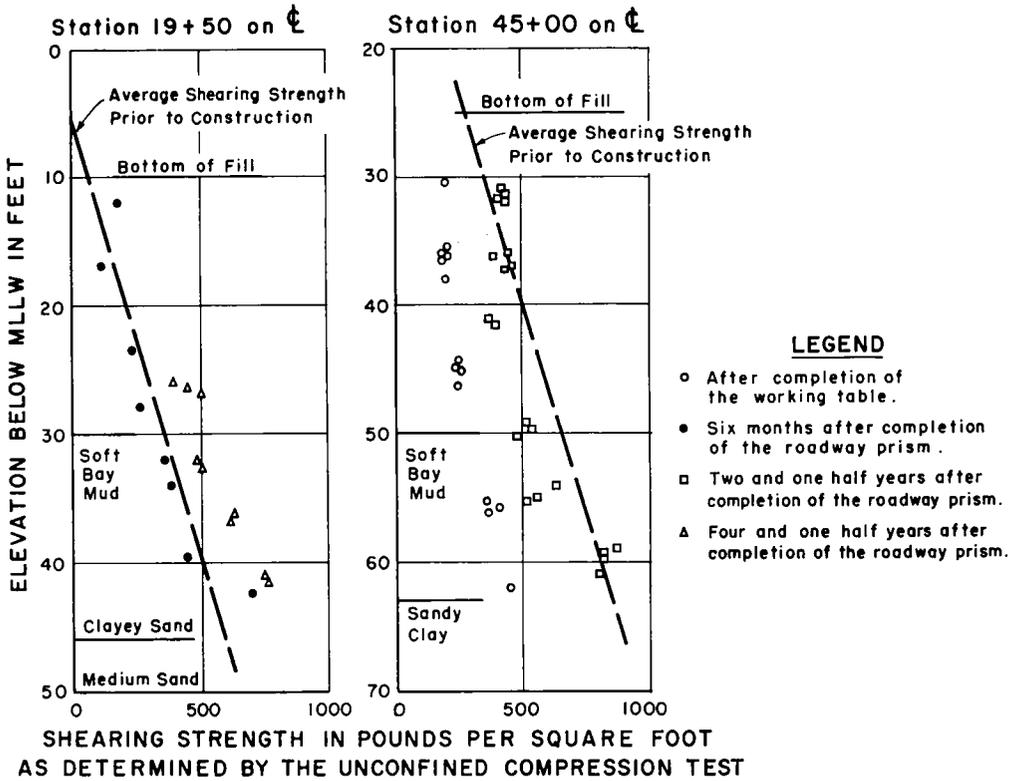
Figure 7. Shearing strength of soft bay mud at various times during and after construction of open water fill.

The borings made at various times after completion of the fill indicated the shearing strength of the soft bay mud gradually increased with time, as shown in Figure 7. The time required for the soft bay mud to regain its original strength depended on the degree of remolding that occurred in the soft bay mud, and varied from one to two years. As further consolidation has occurred, the shearing strength of the soft mud increased and now exceeds its original strength. This increase in the strength of the soft bay mud has improved the stability of the main fill.

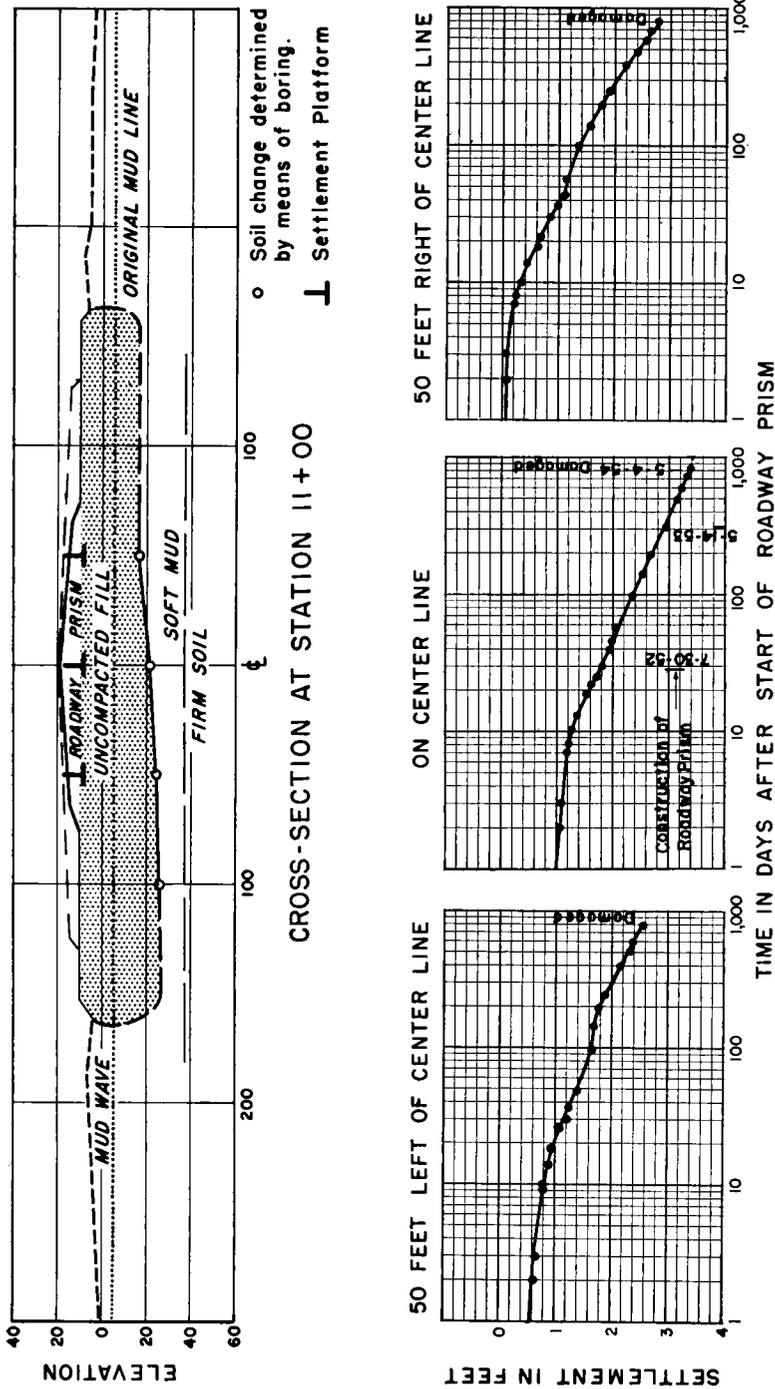
Figure 8. First unit, 300 ft wide.

SETTLEMENTS AT STATION 11+00

As placement of the working table progressed, settlement platforms were placed on centerline at each station on the surface of the working table. A limited number of settlement platforms were also placed 75 ft right and left of centerline. These settlement platforms would measure the total settlement of the roadway prism. At five locations, settlement platforms were placed at the bottom of the fill and would measure the settlement due to the soft bay mud and stiff bay mud. Four settlement platforms were installed at the top surface of the stiff mud layer to measure the settlement due to this layer. Typical settlement curves are shown in Figures 8 to 14.

The total settlement curves from Stations 6+00 to 60+00 are quite similar. The slope of the log-time settlement curves is about the same and indicates that only small differential settlement is occurring between any two adjacent stations. The total settlement to date in this area is between 3 and 6 ft. The settlement since paving has varied from 0.3 to 1.5 ft and has produced long, rolling waves in the pavement. It is expected that this differential settlement will continue to increase for many years.

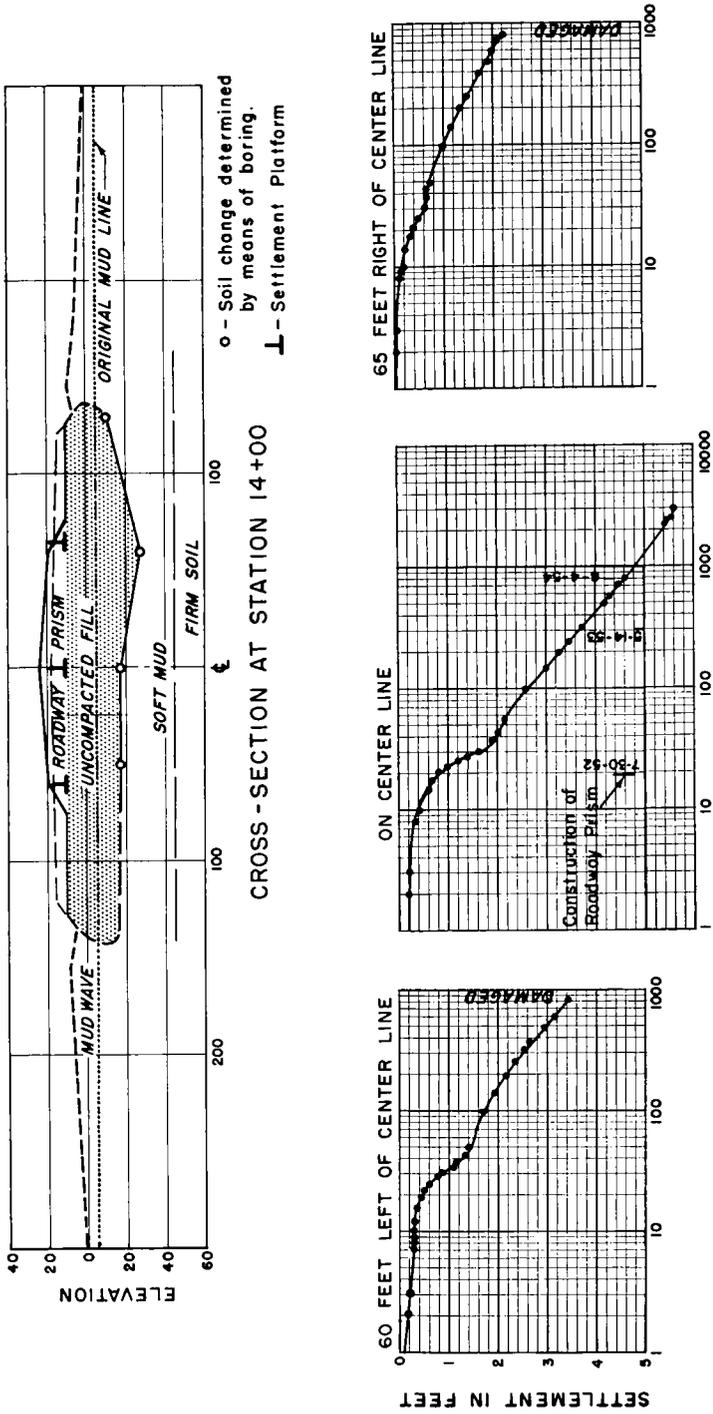
Figure 9. First unit, 250 ft wide.

TIME IN DAYS AFTER START OF ROADWAY PRISM
SETTLEMENTS AT STATION 14+00

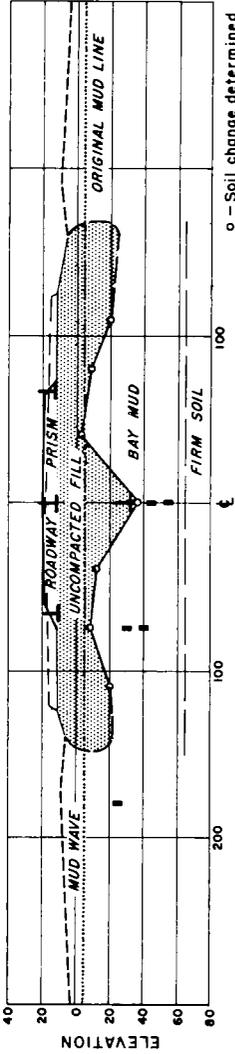
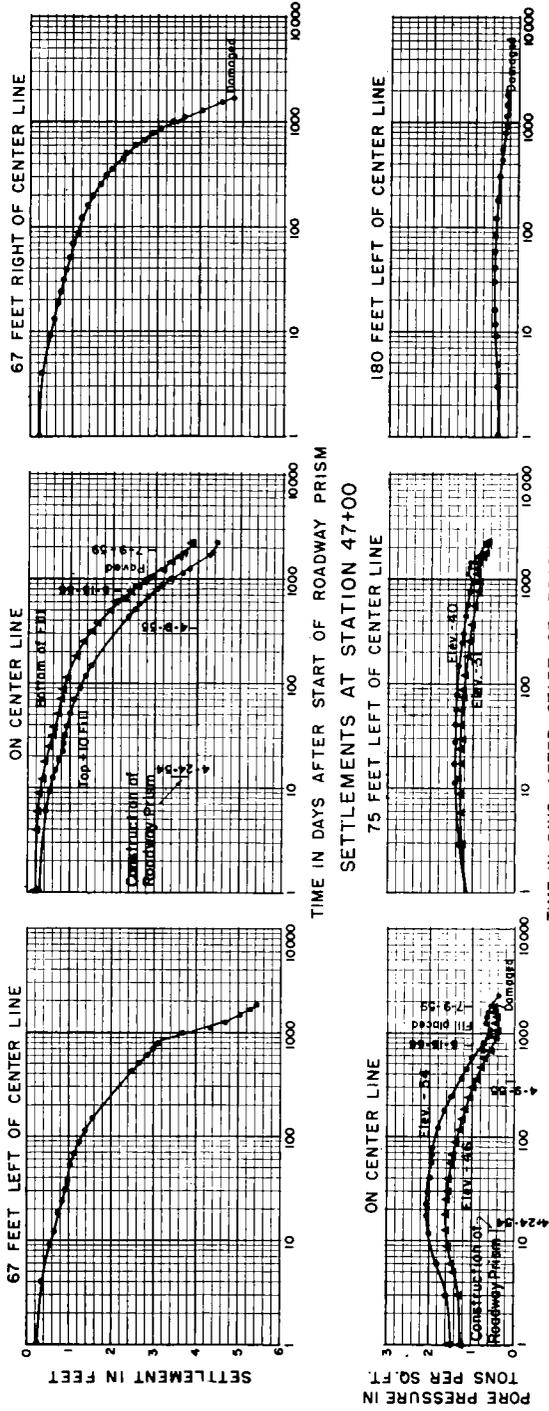
Figure 11. Second unit, 250 ft wide.

CROSS-SECTION AT STATION 47+00

o - Soil change determined by means of boring.
 ↓ - Settlement Platform
 ■ - Piezometer

EXCESS HYDROSTATIC PRESSURE AT STATION 47+00

The piezometers were placed so as to obtain a half cross-section of the excess hydrostatic pressure: one or more on centerline, one or more 75 to 80 ft left of centerline near toe of roadway prism, and one under the crest of the mud wave. Four piezometers were installed in the sand to clayey sand between the soft mud and stiff mud layers. Typical excess hydrostatic pressure data obtained are shown in Figures 10 to 12.

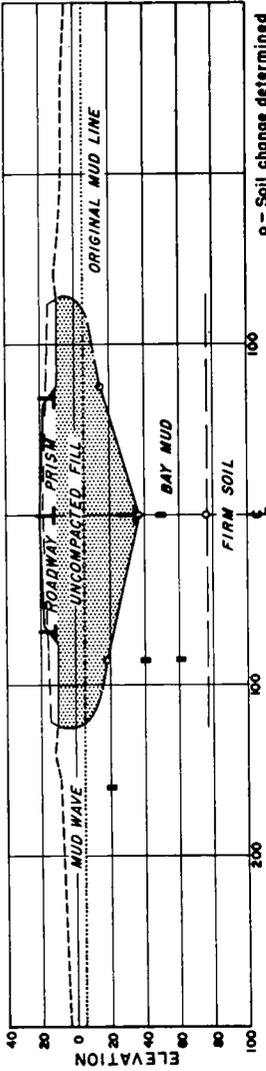
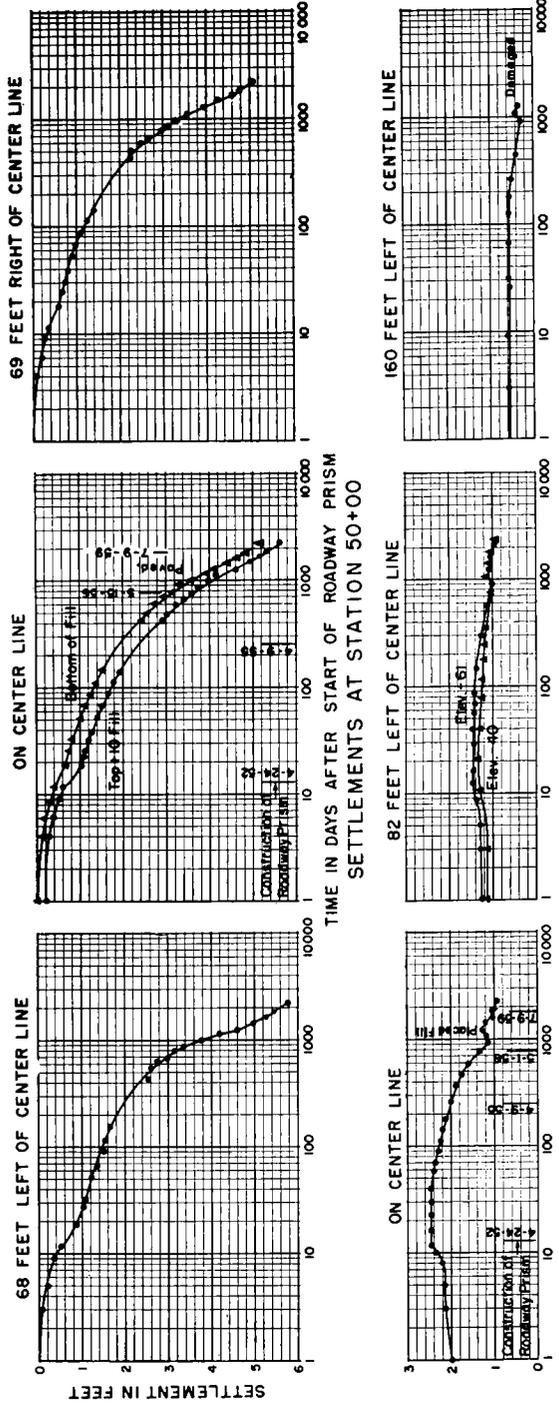
Figure 12. Second unit, 250 ft wide.

CROSS-SECTION AT STATION 50+00

EXCESS HYDROSTATIC PRESSURE AT STATION 50+00
 TIME IN DAYS AFTER START OF ROADWAY PRISM SETTLEMENTS AT STATION 50+00

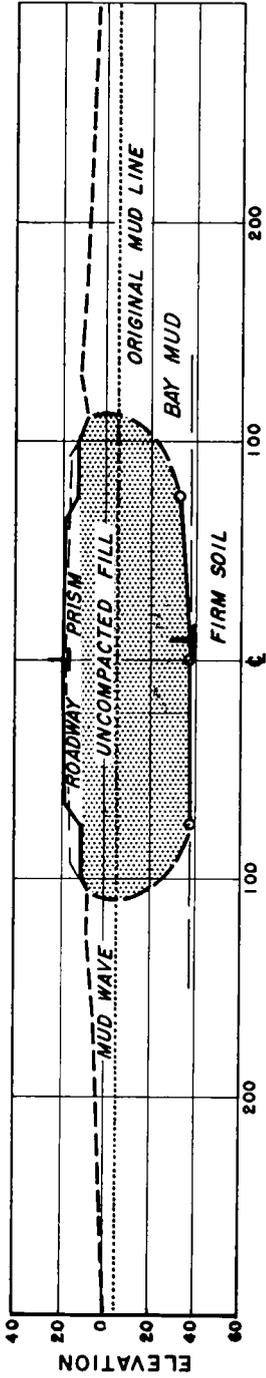
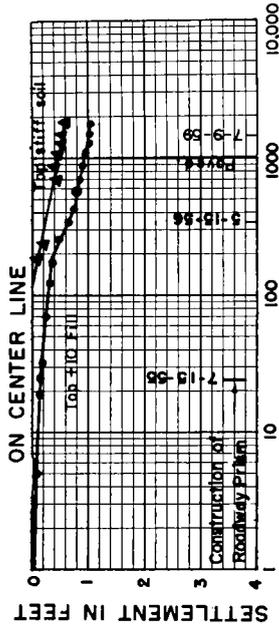
Figure 13. Third unit, 200 ft wide.

o - Soil change determined by means of boring.
 ↓ - Settlement Platform

CROSS-SECTION AT STATION 71+00

TIME IN DAYS AFTER START OF ROADWAY PRISM
 SETTLEMENT AT STATION 71+00

The total settlement curves from Stations 60+00 to 120+00 indicate that little settlement occurred during the placing of the roadway prism. The slope of the log-time settlement

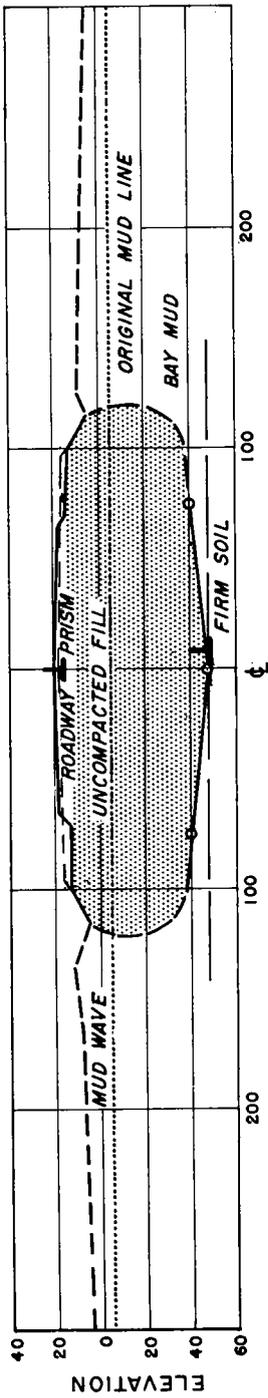
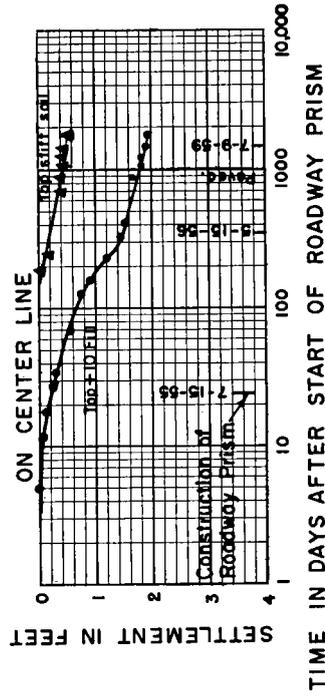
Figure 14. Third unit, 200 ft wide.

o - Soil change determined by means of boring.
 L - Settlement Platform

CROSS-SECTION AT STATION 98+00

SETTLEMENT AT STATION 98+00
