# HIGH SPEED APPROACHES AT ROUNDBABOUTS

Scott Ritchie, P.E.  
Roundabouts & Traffic Engineering

MAY 10, 2005

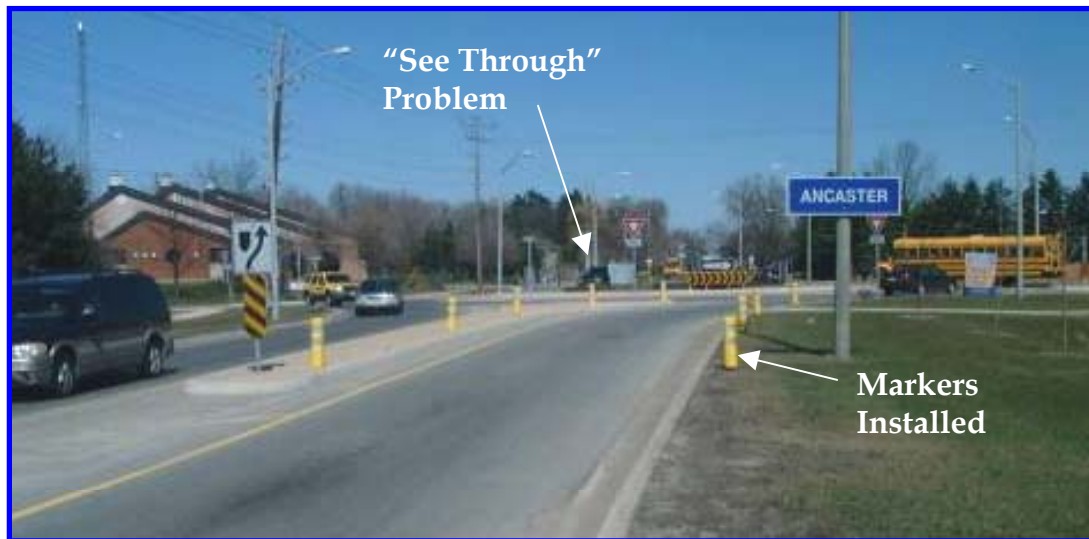
Another factor identified in the review of this case study roundabout was the visibility of the eastbound entry at night due to a potential lack of illumination. Since lighting levels are within acceptable ranges, it was recommended to landscape the central island and to place some ground level reflectorized markers on either side of the roadway to define and delineate the entry. In the case of this design, the eastbound approach splitter island could not be extended because the adjacent road authority would not permit it. **Figure 8** demonstrates the implemented markers on the eastbound approach. The figure also shows the "see through" problem of the intersection due to the lack of sight-obstructing landscaping.

**Figure 8:** Ancaster Roundabout with Candlestick Bollards on EB Approach  
(Note “see through” problem of central island)

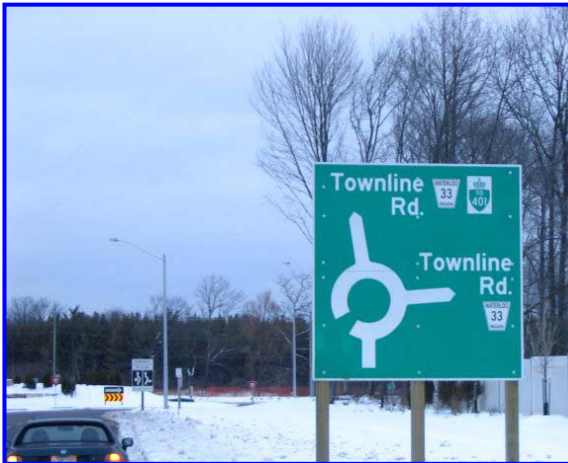
**Figure 26: Correct Maptype Sign**

As shown in the tables above, the measured speeds at the roundabout are slightly less than the predicted design speeds. These are positive results. Another noting factor with this rural high-speed roundabout are the implemented sign designs. The signs at the multi-lane Townline Roundabout aid in detecting the presence of the roundabout ahead, deciding on the correct entry lane to use, and slowing to an appropriate speed. Signs at multi-lane roundabouts also aid in deciding on the correct exit to use. The photos below in **Figures 26** and **27** are good examples of proper signing at modern roundabouts.

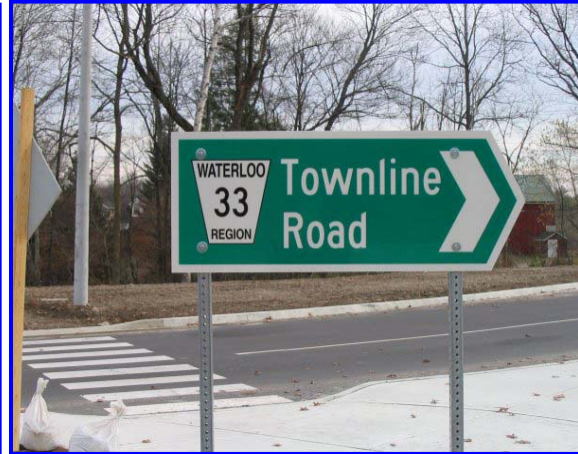
**Figure 27: Correct Exit Sign**

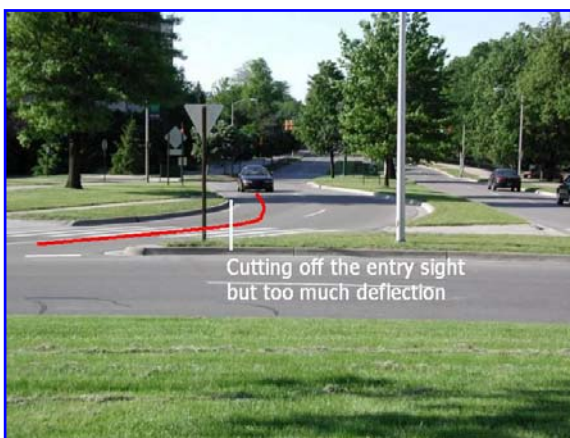
**Figure 35:** An Over-deflected Entry  
(But good use of landscaping on the splitter island prior to entry)

The illustrations below depict examples of too much deflection ([Figure 35](#)) and insufficient deflection ([Figure 36](#)).

The conditions shown in **Figure 35** control the speed of entry, but are prone to approach type crashes such as rear end, side swipe, and single vehicle crashes if entering traffic flow is higher using both travel lanes. This condition can lead to overlap of the paths of two entering vehicles upstream of the entry. **Figure 36** depicts a condition that is prone to entry circulating crashes and overlap of the paths of two entering vehicles in the roundabout. Tight entry radii coupled with insufficient entry path curvature produces a combination of crash results. Although this roundabout was recently completed in 2004 on US Highway 6 in Avon, Colorado, the designer did not recognize the multiple problematic issues such as crash related safety hazards, capacity reducing geometry, and high approach speeds.

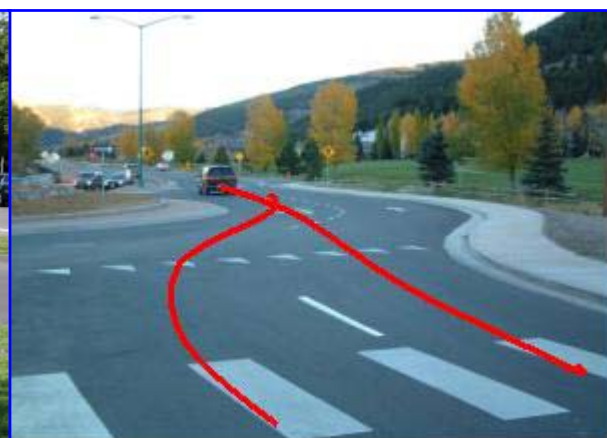
**Figure 36:** Insufficient Entry Path Curvature  
(This layout also suffers from an entry path overlap creating safety and capacity issues)

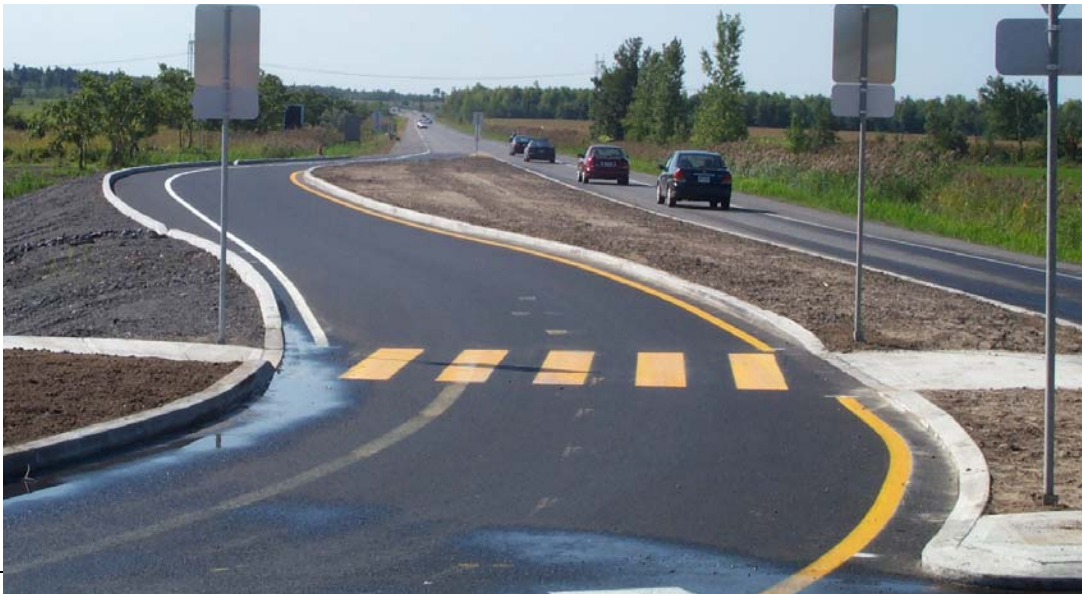
**Figure 42:** Successive Approach Curves Implemented

Although renowned roundabout design specialists in the U.K. caution against using such methods due to increased approach accidents at or prior to entry, studies still need to be conducted to verify this type of Australian design. The risk associated with this high-speed mitigation measure is that decreasing the radius of an approach curve may increase the single-vehicle crash rate on the curve, particularly when the required side-friction for the vehicle to maintain its path is too high. On multi-lane approaches this may encourage drivers to cut across lanes and increase sideswipe crash rates on the approach curve. Examples of this treatment are illustrated below in **Figures 41** and **42**.

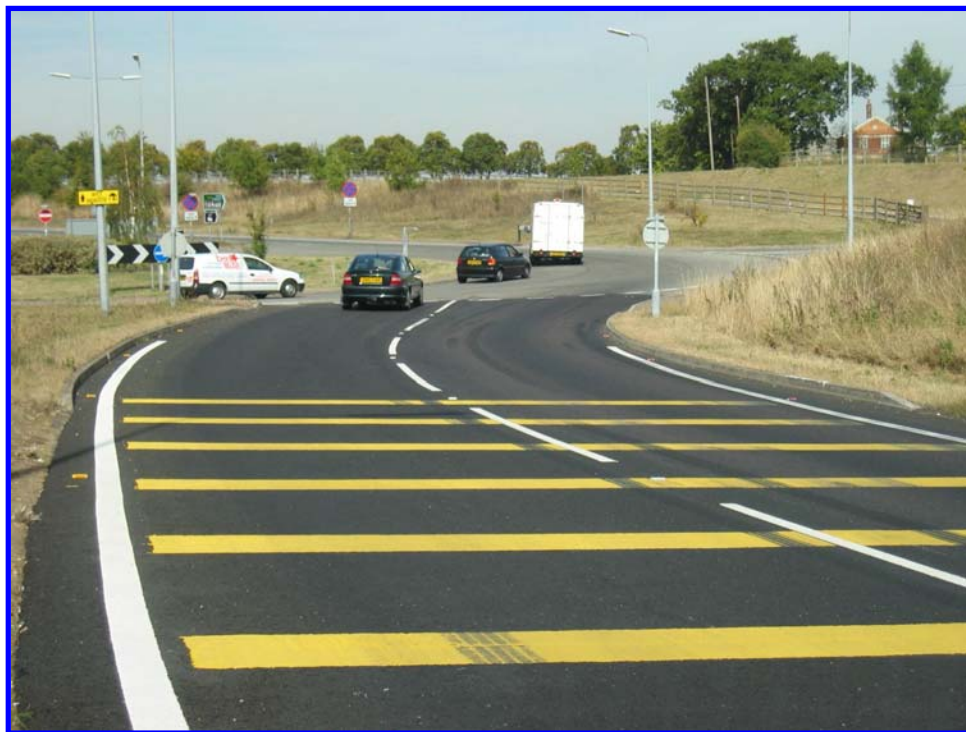
Road Research Laboratory have shown that transverse yellow bar markings are appropriate contributions to road safety when placed on the approaches of roundabouts where there is a history of speed related accidents. However, only suitable sites and prior authorization of headquarters is required to ensure that the markings are used only at sites with similar characteristics in the TRRL studies. The TRRL criteria are also sensitive to surrounding area conditions and intersections before consideration of use. In general, the bar markings are placed successively with decreased spacing to create the illusion to the driver of an increase in speed despite the fact that the vehicles speed may be decreasing. An illustration of an implemented example of the transverse yellow bar markings at a roundabout is shown below in [Figure 46](#).

**Figure 46: Transverse Yellow Bar Markings at Roundabout Approach**
