# Low-Level Stream Crossings in Developing Areas

Eddie Otte, *Van Wyk & Louw Inc., South Africa*

Andries J. Pienaar, *Northern Transvaal Province Department of Public Works, South Africa*

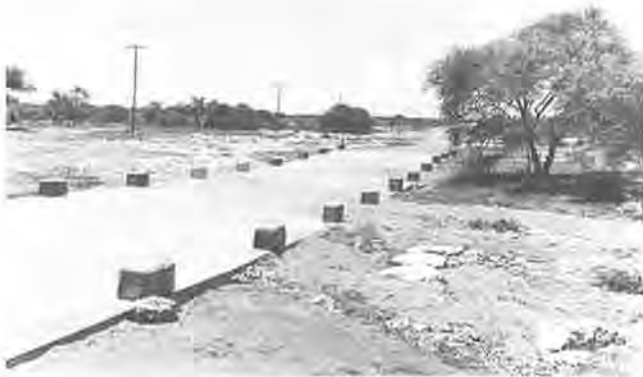
FIGURE 1 Concrete slab constructed so that water could flow over structure.

1. A concrete slab or causeway in which all the water would flow over the road. The length of the concrete slab and the vertical curvature (i.e., the *k*-value) were selected to ensure a flow depth of less than 300 mm (1 ft) during the 1-in-2-year flood (Figure 1).

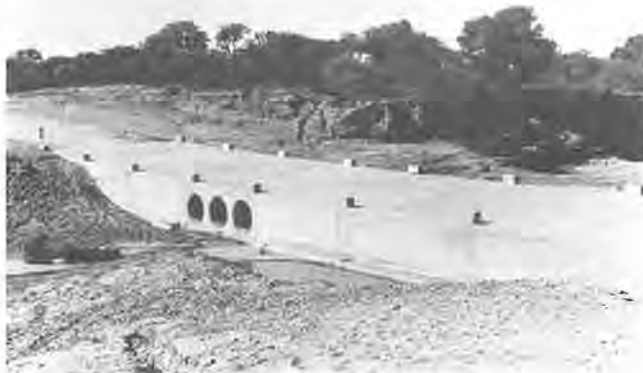
FIGURE 2 Concrete slab with three openings.

2. A concrete slab with one or more openings at the bottom to accommodate the base flow and to increase the hydraulic capacity to ensure compliance with the design standards (Figure 2).

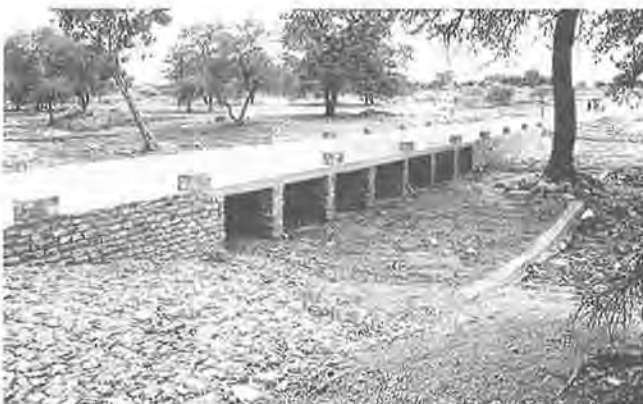
FIGURE 3 Stone masonry bridge (note guide blocks on deck and gabions and cut-off wall in foreground).

3. A bridge or culvert with several openings to accommodate an extensive flood. These structures were generally built with stone masonry walls and a simply supported cast in situ concrete deck (Figure 3).
