Thin Overlay Bituminous Macadam for the Control of Reflex Cracking

ROBERT D. JOHNSON, Maine Aeronautics Commission

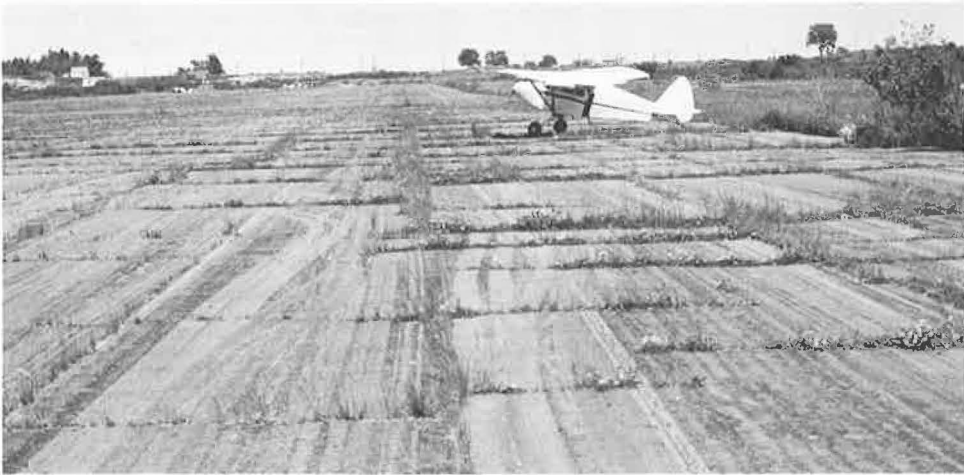
Figure 1. Eastport Airport before bituminous macadam overlay.

Pavements in concern, for the most part, have been over 20-years-old, have retained their general shape, but are severely cracked. The cracks commonly prevail in two directions—longitudinally with a reasonably consistent pattern and straight alignment, and transversely with a very irregular pattern and irregular alignment. The width of the cracks is most often from $\frac{1}{2}$ to $\frac{3}{4}$ in.

In the summer of 1959, a typical 3-in. bituminous macadam overlay course was placed over 1 of the 2 runways at the Eastport Airport, Eastport, Maine. Inspections during the next 4 years revealed no evidence of reflex cracking. During the fifth year one crack occurred, but it had actually healed itself. Obviously the $2\frac{1}{2}$ gal./yd² of flexible asphalt used in this macadam course added greatly to its ability to resist cracking; when cracking did take place, the asphalt was a great asset in rehealing it. The actual material description, amounts and order of application used on the Eastport project, is described in Table 1. Pavement conditions before and after this project are shown in Figures 1 and 2.

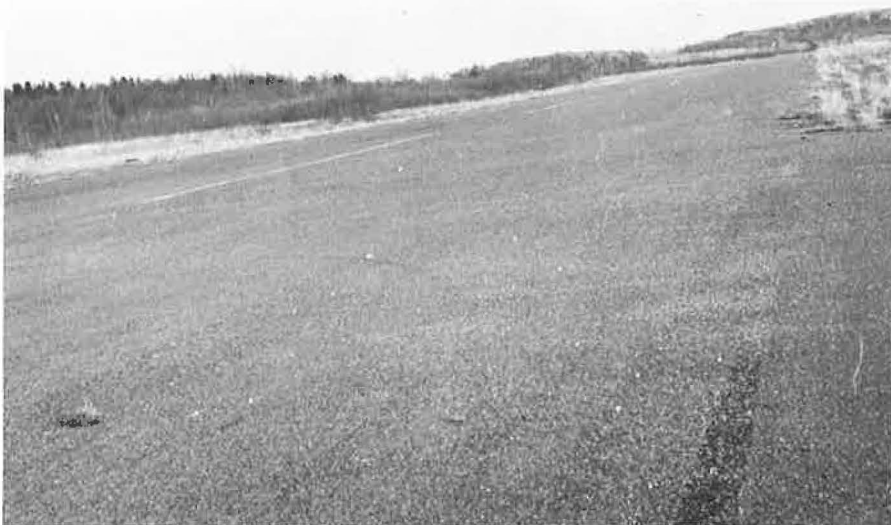
Figure 2. Eastport Airport after a 3-in. bituminous macadam overlay.

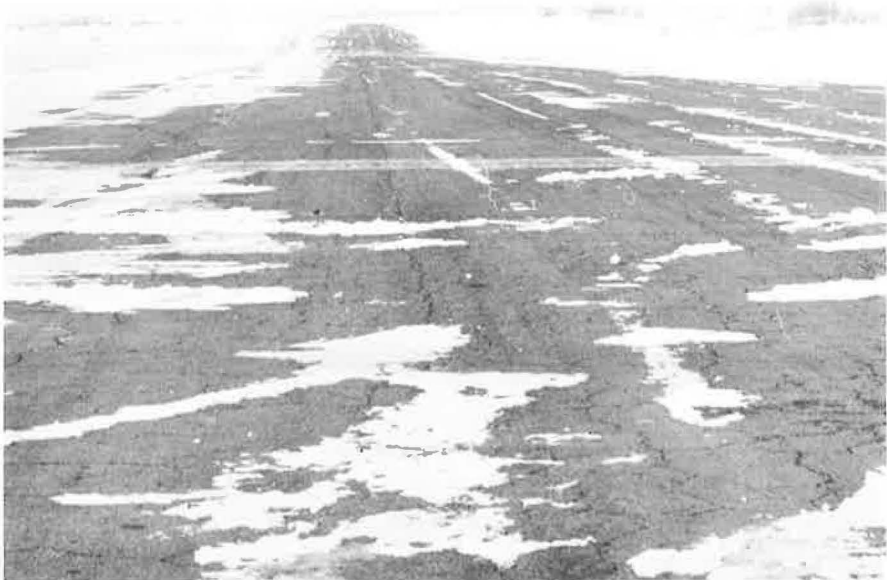
Figure 3. Caribou runway before bituminous macadam overlay.

A 1½-in. macadam overlay pavement was placed on runways at 2 different airports. One was at Caribou, Maine, and the other at Dexter, Maine. Pavement conditions before and after the Caribou project are shown in Figures 3 and 4.

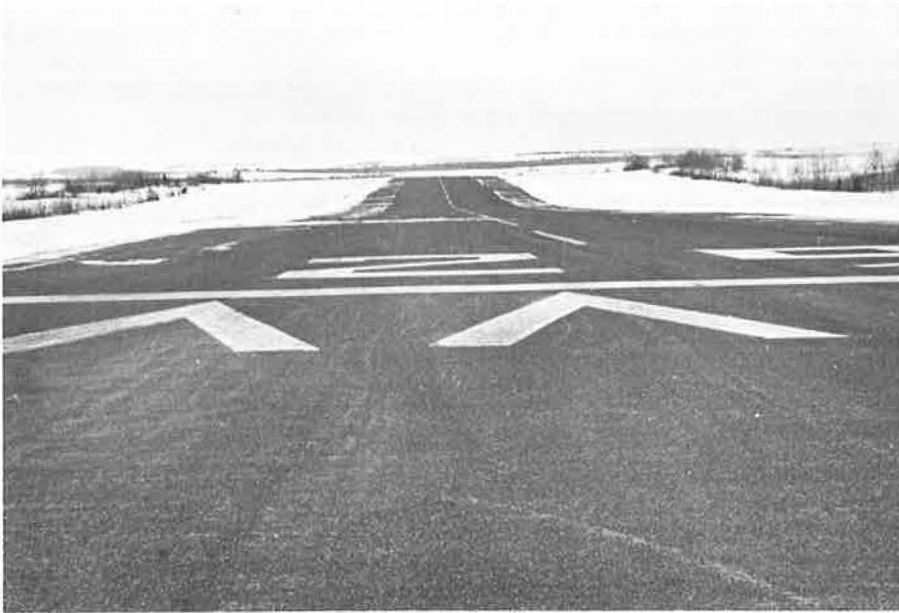
Figure 4. Caribou runway after a $1\frac{1}{2}$ -in. macadam overlay.

Observations in May 1965 of both the Caribou and the Dexter projects revealed

that they were holding up very well, and most importantly, that reflex cracking was practically nonexistent. Therefore, we now believe that thin overlay bituminous macadam is the most economical and practical approach to the control of pavement reflex cracking that we have tried, observed, or researched to date.
