Sweden Changes to Right-Hand Driving

DAVID M. BALDWIN, U. S. Department of Transportation, Federal Highway Administration, Bureau of Public Roads

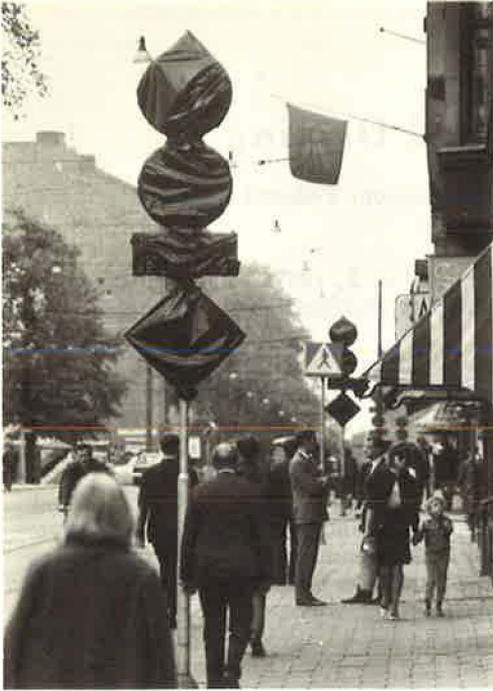
Figure 1. New signs in Stockholm covered prior to the changeover.

About 800 traffic signals were revised throughout the country, and an estimated 220,000 highway signs were replaced or newly installed. As was mentioned earlier, left-hand signs were duplicated on the right-hand side, partly as an education measure. This was not practical in all cases (for example, in the case of directional arrows) and so many of the new signs had to be erected and then covered or masked out. Following the change the old signs were removed as rapidly as possible. Some critical signs were covered the day of the change, with removal scheduled for later.

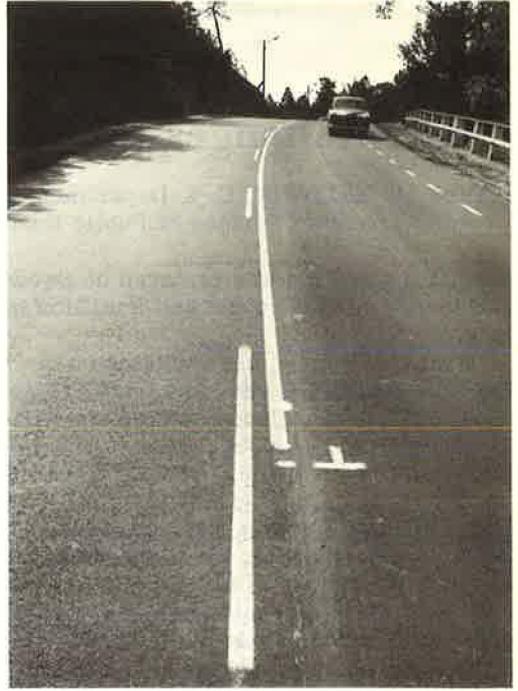
Figure 2. New pavement markings installed before the changeover while left-hand traffic was still operating.

Road or pavement markings had to be changed, and this presented a special problem because it could not be done at the last minute and left-hand traffic would be forced to operate for some period of time with any new markings for right-hand traffic. Yellow had been used for all pavement markings, and the authorities decided to solve the problem by using white for all markings for right-hand traffic. Drivers were instructed to obey the yellow markings up to the date of the change-over, then to obey the white markings. Certain arrows were left without heads, with these all-important features added the day of the change-over.

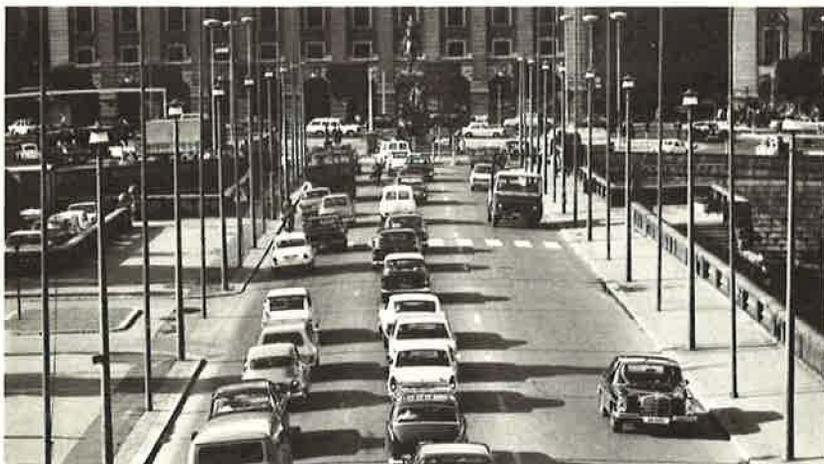
Figure 3. A main street in Stockholm with three lanes of traffic before the changeover.

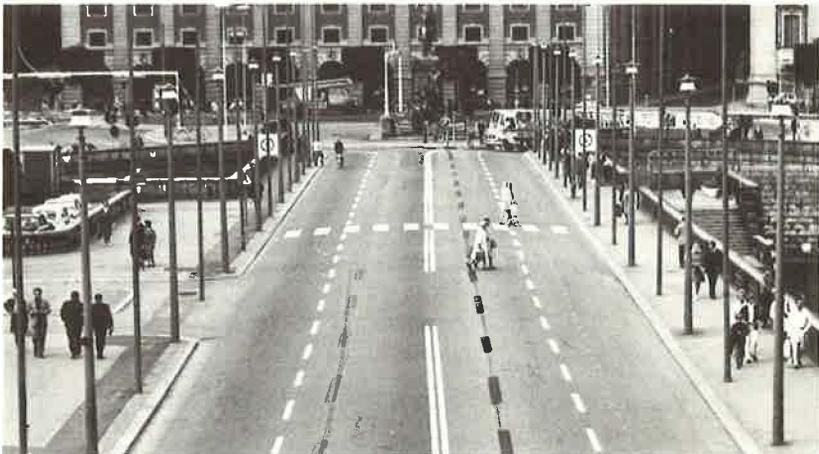
Figure 4. The same street on H-Day.

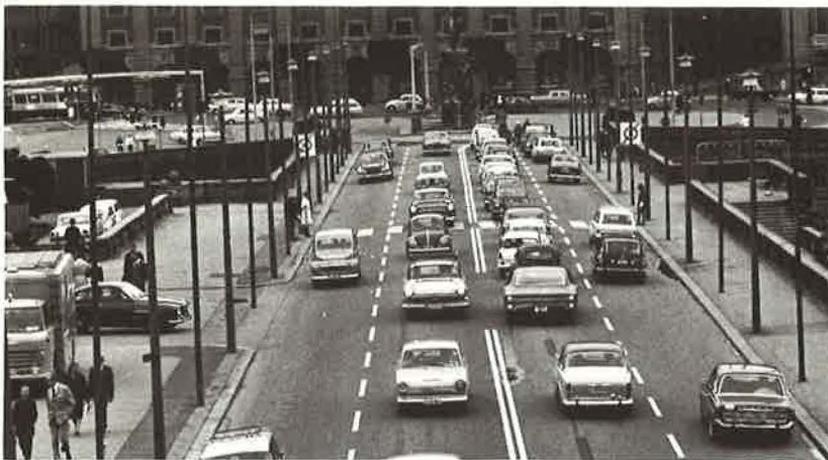
Figure 5. The same street operating with four lanes of traffic keeping to the right.
