Lead-Free Painting: Mystic River Bridge in Boston

MARILYN H. TOBEY

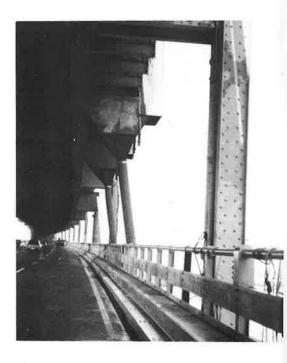
Below left:

View of sandblasting enclosures hung from upper level of Mystic River Bridge. Vertical supports were blasted with Vac-U-Blast equipment. On lower level and vertical support, sandblasting has been completed and midcoat applied.

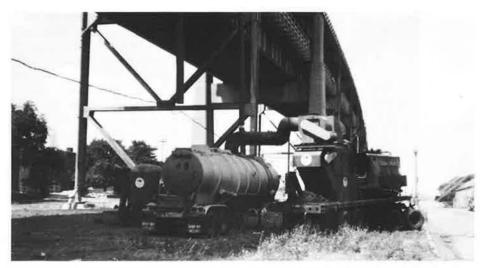
Below:

View of viaduct portion of Mystic River Bridge with sandblasting enclosures hung at upper level. Recoating is in process at lower level. Flexible tubing connects to disposal truck and water scrubber below.

Sandblasting dust and debris are exhausted from enclosure above the disposal truck (left) and through water scrubber (right) to purify air.

For the Mystic River Bridge repainting, a modification was made to this enclosure design: a mechanical suction device was added to exhaust the dust from the enclosure, which improved health and visibility conditions inside the booth. In the first contracts, the flexible tubing was connected to a disposal truck to catch heavy particles; an additional hose, a centrifugal exhaust fan to provide suction to pull the dust down, and a heavy cotton-canvas bag to trap fine particles were also attached. In later contracts were further improvements: metal sheathing was substituted on the enclosure to make it more durable (canvas and polyethylene were too easily shot out by misdirected blast guns), and a venturi water scrubber unit was added to catch fine particles and emit them as sludge.
