Automated Track-Geometry Inspection

Edward J. Ward

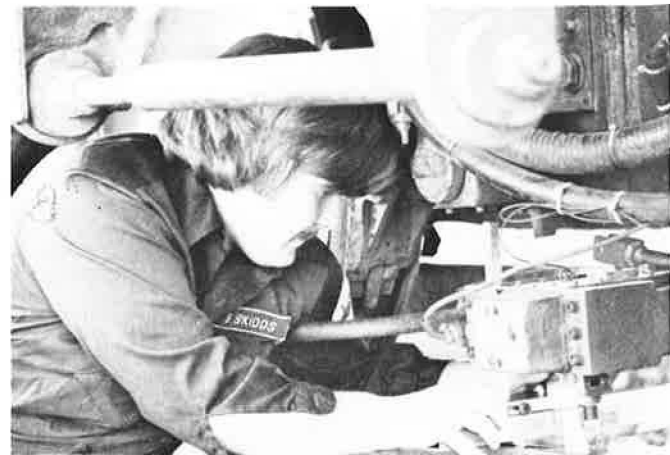
A technician verifies the calibration of the gage-measuring sensor mounted underneath the car.

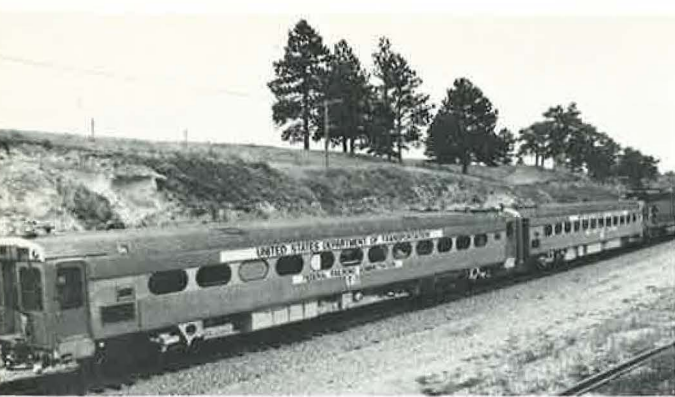
The two-car T1/T3 inspection facility is propelled by a locomotive unit belonging to the railroad that is being inspected. It is equipped with high-intensity halogen lights on the roof and lights mounted underneath the coupler.

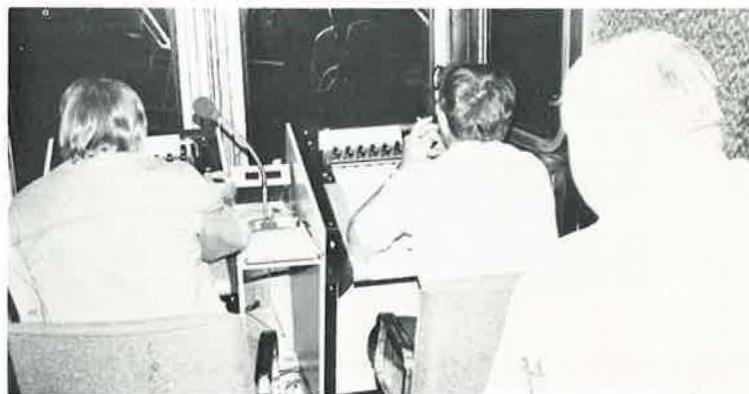
The interior of the T3 observation area includes two eight-channel oscillographs. They are being used here by an FRA inspector and a railroad representative.

The oscillograph displays are compared with the condition of the track as viewed from the rear of the survey car by an FRA track inspector and a railroad representative. Each can make notes on his own chart and can see the other's notes. Measurements are made at the posted speed limit for each section of track.
