Project No. 12-69

# **DESIGN AND CONSTRUCTION GUIDELINES FOR LONG-SPAN DECKED PRECAST, PRESTRESSED CONCRETE GIRDER BRIDGES**

## **FINAL REPORT**

July 30, 2009

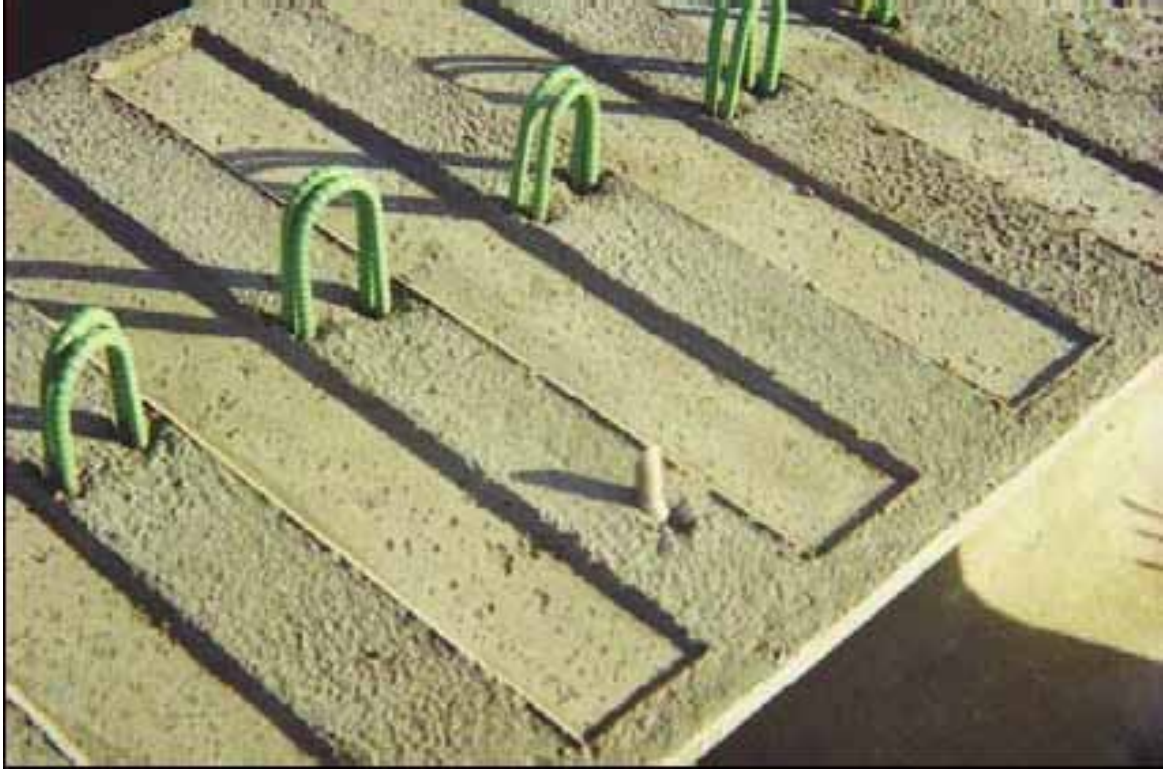
Figure 3.1 View of the Recessed Shear Key System

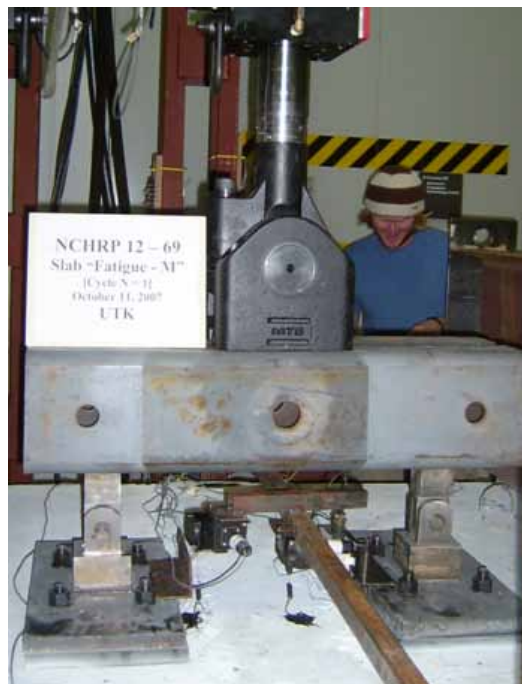
*Figure 3.17. Apparatus Applying Fatigue Forces*

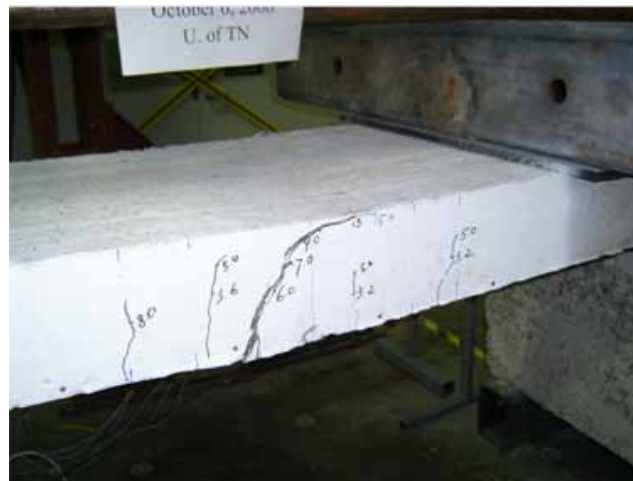
Figure 3.34. Crack Behavior for Specimen H-2.5-4 and H-2.5-6

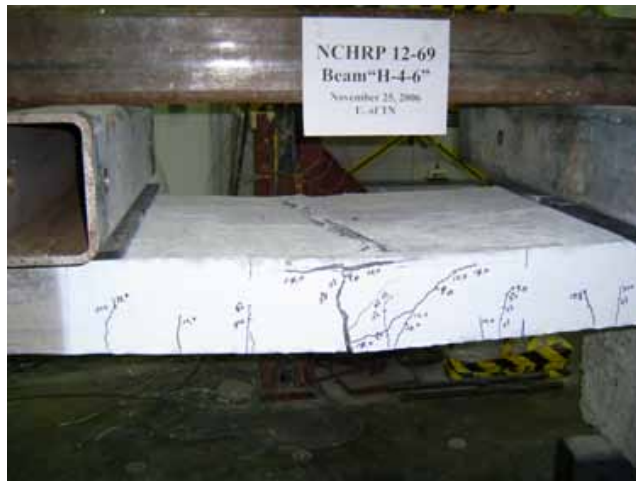
Figure 3.35. Crack Behavior for Specimen H-4-6

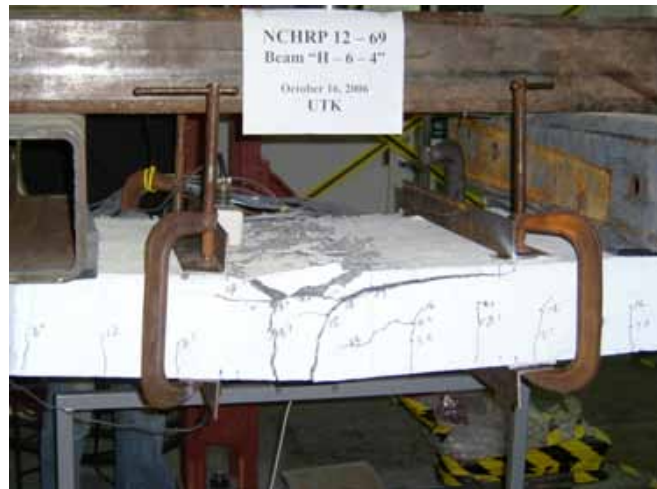
Figure 3.36. Crack Behavior for 6 in. Lap Length Specimen

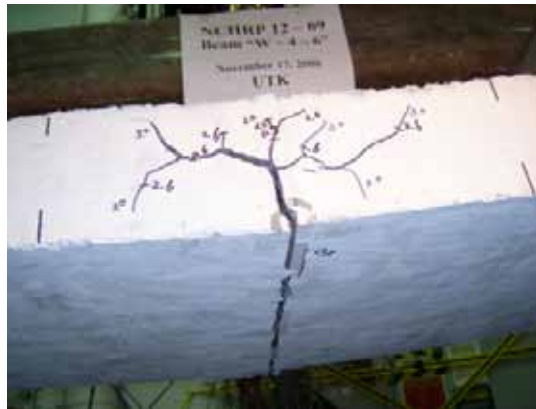
*Figure 3.37. A Large Crack Propagating along Midspan in WWR Specimens*

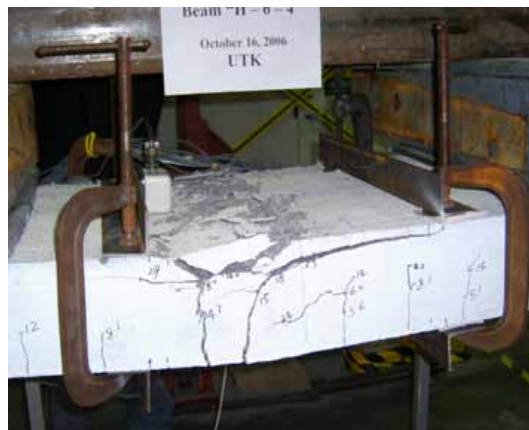
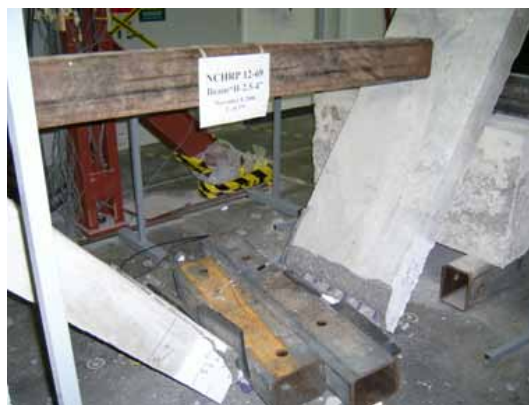
*(a): Ductile failure*

*(b): Brittle Failure*

*Figure 3.38. Failure Types*

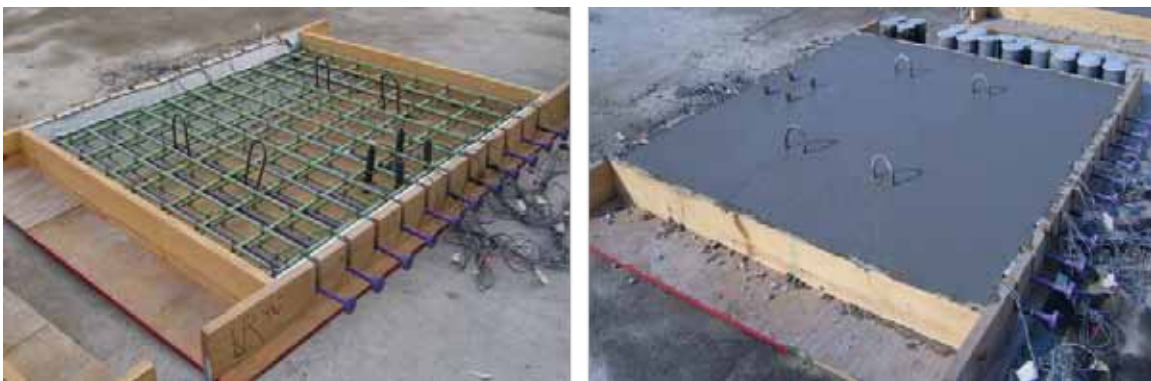
Figure 3.42. Panel Fabrication

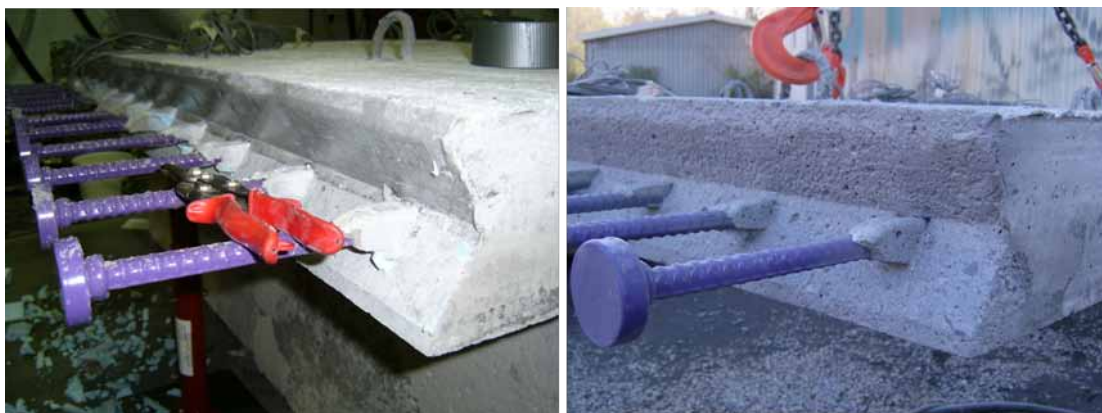
Figure 3.43. Profile of Joint Surface

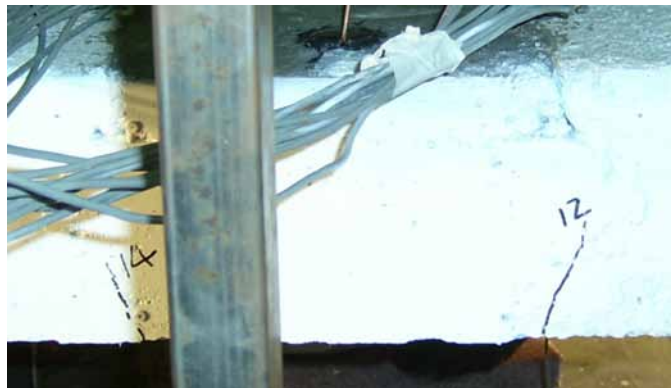
Figure 3.49. Cracks at Interface of the Joint

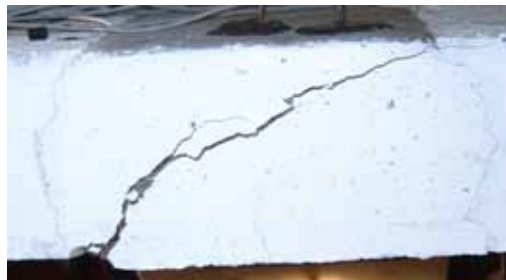
Figure 3.51. A Flexural-Shear Crack across Joint Zone

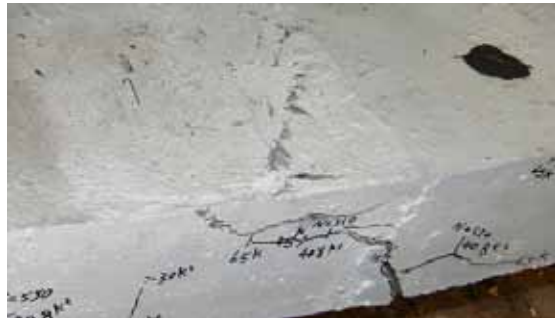
Figure 3.54 Specimen Failures
