SYNTHESIS 354

Inspection and Management of Bridges with Fracture- Critical Details

A Synthesis of Highway Practice

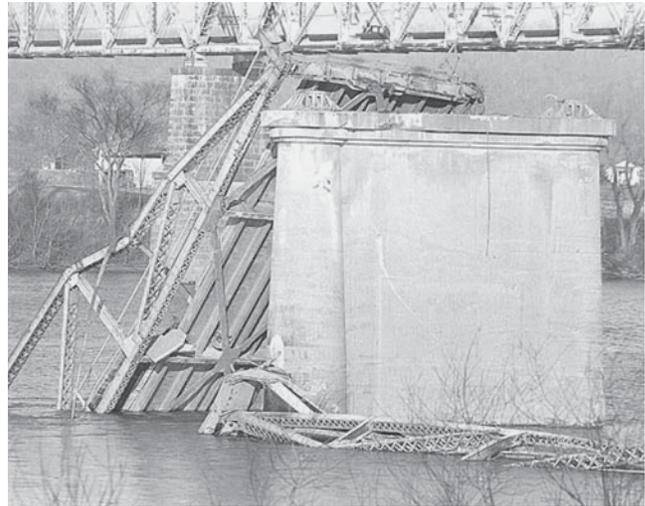
FIGURE 1 Collapse of Point Pleasant Bridge.

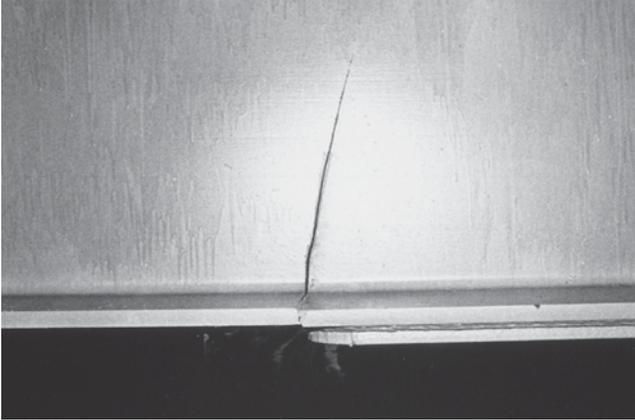
FIGURE 2 Development of fatigue crack at cover plate ends on the multibeam Yellow Mill Pond Bridge in Connecticut in 1976. (Courtesy: John W. Fisher.)

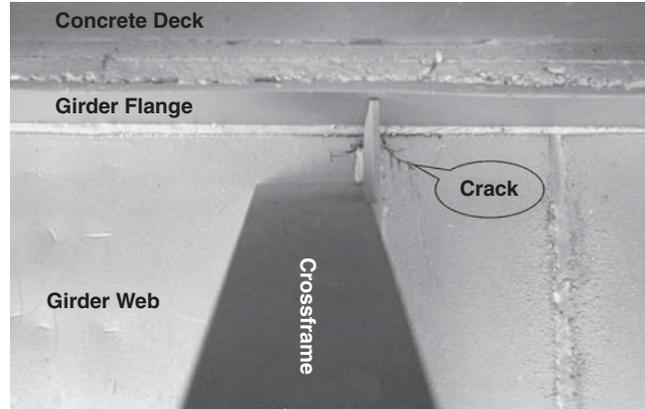
FIGURE 3 Typical web-gap fatigue cracking.

Distortion-induced fatigue cracking, discussed further in Appendix A, continued as a fatigue problem in typical plate girder bridges designed before the mid-1980s (11,12,15,16). A common example of distortion-induced fatigue cracking is web-gap cracking, which occurs in the gap when a connection plate is not attached to a flange and is subject to out-of-plane distortion (Figure 3). This problem was cor-

rected in 1985 by a change in AASHTO specifications that mandated the attachment of the connection plate to both flanges.

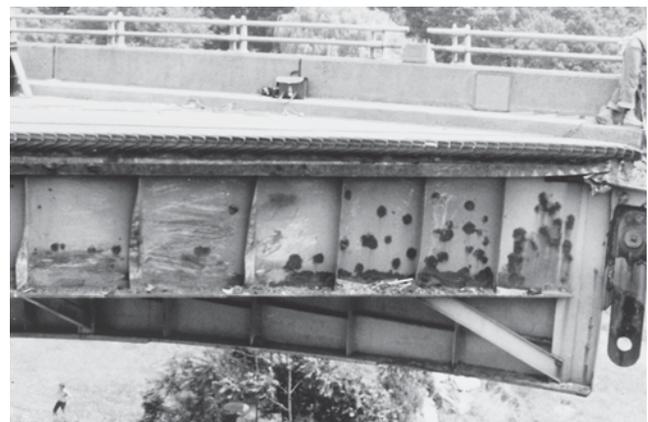
FIGURE 4 Collapse of Mianus River Bridge. (Courtesy: John W. Fisher.)

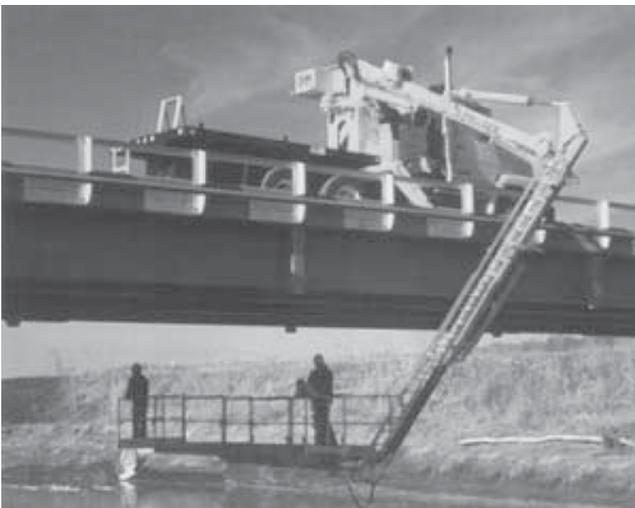
FIGURE 5 Snooper used for hands-on inspection from bridge deck.

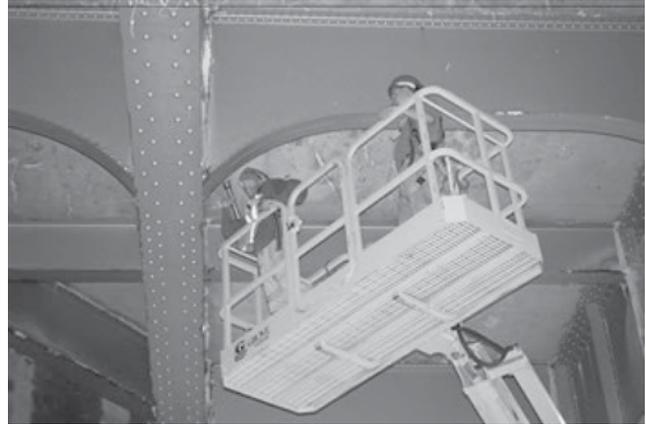
FIGURE 6 Hands-on inspection from manlift.

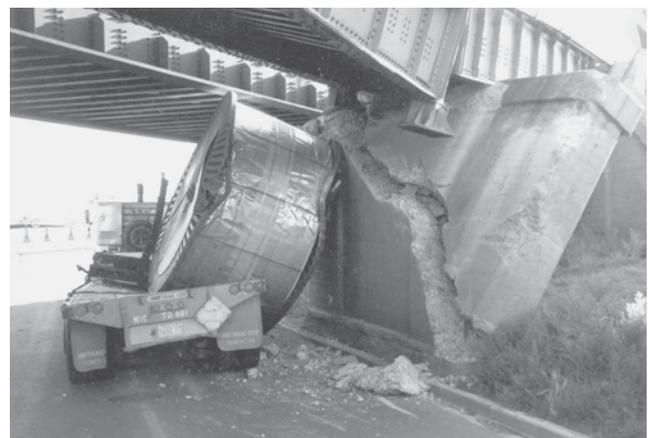
FIGURE 7 Example of vehicle–bridge collision causing collapse owing to nonredundant substructure. (Courtesy: Robert Sweeney.)

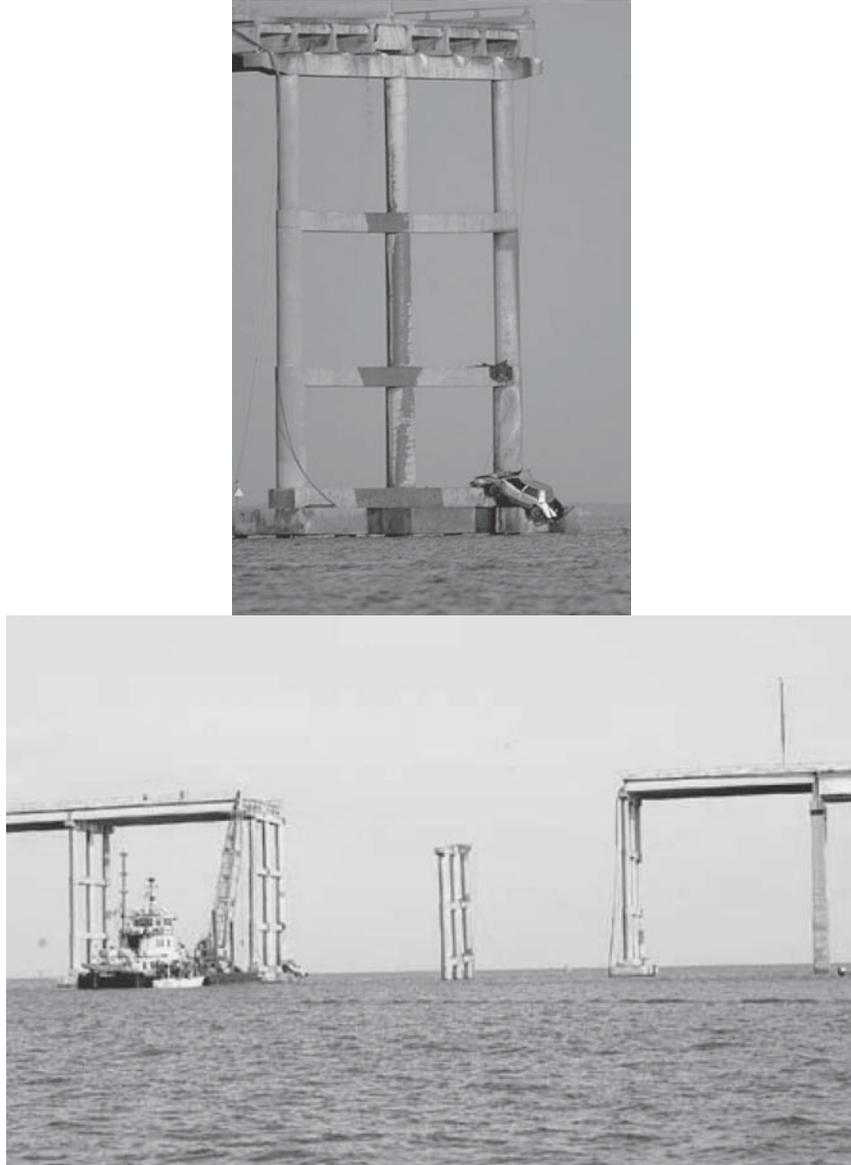
FIGURE 8 Collapse of Queen Isabella Causeway Bridge in Texas in 2001 when pier was struck by a barge.

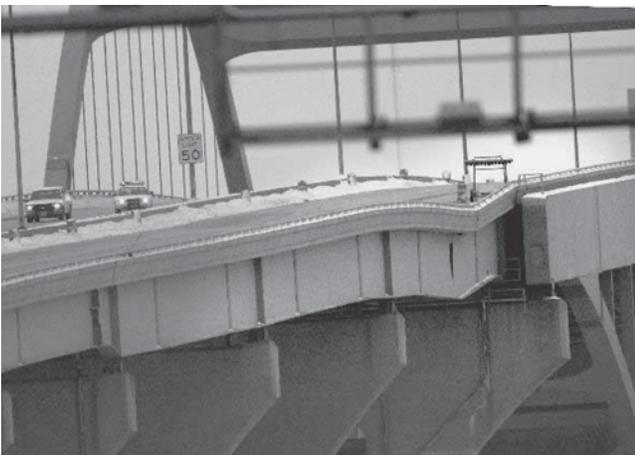
FIGURE 9 Example of bridge deck acting as catenary with hinge at fracture location in end span of the approach spans of the Hoan Bridge in Wisconsin—two of the three girders had full-depth fractures in December 2000.

As explained in chapter three, some agencies even classify three-girder bridges as FCBs. The Hoan Bridge fracture, shown in Figure 9, is an example of a three-girder bridge end span (which is viewed as most critical owing to inadequate con-

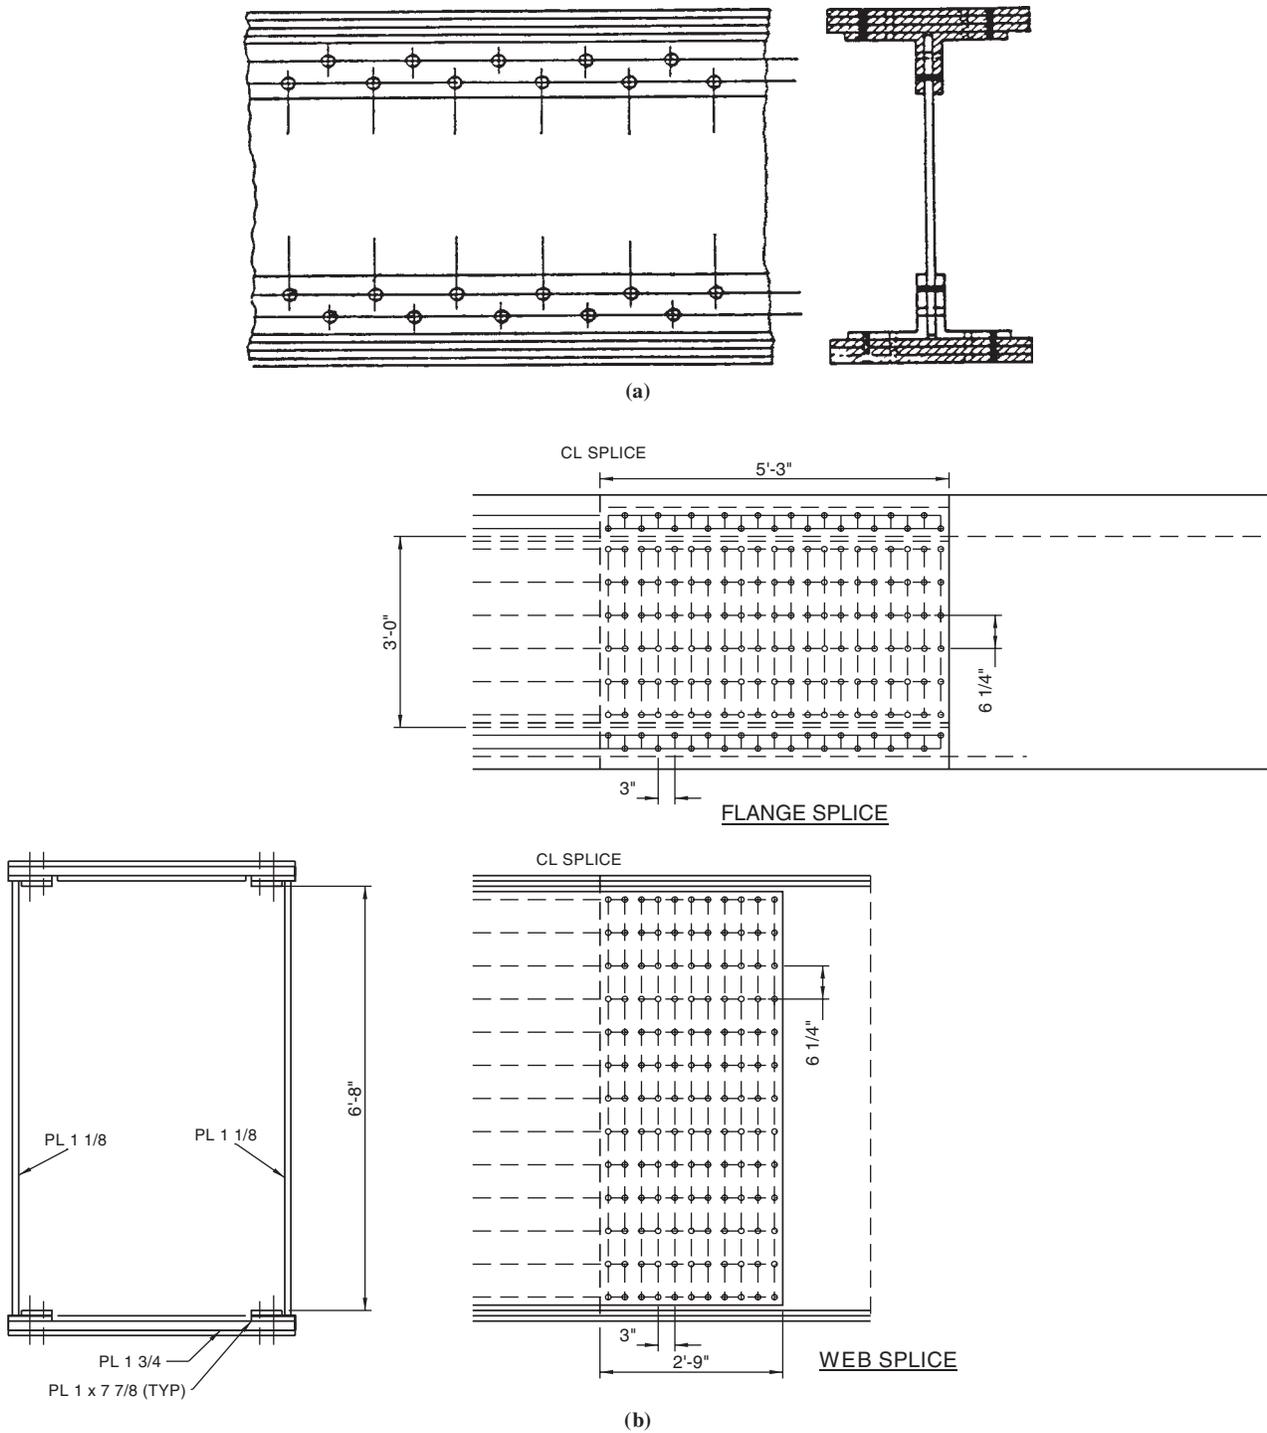
FIGURE 10 Examples of internally redundant members: (a) riveted built-up girder and (b) bolted built-up tie girder proposed for Blennerhassett Arch Bridge. (Courtesy: Michael Baker Jr., Inc.)

- Internal redundancy, also called member redundancy, exists when a member is comprised of multiple elements and a fracture that formed in one element cannot propagate directly into the adjacent elements. Examples include girders with composite deck (the deck remains intact in the event of a girder fracture as in Figure 9); riveted or bolted built-up girders, tie girders, or tension members of a truss (Figure 10); split box sections with longitudi-

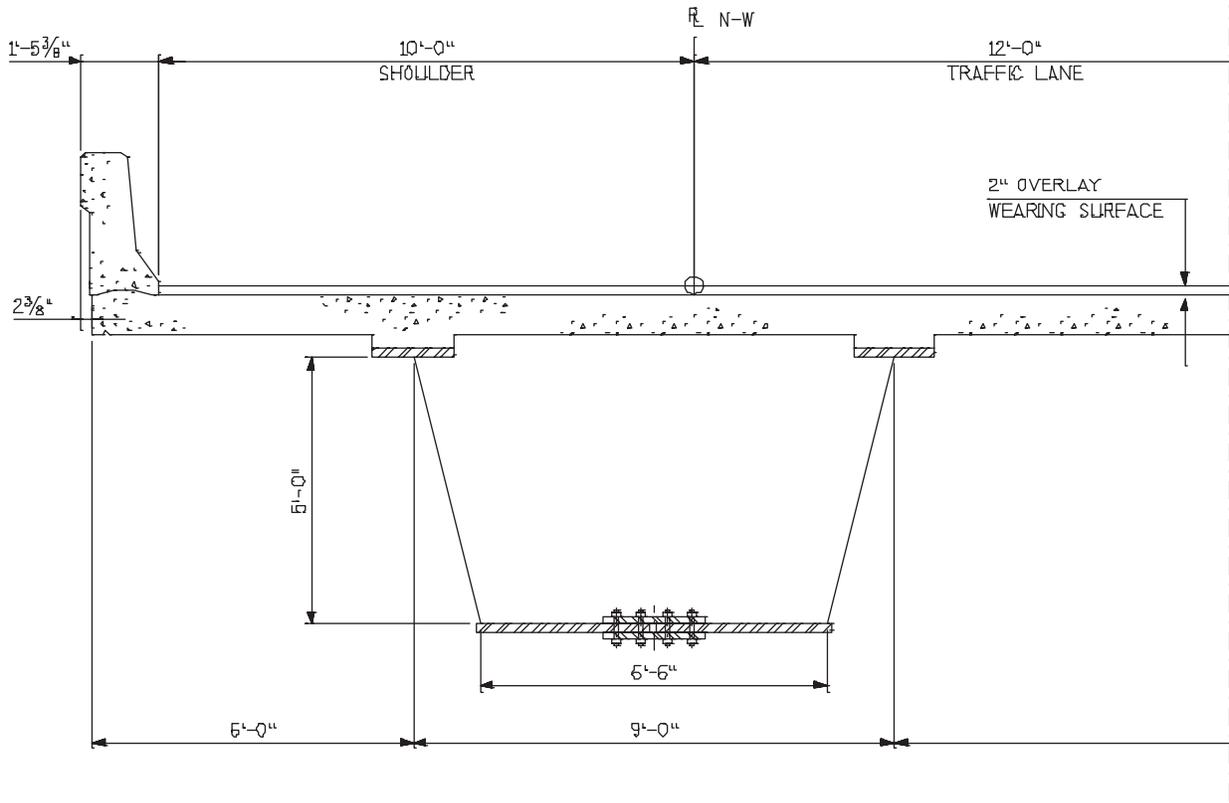
FIGURE 11 Splitting a box section with a bolted longitudinal splice to give it internal redundancy. (Courtesy: HNTB.)

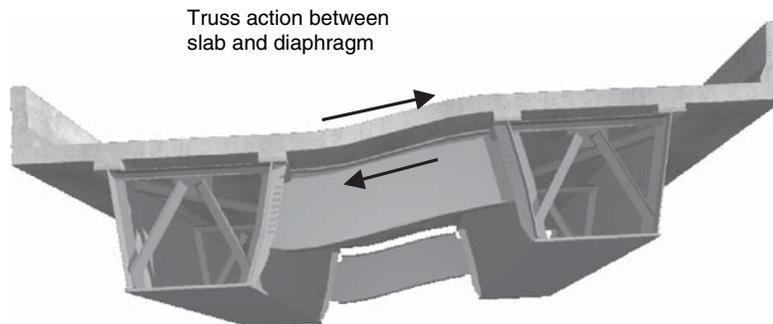
FIGURE 12 Schematic of twin composite tub girder superstructure showing internal redundancy provided by bracing system and possible alternative load path provided by slab and diaphragm. (Courtesy: HNTB.)

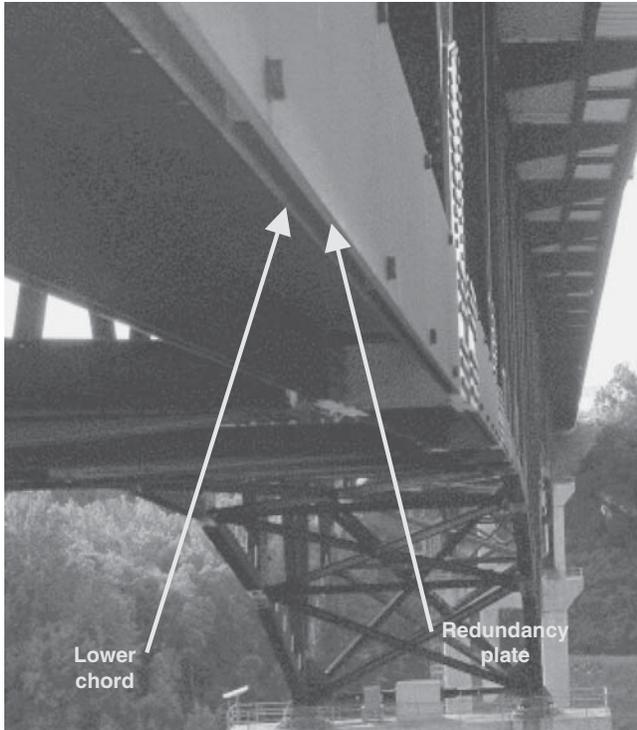
FIGURE 13 Redundancy plate bolted to lower chord of SR-33 bridge near Easton, Pennsylvania. (Courtesy: HNTB.)

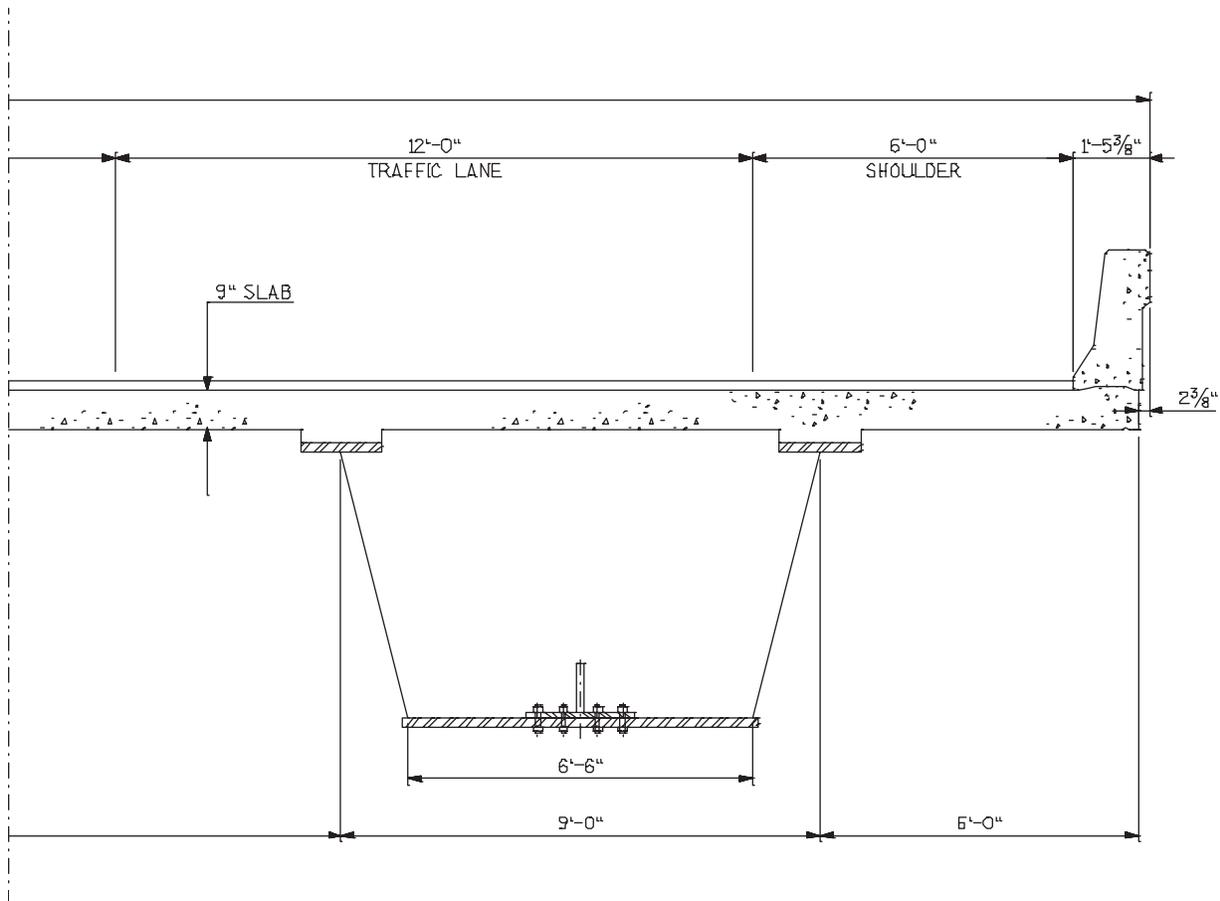
FIGURE 14 Tee section bolted to continuous lower flange of box section to provide redundancy. (Courtesy: HNTB.)

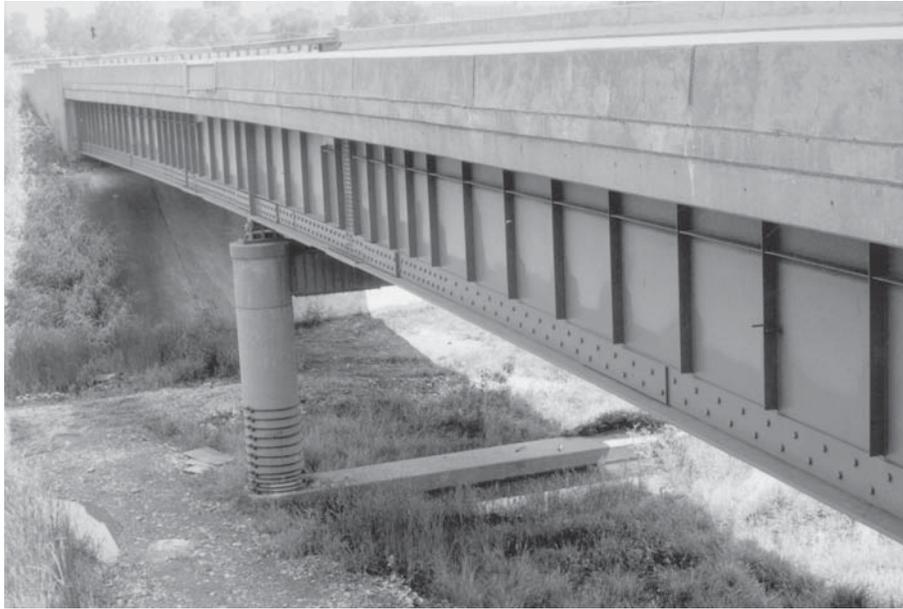
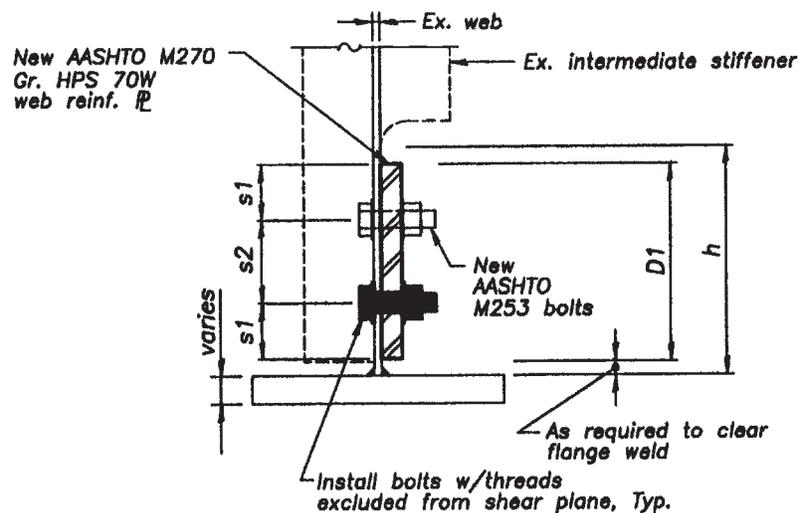
FIGURE 15 Retrofit redundancy plate bolted to web of existing two-girder superstructure in Poplar Street Bridge complex in East St. Louis. (Courtesy: Wiss, Janney, Elstner Associates.)

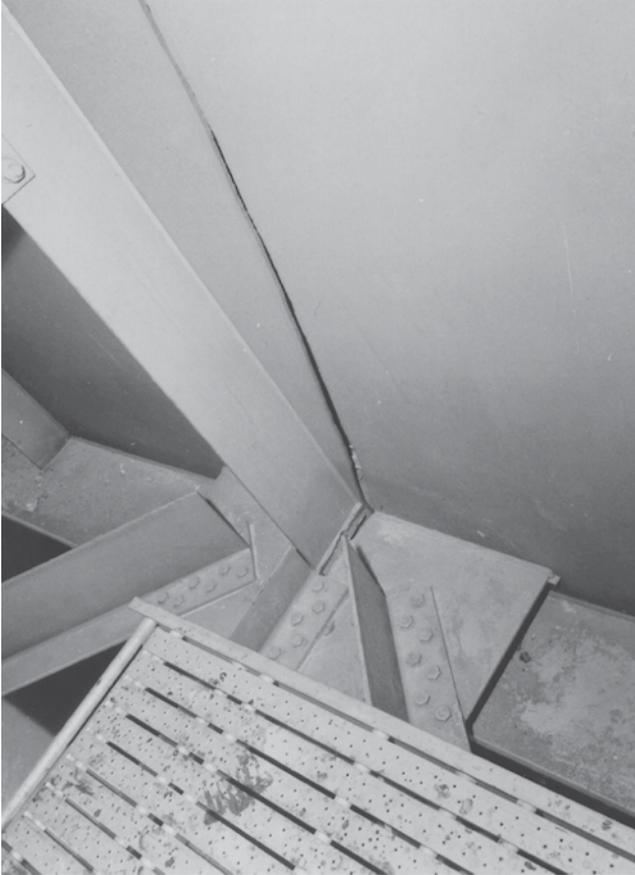
FIGURE 16 View of cracked girder in two-girder span of Lafayette Street Bridge in St. Paul, Minnesota, as an example of a bridge that is sufficiently redundant to avoid collapse despite a fracture of the tension flange and the web of one girder.

- The 1976 full-depth fracture of the US-52 bridge over the Mississippi River in St. Paul, Minnesota (called the Lafayette St. Bridge) (see Figure 16) (11,36). (It should be noted that during the course of this synthesis, it was mentioned that the bridge remained stable

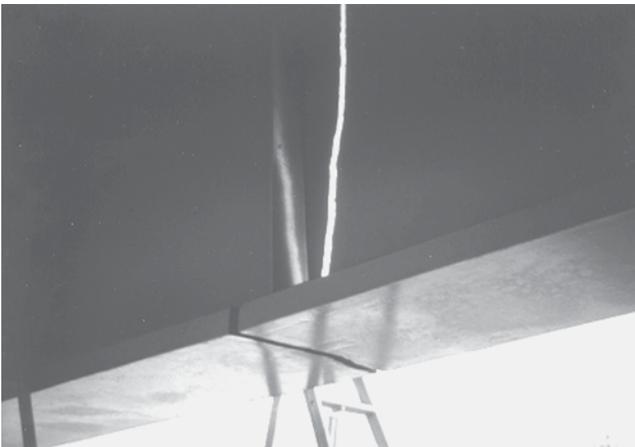
FIGURE 17 View of cracked girder in two-girder span of I-79 Bridge at Neville Island in Pittsburgh as an example of a two-girder bridge that is sufficiently redundant to avoid collapse despite a fracture of the tension flange and the web of one girder.

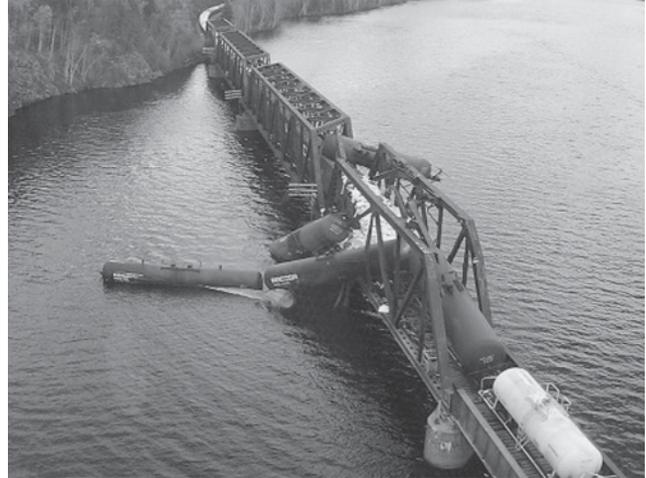
FIGURE 18 Example of train derailment on a fracture-critical truss bridge that severed several members but did not collapse. (Courtesy: Robert Sweeney.)

Although not caused by a fracture, a train derailment on a nonredundant truss bridge, shown in Figure 18, is another example of valuable in-service behavior of a full-scale bridge. Note that several diagonals, hangers, and upper chord braces are completely severed, but the truss did not collapse even though a significant portion of the live load remained on the bridge.

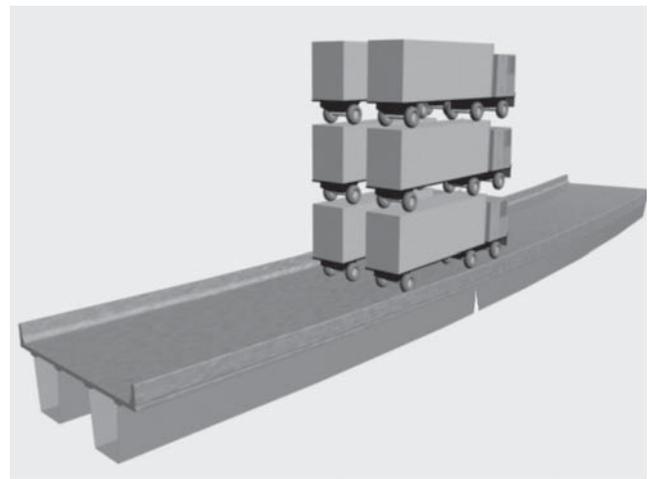
FIGURE 19 Schematic of multiple HS-20 loads on damaged superstructure. (Courtesy: HNTB.)

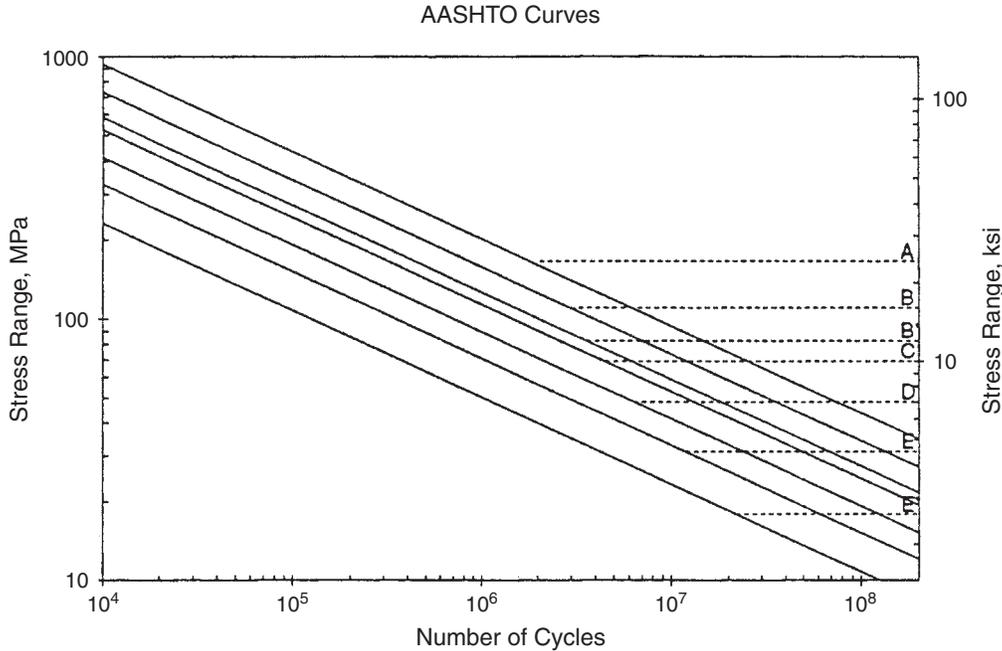
FIGURE A1 Lower-bound *S-N* curves for seven primary fatigue categories from AASHTO specifications. Dotted lines are the constant-amplitude fatigue limits and indicate detail category.

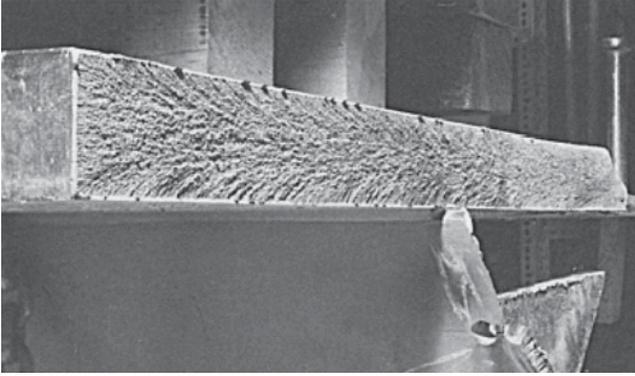
FIGURE A2 Brittle fracture of flange of tub girder of Bryte Bend Bridge in Sacramento, California, while under construction.

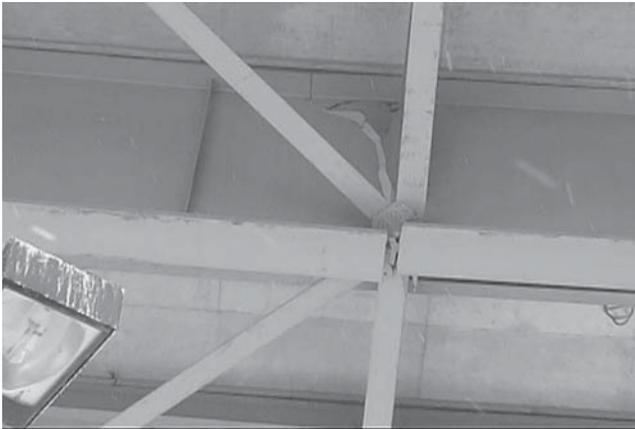
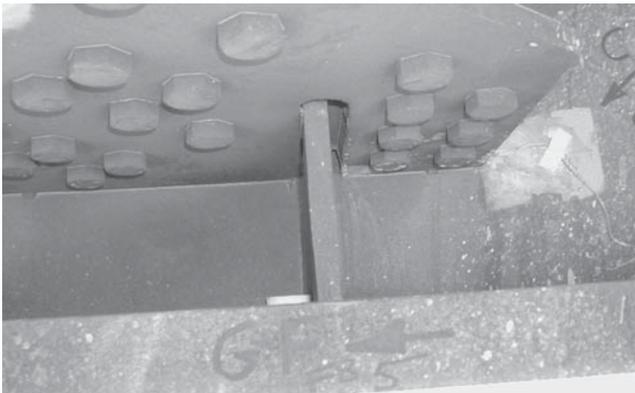
FIGURE A3 Fractured girder of the Hoan Bridge in Milwaukee (top) and view of critical shelf plate detail featuring intersecting welds.

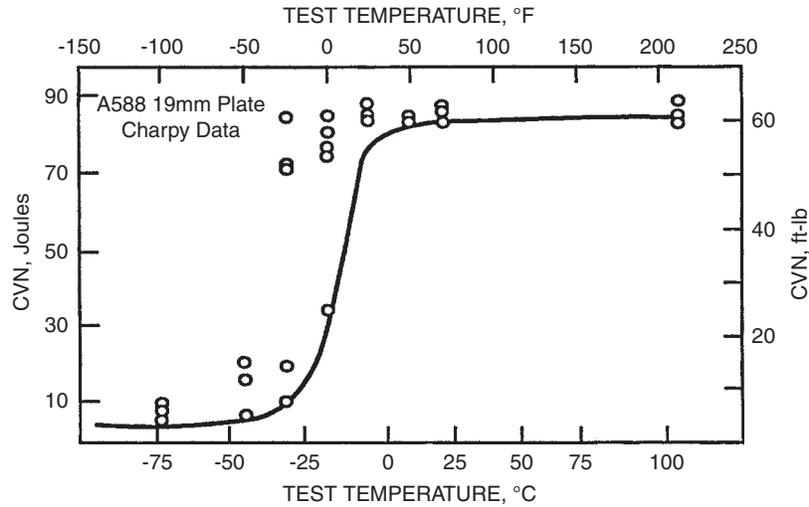
FIGURE A4 Charpy energy transition curve for A709 Grade 50 (350 MPa yield strength) structural steel.

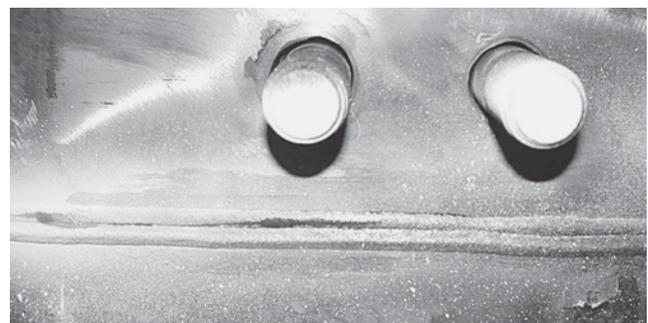
FIGURE A5 Example of indication from dye penetrant inspection.

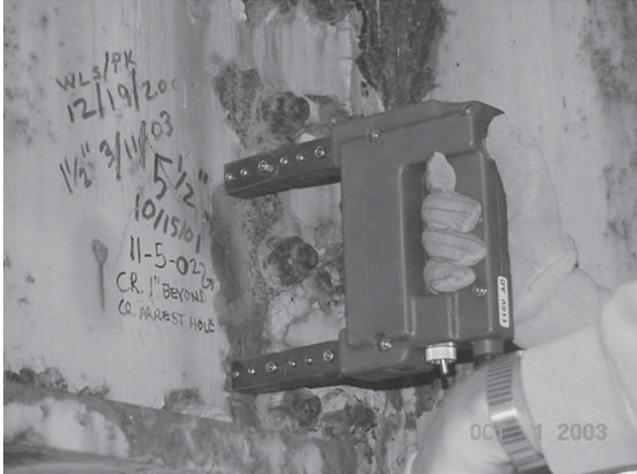
FIGURE A6 Magnetic particle testing—Placement of magnetic field.

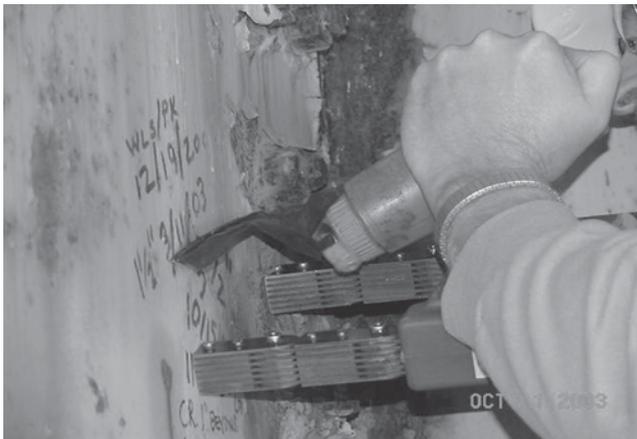
FIGURE A7 Magnetic particle testing—Application of magnetic particles.

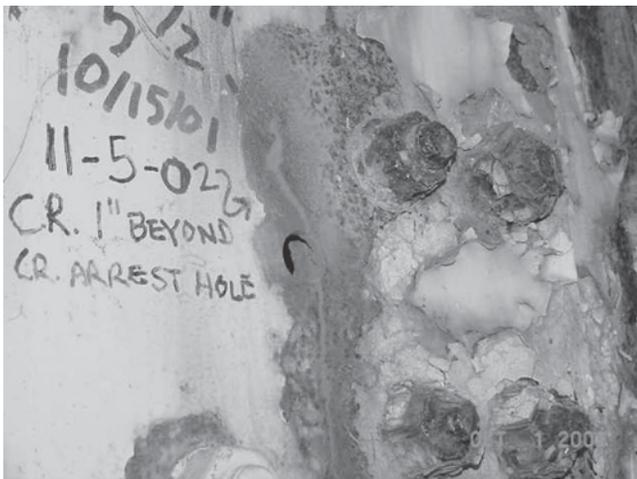
FIGURE A8 Magnetic particle testing—Indication.

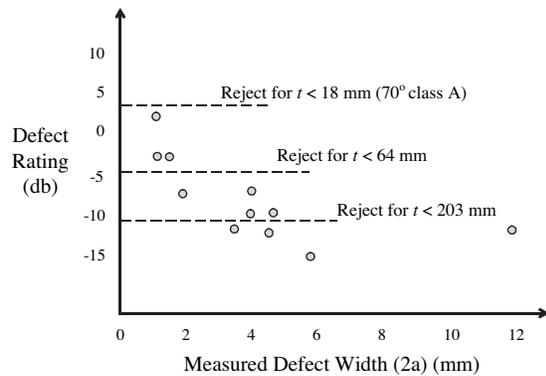
FIGURE A9 Actual defect size from destructive examinations of cores from welds with UT indications of various dB rating. (Data from Lehigh University.)

Notwithstanding that it is a misapplication, the AWS D1.5 criteria have frequently been used to assess the UT of butt welds in service. On many occasions, an indication with a rejectable decibel (dB) rating will be cored out of a large groove weld for destructive examination and characterization of the actual flaw. Figure A9 shows the results of many of these investigations, as conducted by Dr. Eric Kaufmann at Lehigh University's Advanced Technology for Large Structural Systems (ATLSS) Center, plotted in terms of the dB rating versus the actual flaw size. Also shown are the D1.5 rejection limits for various thickness butt welds. It can be seen that the AWS criteria are very conservative. For typical plating thickness, the AWS criteria will reliably screen out defects of only a few millimeters in width.

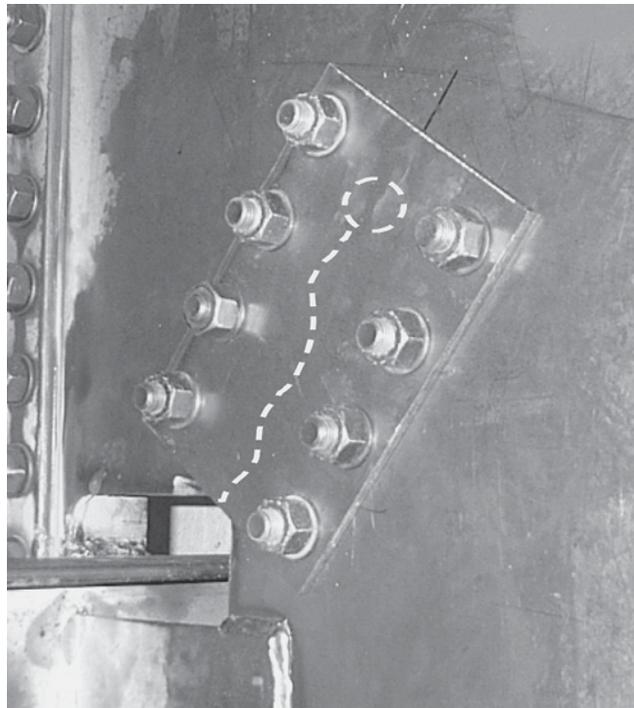
FIGURE A10 Bolted doubler plate repair. Dotted line represents crack line beneath doubler plate and circle is the hole drilled at crack tip to intercept further growth.

The philosophy of doublers for fatigue crack repair is to add cross-sectional area, which in turn reduces stress ranges. For instance, if a fatigue crack grows across the full depth of the bridge girder, there are two ways that it can be repaired. First, a vee and weld repair can be specified, but the base metal that is weld repaired will have at best a Category D fatigue resistance (A54–A56). To ensure that the weld repair

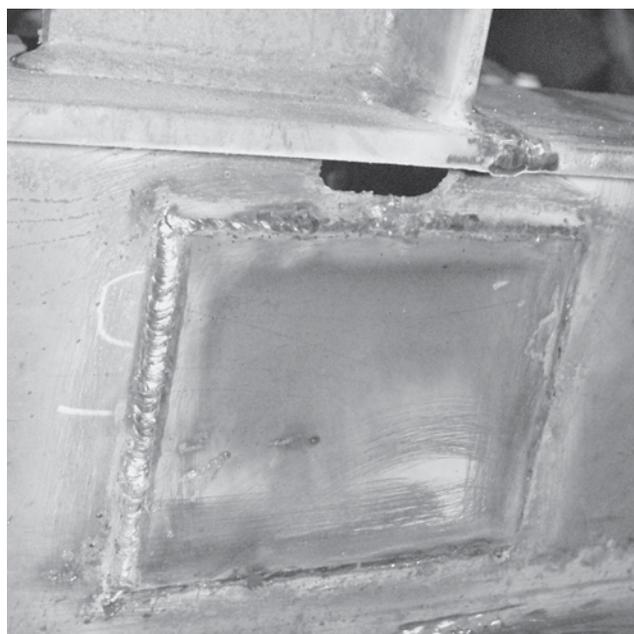
FIGURE A11 Welded doubler plate detail. (Note that corners should be rounded.)

The one problem with this repair is the alignment of the two sides of the crack before the weld repair. As can be seen in Fig-

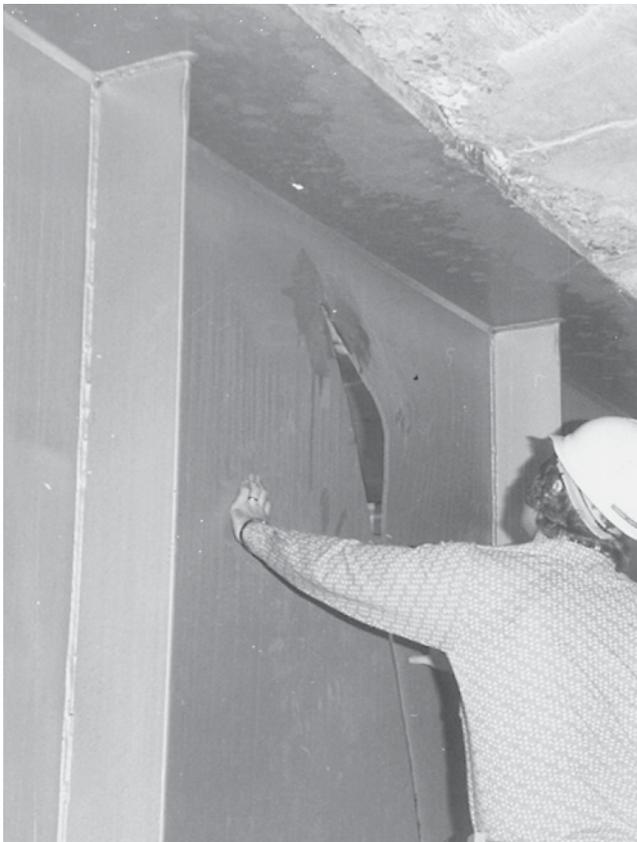
FIGURE A12 Full-girder-depth fatigue crack of Lafayette Street Bridge in St. Paul, Minnesota.

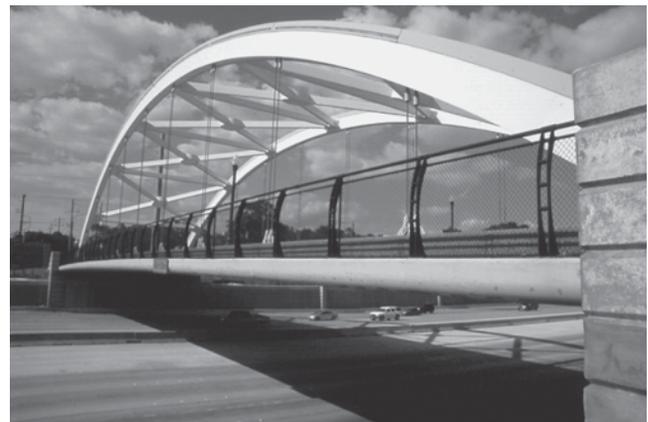
FIGURE A13 Post-tension tied arch bridge in Houston, Texas.

Post-tensioning of the arch tie provided redundancy and virtually eliminated tension in the tie, which allayed concerns about the history of problems with tie beams on other tied arch bridges, but necessitated passing the arch tie flanges through the junction with the arch rib.

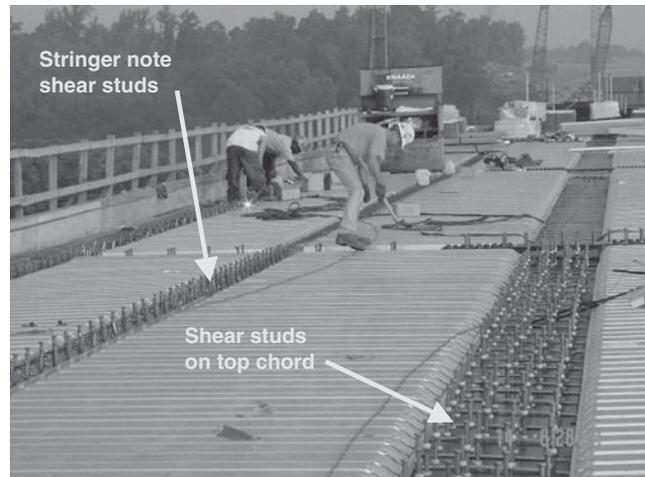
FIGURE A14 Shear studs being installed on top chords, floorbeams, and stringers on the SR-33 bridge near Easton, Pennsylvania.

The SR-33 Bridge near Easton, Pennsylvania, incorporated an additional measure to increase redundancy. The top chord is fully composite with the concrete deck (see Figure A14). Traditionally, in truss bridges, only the floorbeams and stringers are made composite with the deck. The deck is cast-in-place reinforced concrete supported by steel stringers and transverse floorbeams. It is the only composite truss in the state of Pennsylvania and possibly the United States. The structure is a four-span continuous haunched steel deck truss that is composite with the reinforced concrete deck. The main river span is 181 m and the depth of the trusses varies from 11 m to 22 m.

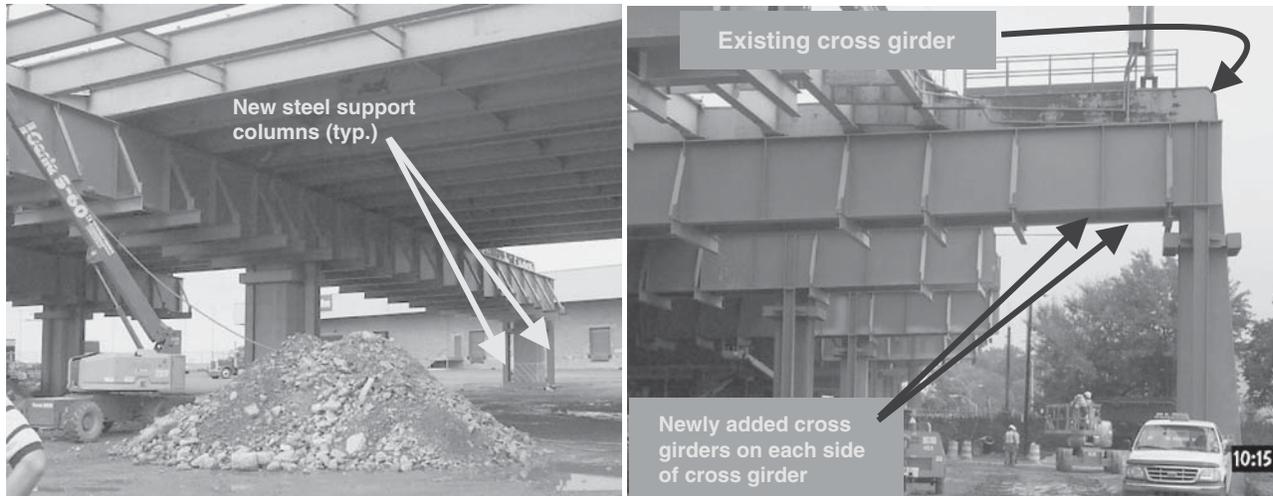
FIGURE A15 Additional support girders are used to provide redundancy to steel cross girders on I-95 bridge north of Philadelphia, Pennsylvania.

The additional girders can also be used to retrofit cross girders. For example, two girders were used to provide redundancy to existing steel cross girders carrying multi-girder composite spans, as shown in Figure A15. The bridge carries I-95 just north of Philadelphia. The retrofit required

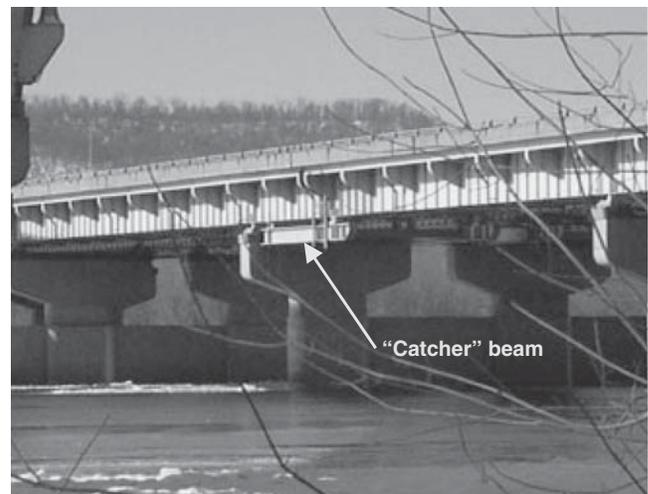
FIGURE A16 Catcher system as used on a typical pin and hanger bridge. (Courtesy: Modjeski and Masters, Inc.)

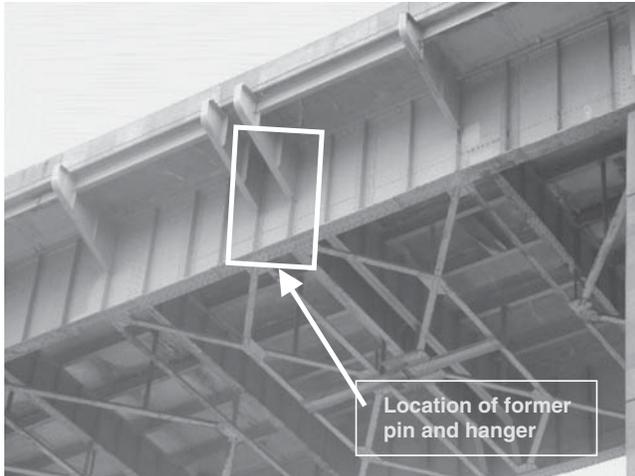
FIGURE A17 Typical complete girder splice installed to replace a pin and hanger connection in a two-girder bridge.

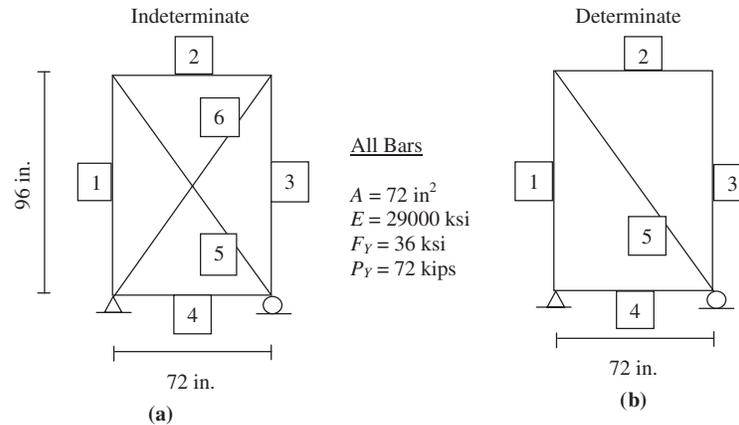
FIGURE D1 Two elementary trusses (ref. 11 in Appendix D).

The definition of structural redundancy including system reliability and damage assessment concept was utilized to analytically investigate the effect of redundancy deterioration on the reliability of truss systems and bridges. Using Figure D1, Frangopol and Curley (11) illustrated that the degree of redundancy of a system is not an adequate measure of system strength. The example showed that the redundant truss has an increase in ultimate load capacity compared with the nonredundant truss of 78%, 100%, and 131% for brittle, ductile and hardening behavior of members, respectively.
