# **WIDE-GAP WELDING TECHNIQUES**

Transportation Technology Center, Inc. (TTCI)

# WIDE-GAP WELDING TECHNIQUES

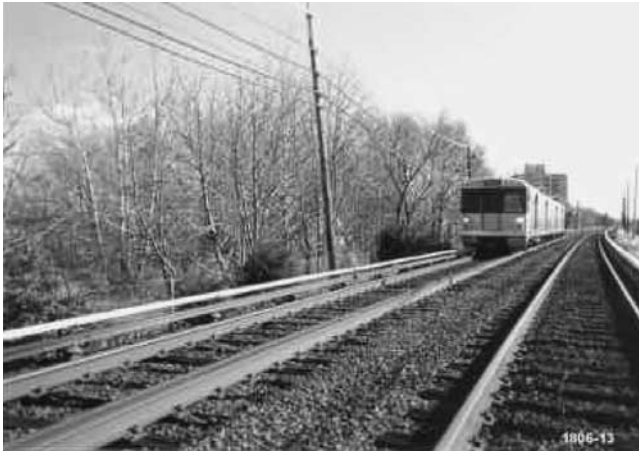
Figure 1. Test site—PATCO tracks in New Jersey.

To evaluate the suitability of wide-gap thermite welds for transit revenue tracks, PATCO and TTCI installed 10 wide-gap thermite welds in PATCO's tracks with Railtech Boutet QP CJ "one-shot" wide-gap thermite welding kits. The welds were monitored for their integrity and their suitability for transit rail traffic.

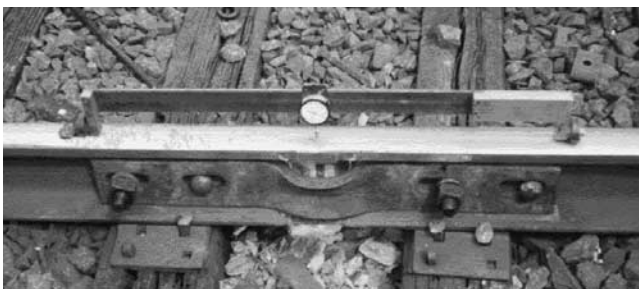
Figure 2. TCI device used for measuring differential wear of rail welds.

height differences between the weld (weld fusion zone and heat-affected zones) and the surrounding rail. The center of the weld and the outer edges of the heat-affected zones are often the softest spots of welds and are most prone to excessive wear. Therefore, those possible soft spots were selected for monitoring of the differential wear of the test welds.

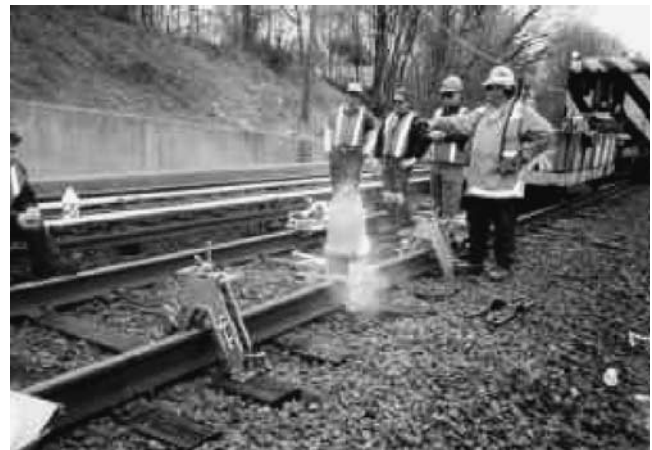
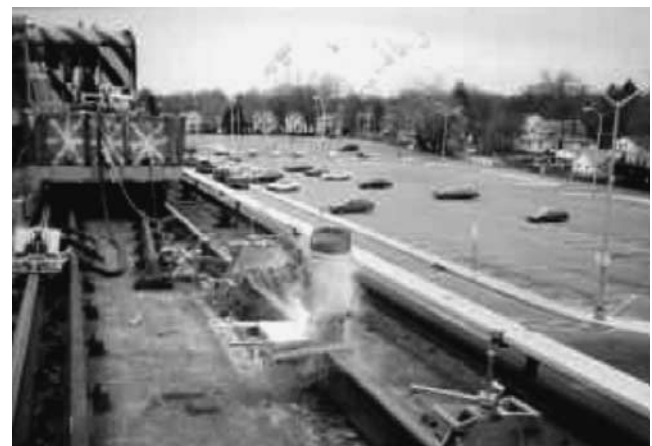
Figure 3. Test welds installation and welder training.

gap process (see Figure 3). The installation operations were successful, and the installed welds appeared to be of good quality. Subsequent ultrasonic tests confirmed the integrity of the welds—no defects were found. PATCO decided to use bulldog bars for all test wide-gap welds. The bulldog bars were used as safety devices, rather than as a means of reducing stress or prolonging the service life of the welds. PATCO will not use bulldog bars in future wide-gap weld installations if PATCO is completely confident of the weld performance. Actually, bulldog bars on 3 of the 10 test welds were taken off later for reasons not related to the welds themselves. Further, the bars were not reinstalled on the welds and there was no intention to do so as of December 2000.

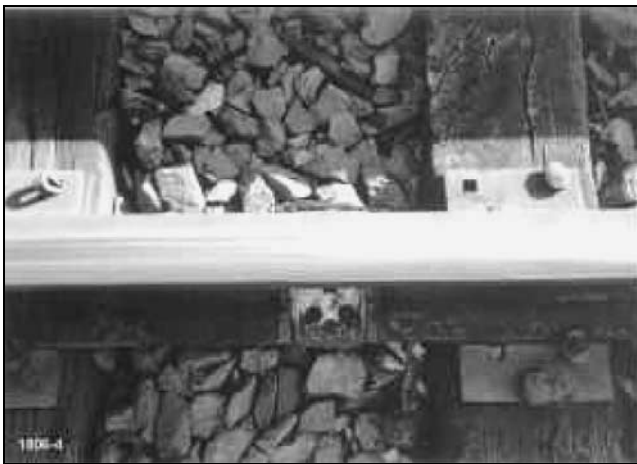
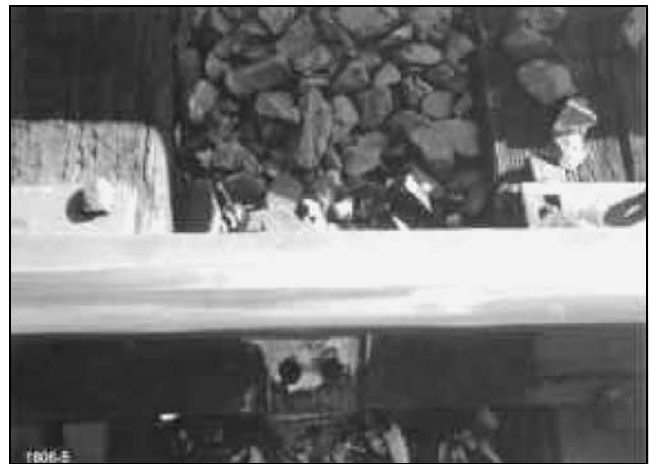
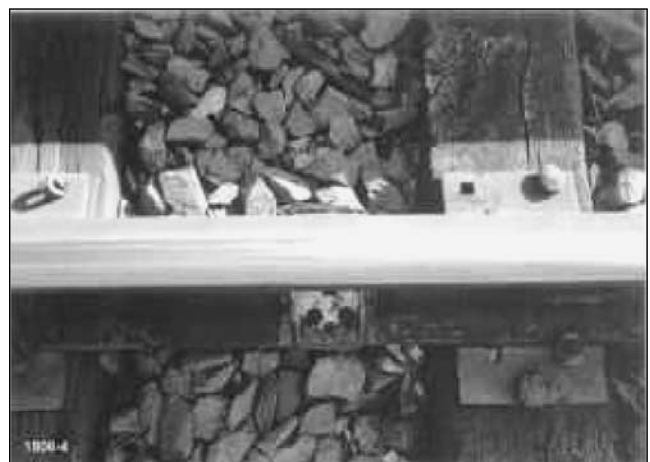
Figure 4. Test wide-gap thermite welds as of December 1, 2000.

TTCI engineers performed a field inspection of the test wide-gap welds on December 1, 2000. The running surface of each wide-gap test weld was measured to examine the differential wear in the weld and its heat-affected zones.

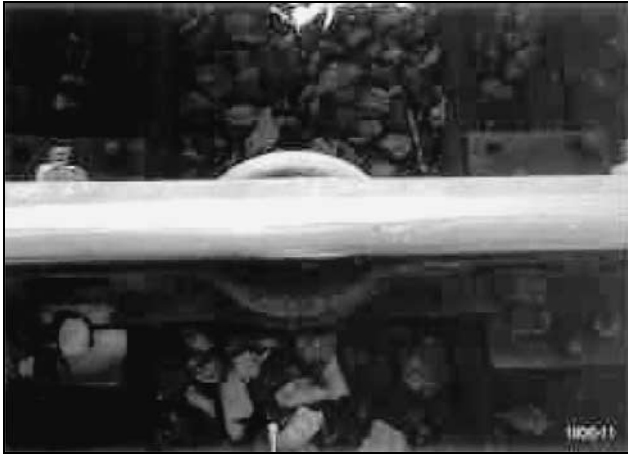
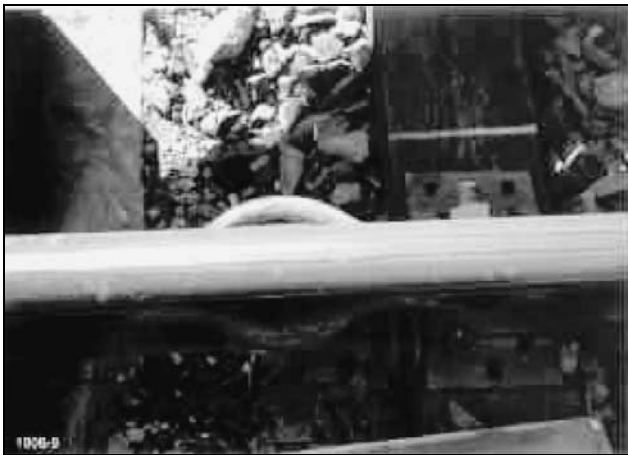
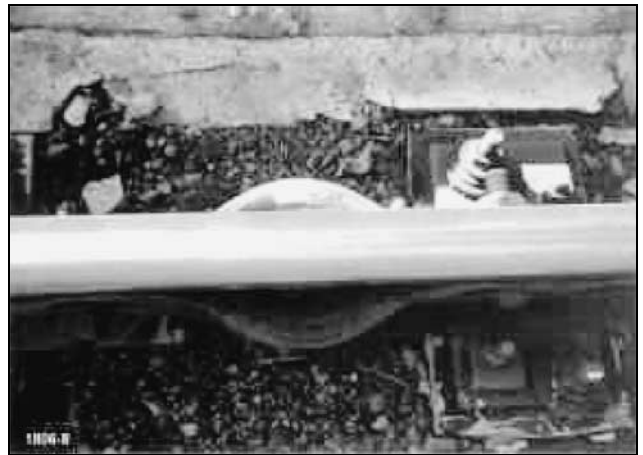
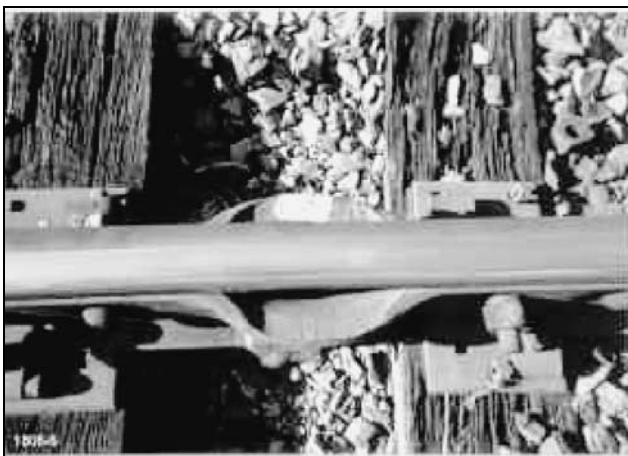
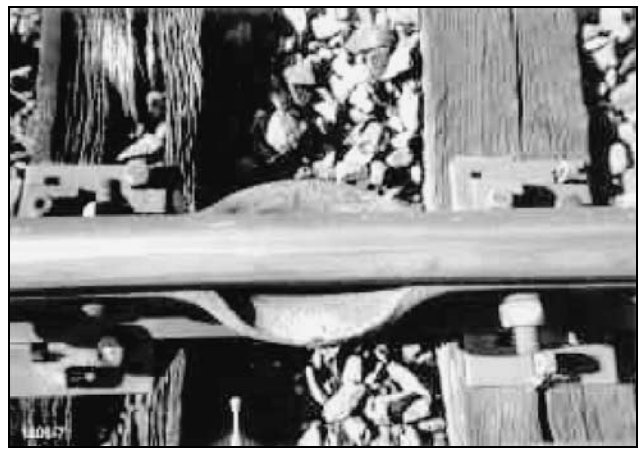
Figure 4. (Continued)

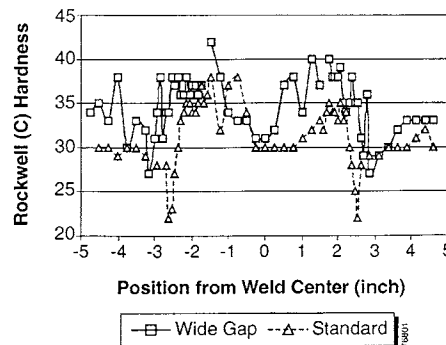
Internal hardness traverses were made 5/8 inches below the running surface, using a Rockwell C tester. The hardness profiles across the two types of weld were similar (Exhibit 3). Results

Exhibit 3. Hardness Profiles across Standard and Wide-Gap Welds

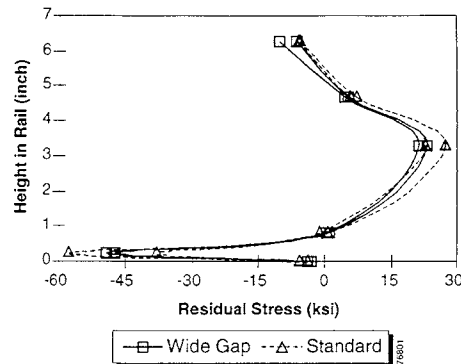
Exhibit 4. Measured Residual Stresses in Thermite Welds
