Construction, Testing and Preliminary Performance Report

State Study No. 137

Resin Modified Pavement Demonstration Project

**Research Division
Mississippi Department of Transportation**

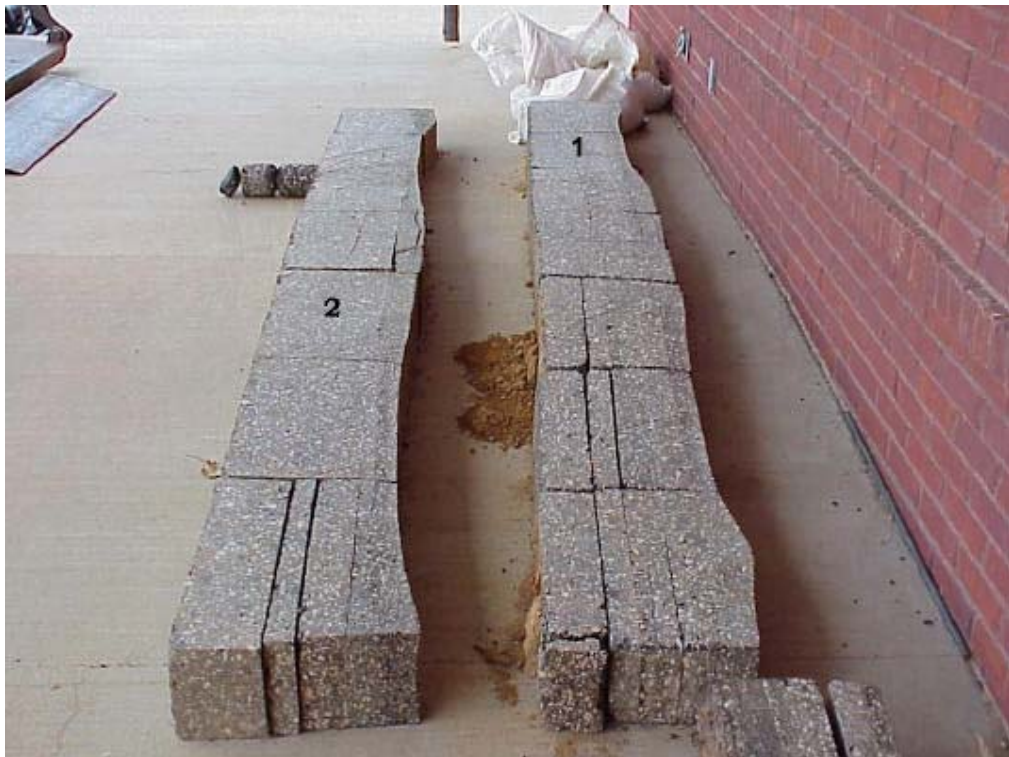
Figure 8 – Trenches taken from the two intersections

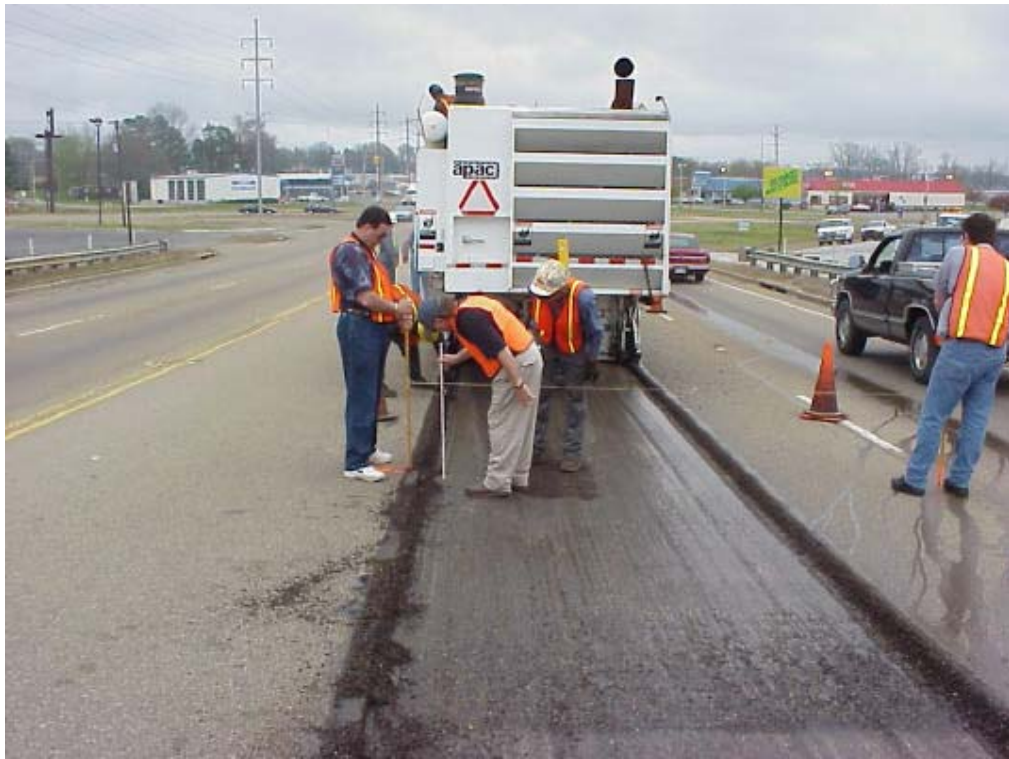
Figure 10 – Milling of the existing asphalt prior to construction of each test section

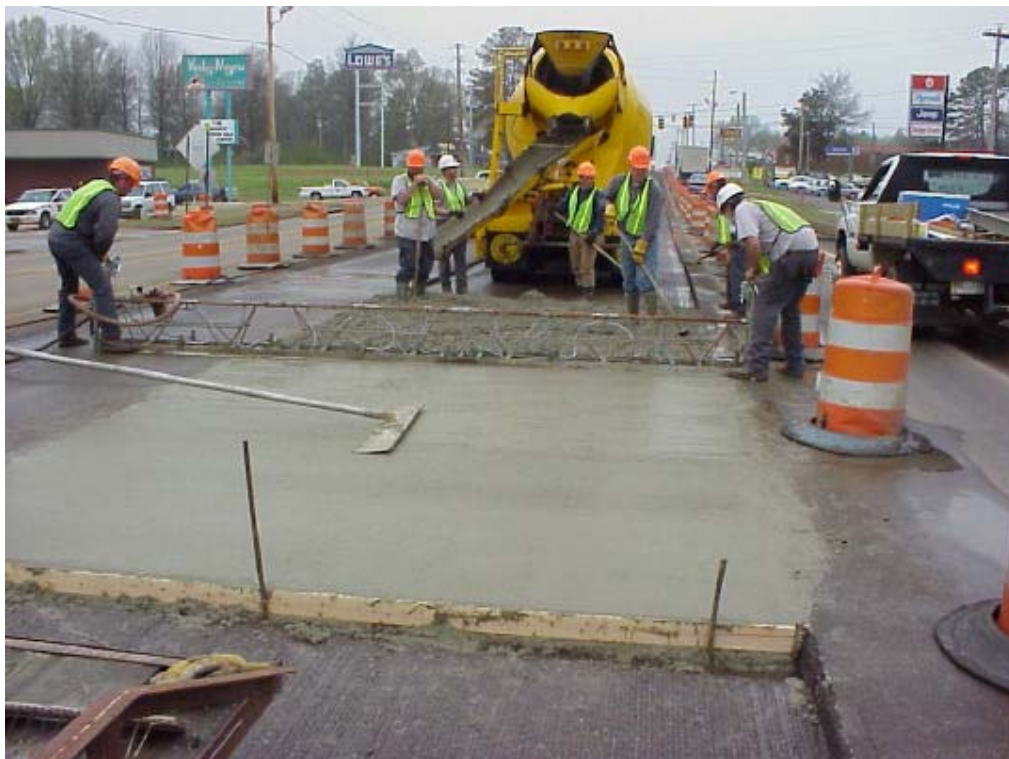
Figure 11 – Pouring concrete at the Ultra-Thin Whitetopping test section

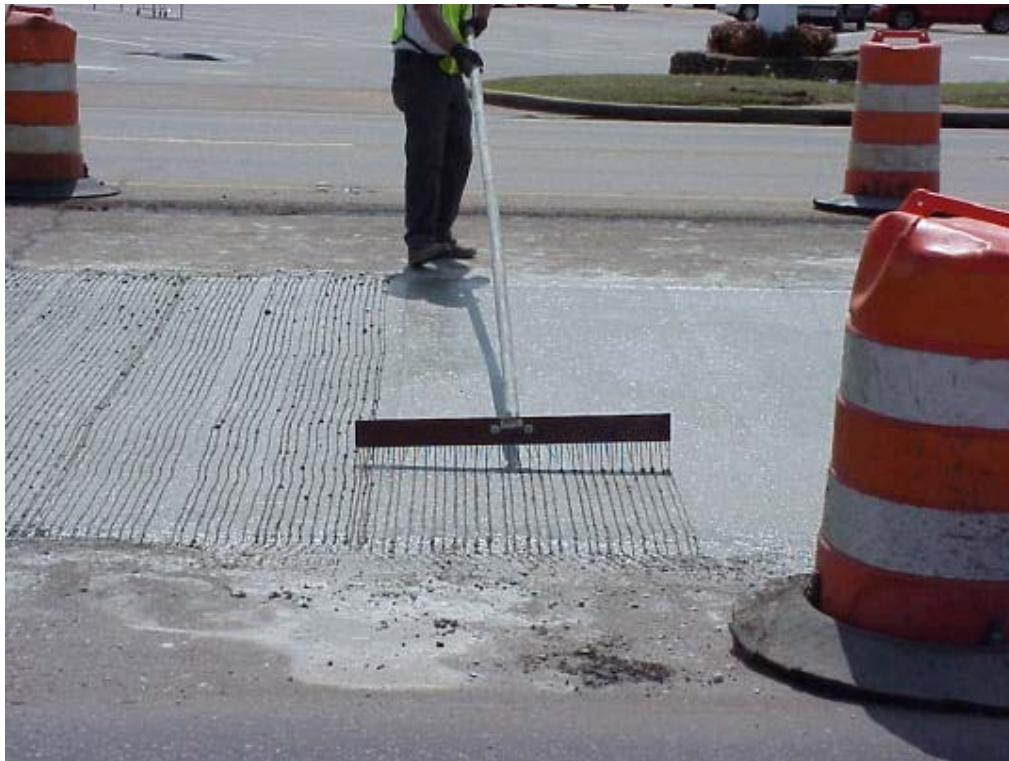
Figure 12 – Whitetopping is given a transverse tined finish with a metal broom

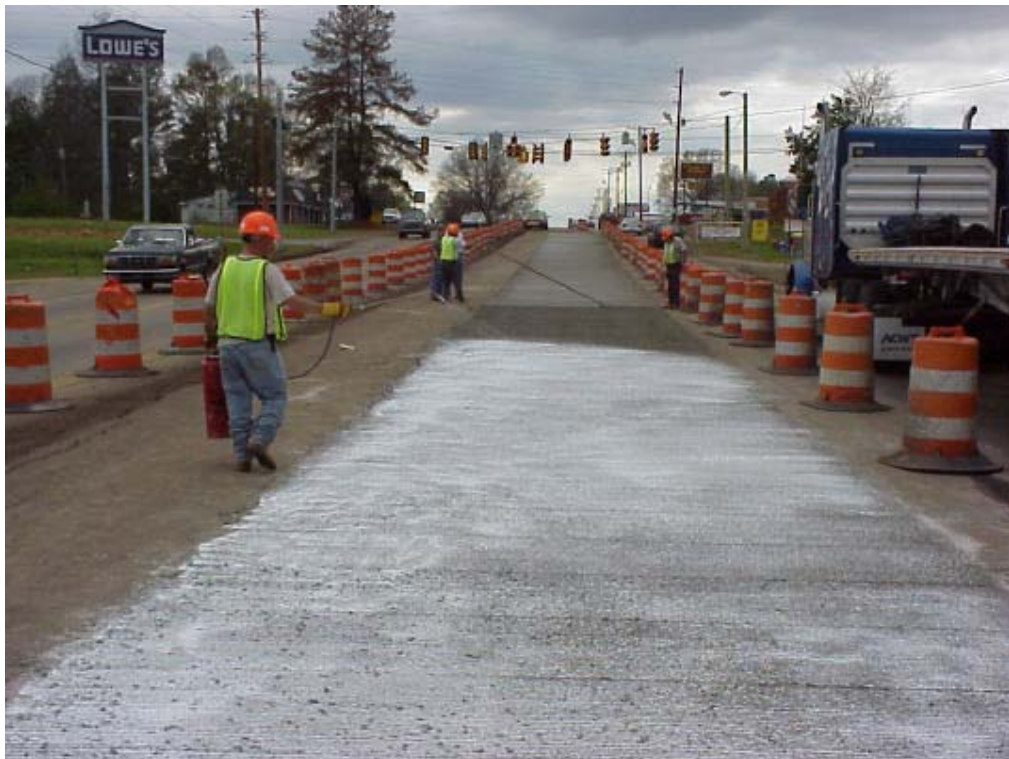
Figure 13 – White pigmented curing compound is applied to fresh concrete

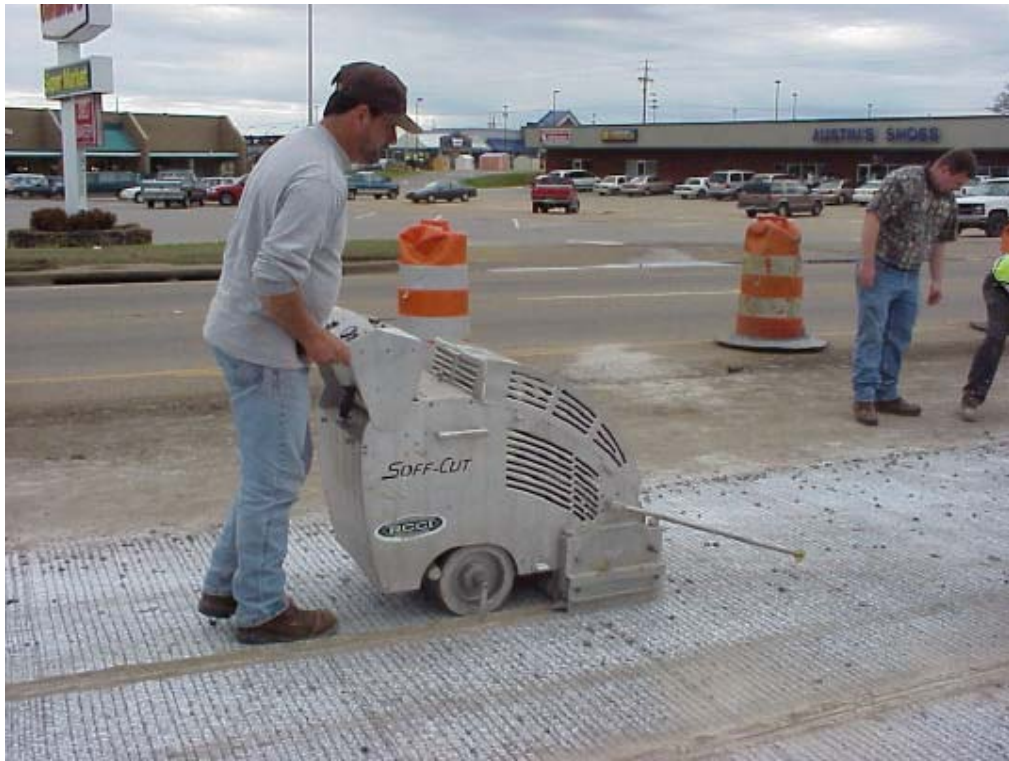
Figure 14 – 3'x3' panels are sawcut into the “green” concrete

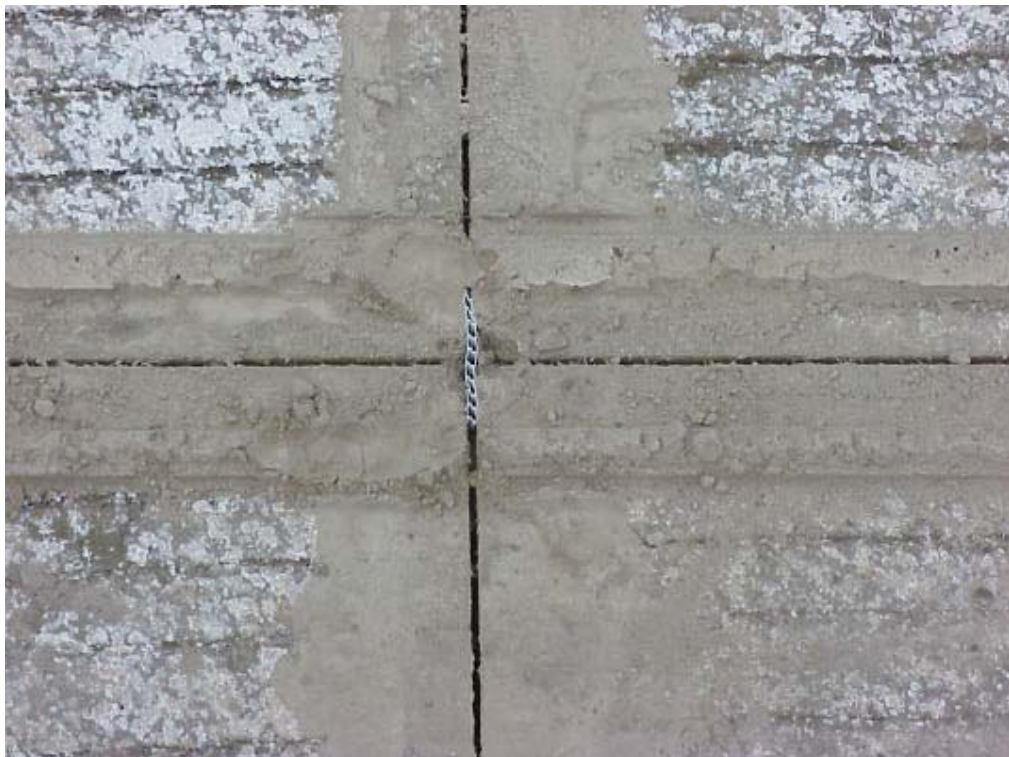
Figure 15 – Plastic spacers are used at the cross cuts to achieve a clean cut

The concrete industry has recommended that plastic spacers be utilized at locations where sawcuts cross. The first cut is made and at the location where the second cut will cross the first, a plastic spacer is inserted in the fresh cut. This prevents the joint from closing up when the second cut is made. The UTW section employed these spacers at every cross cut.

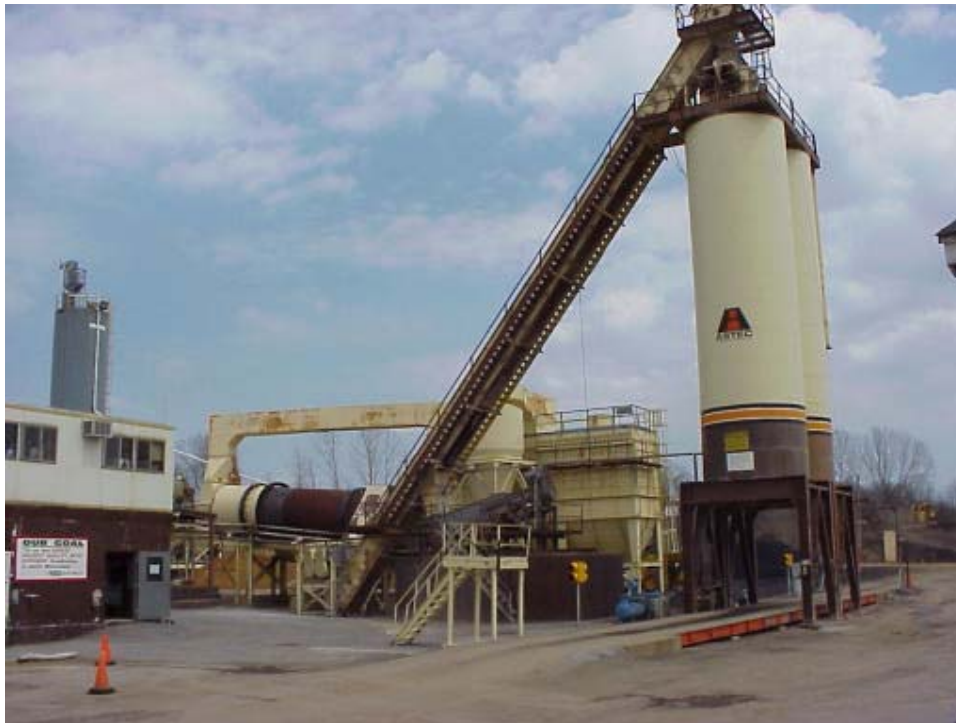
Figure 16 – APAC Corinth “drum” plant which produced both the PG 67-22 open graded mix for the Resin Modified Pavement and the PG 82-22 dense graded mix

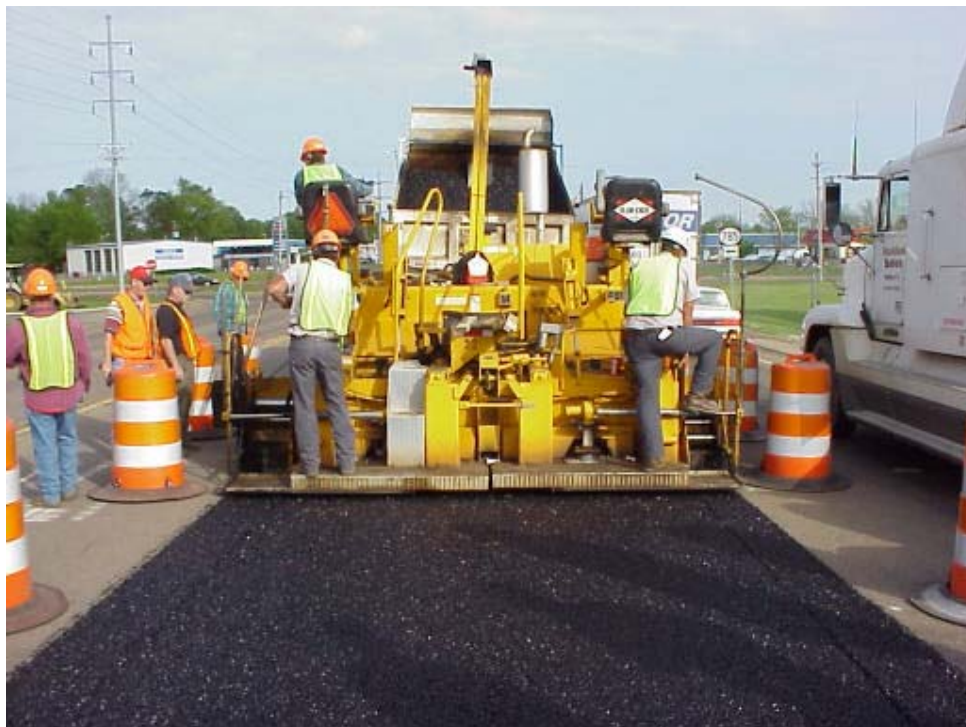
Figure 17 – Paving the PG 67-22 open graded mix for the RMP test section

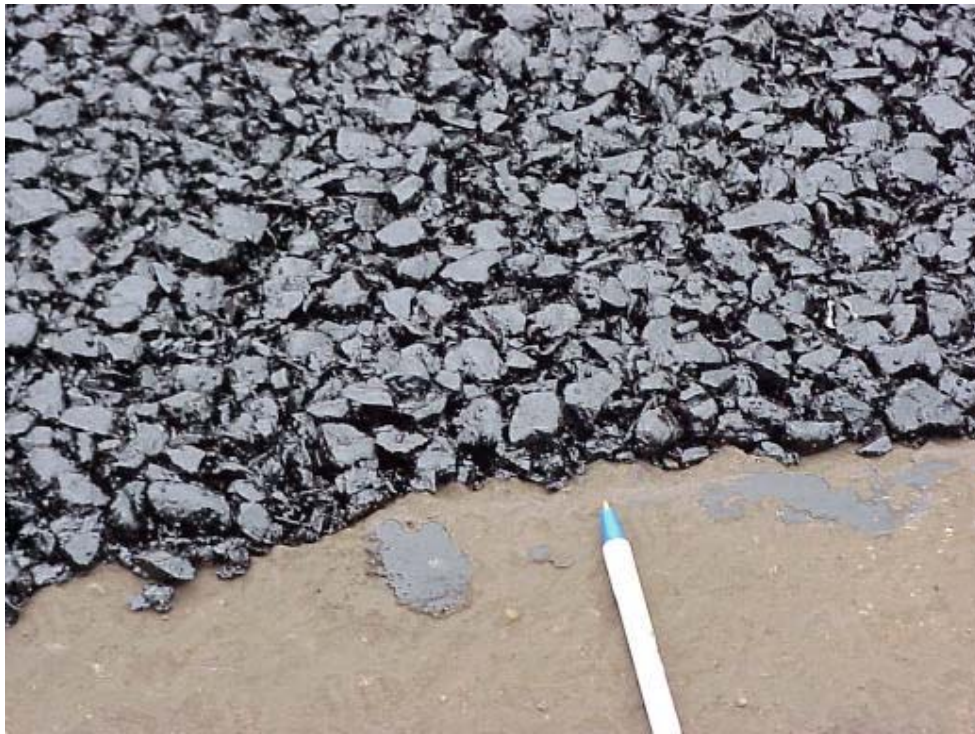
Figure 18 – Close up of the surface of the 2” thick open graded mat

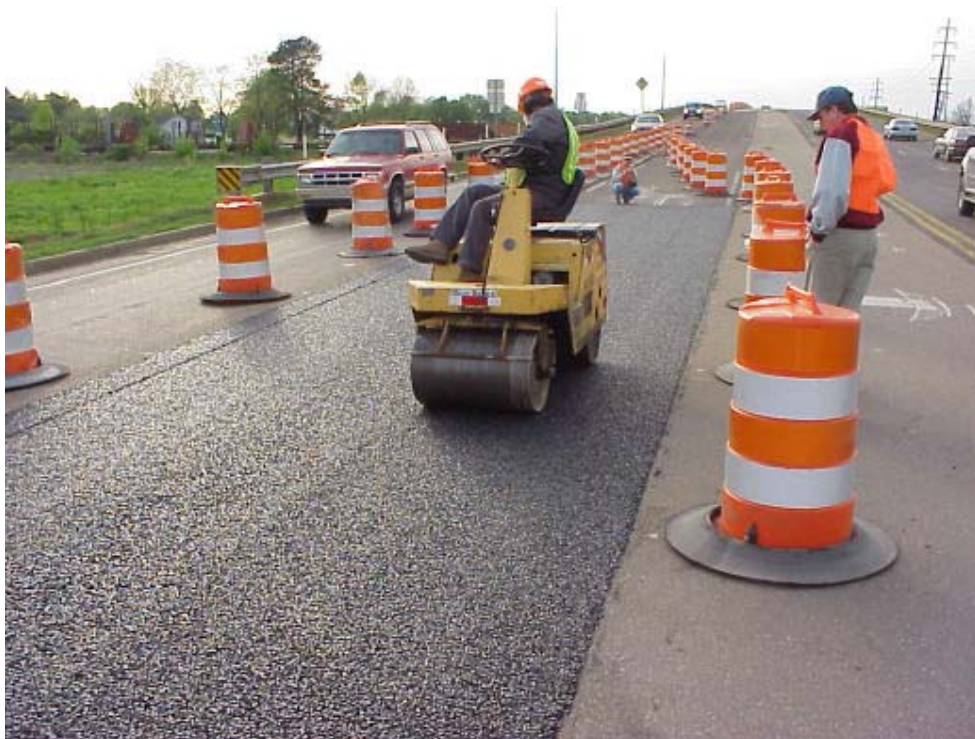
Figure 19 – Open graded mix is subjected to one pass with a 1½ ton roller in static mode @ approximately 150 degrees F to “seat” the aggregate

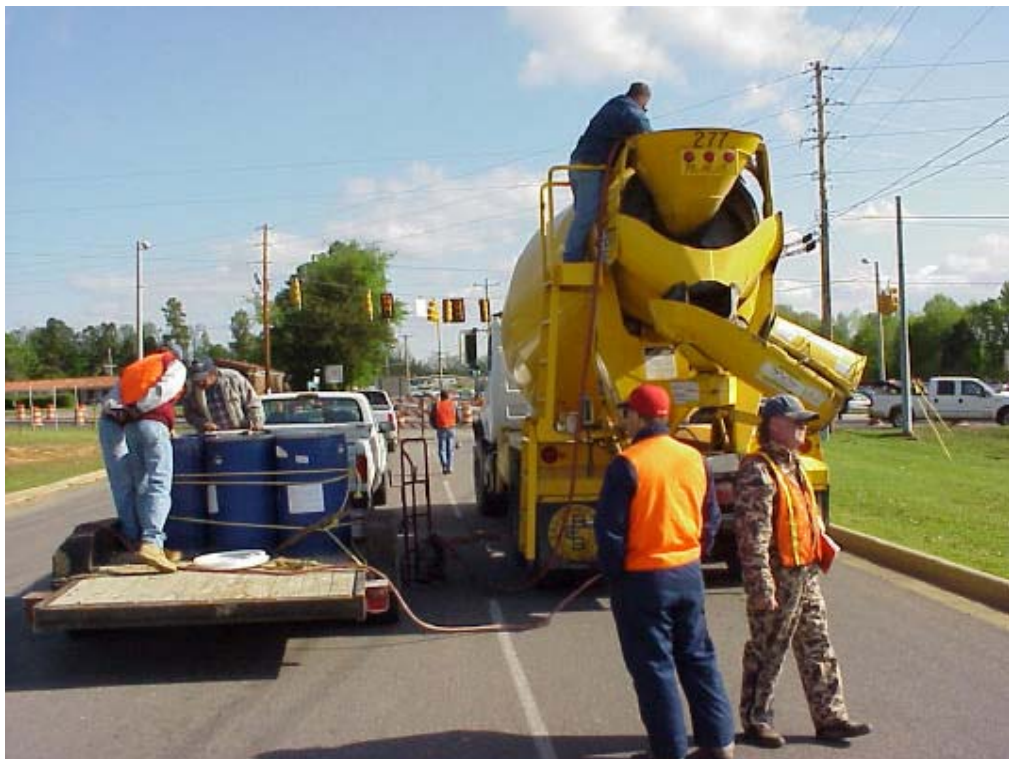
Figure 21 – PL7 latex additive is added to the grout at the site

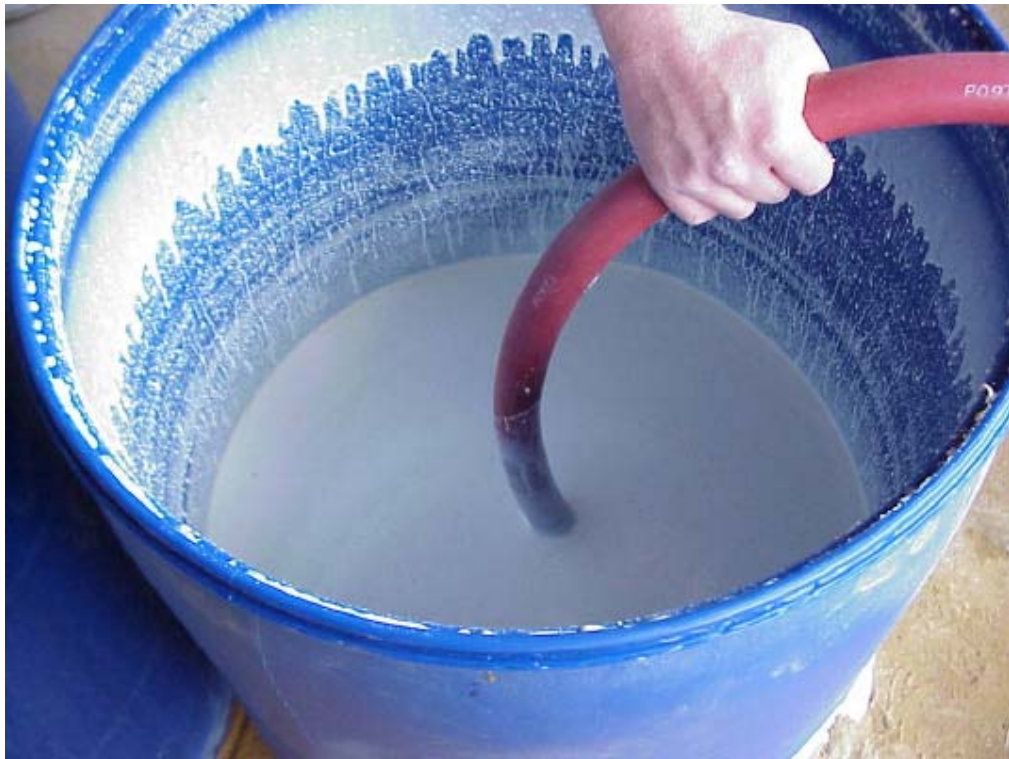
Figure 22 – Close up of PL7 latex additive

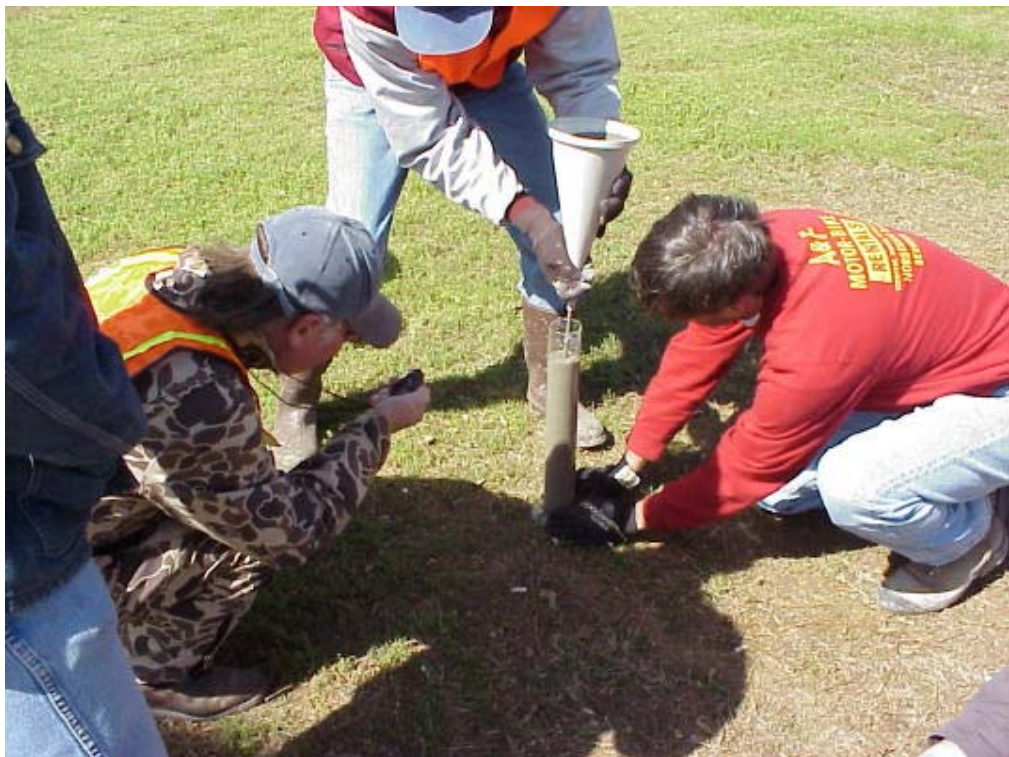
Figure 23 – Flow time of the grout is checked with a Marsh cone

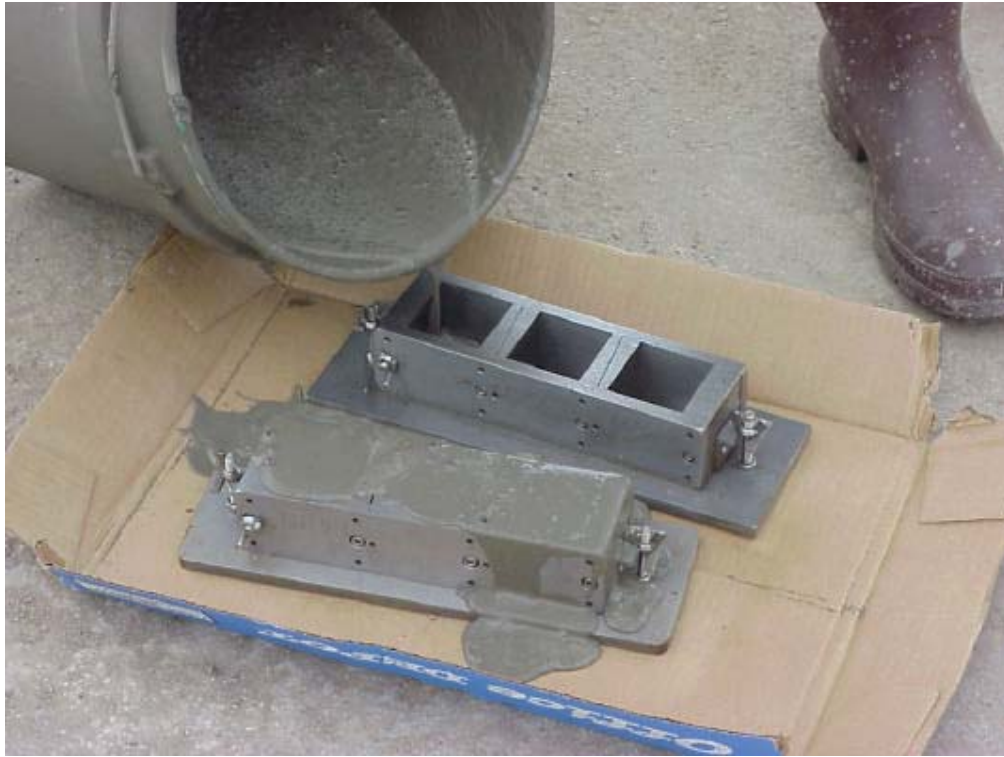
Figure 24 – 2” mortar cubes are made to test the grout strength

Also on April 11, our 2” grout cubes were broken in the laboratory to determine their compressive strength. The cubes met the 2000 psi compressive strength after 48 hours requirement. A complete listing of cube breaks appears in Appendix F.

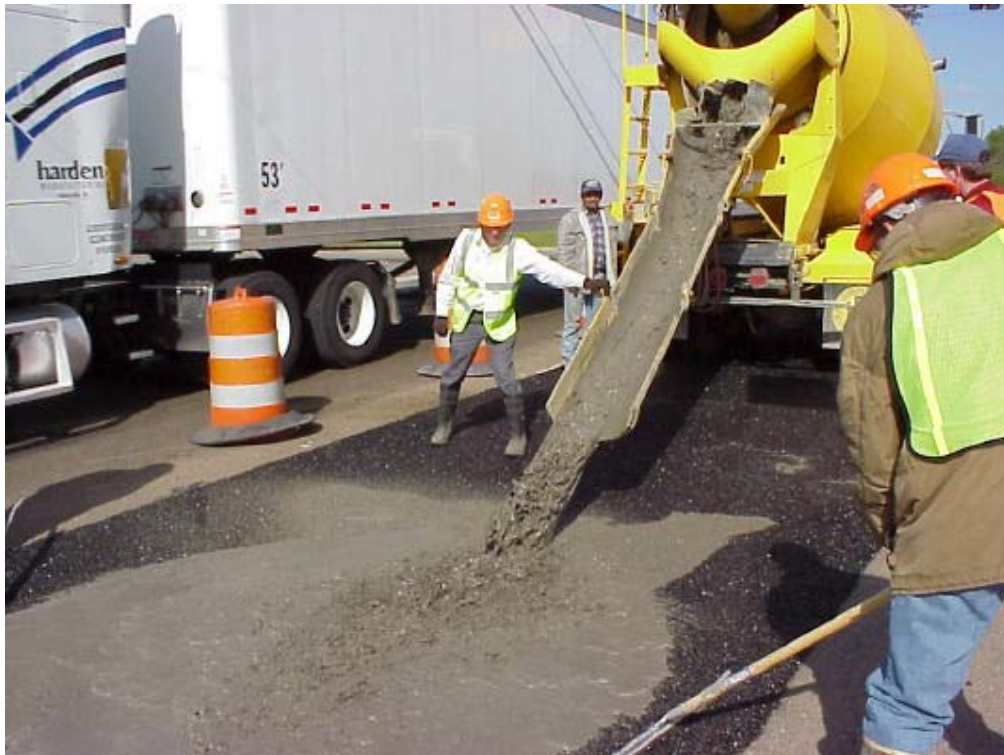
Figure 25 – Grout is poured onto the open graded asphalt mat

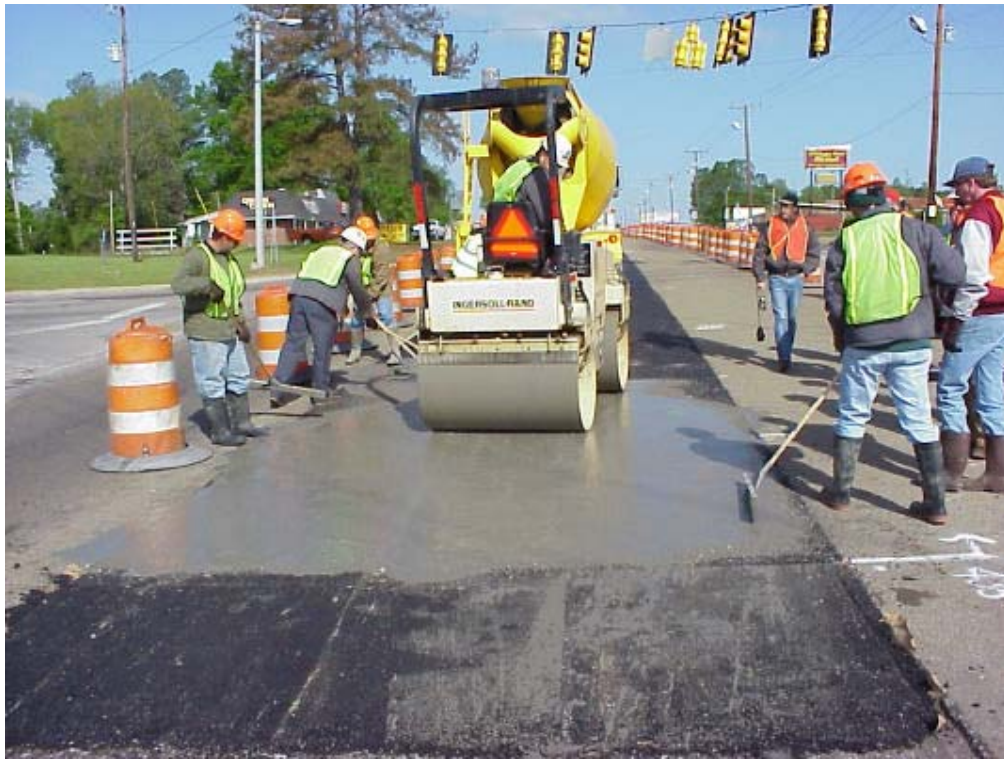
Figure 26 – Using a 3 ton roller in vibratory mode, the grout is forced to penetrate the entire thickness of the 2" open graded asphalt mat

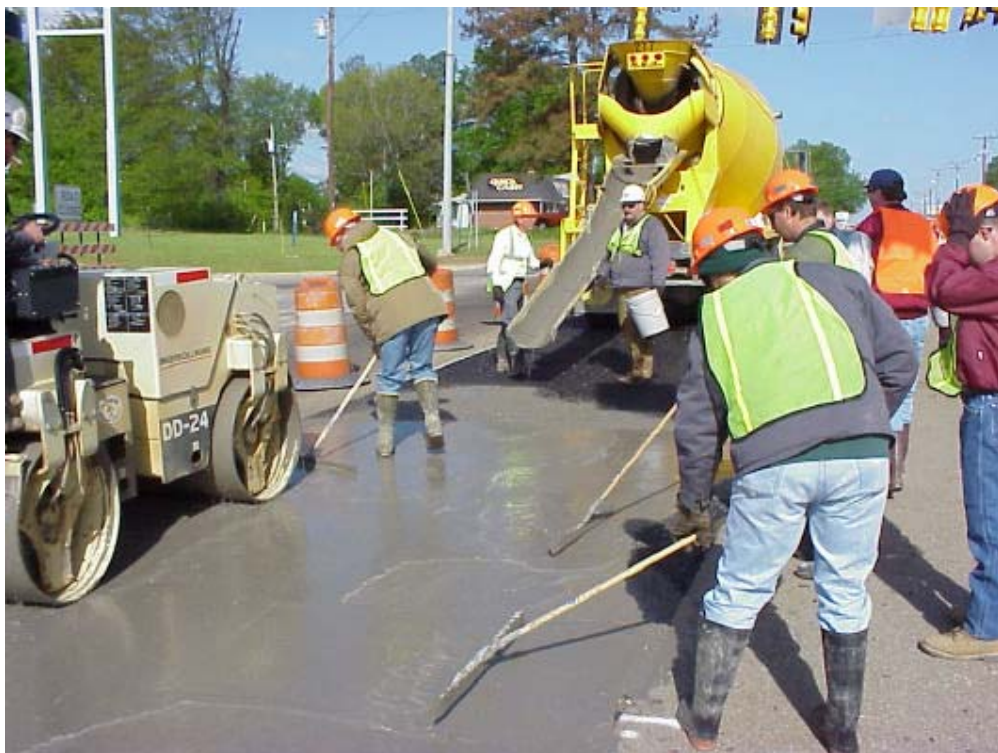
Figure 27 – Excess grout is worked to under grouted areas using squeegees

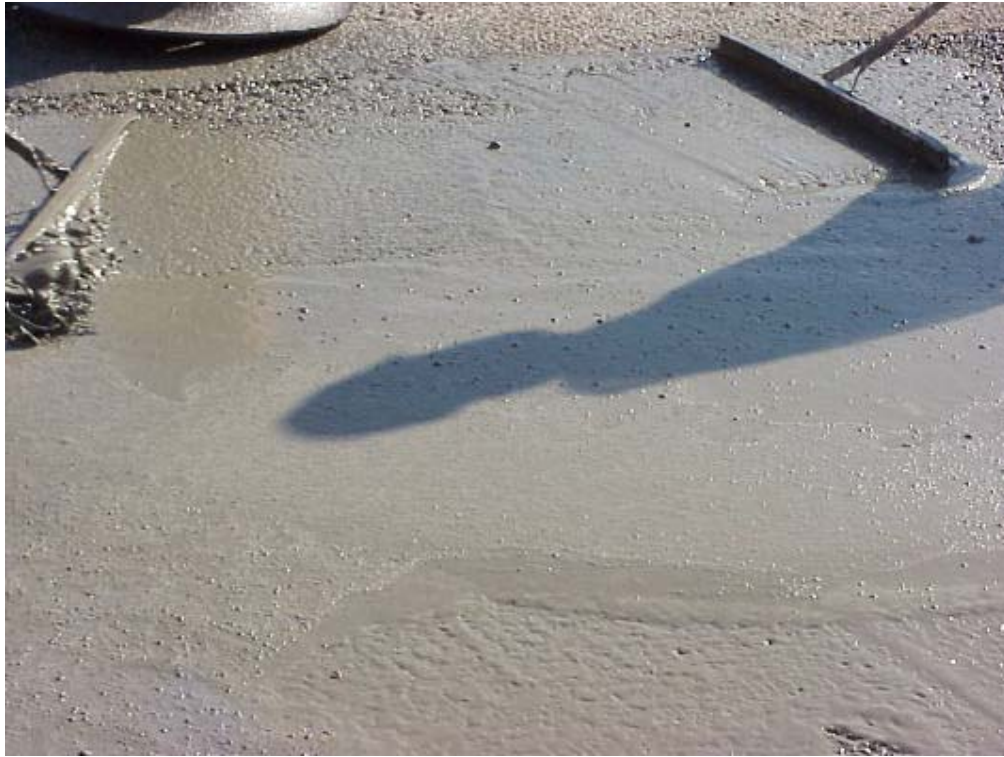
Figure 28 – “Working the grout”

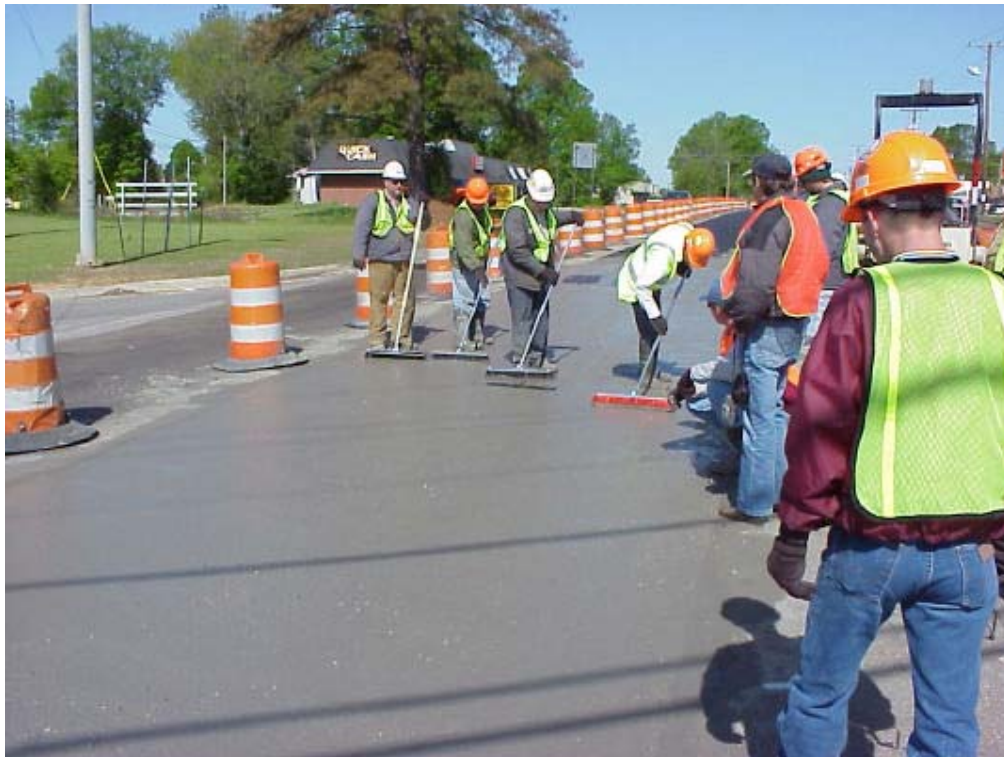
Figure 29 – Excess grout is pulled forward

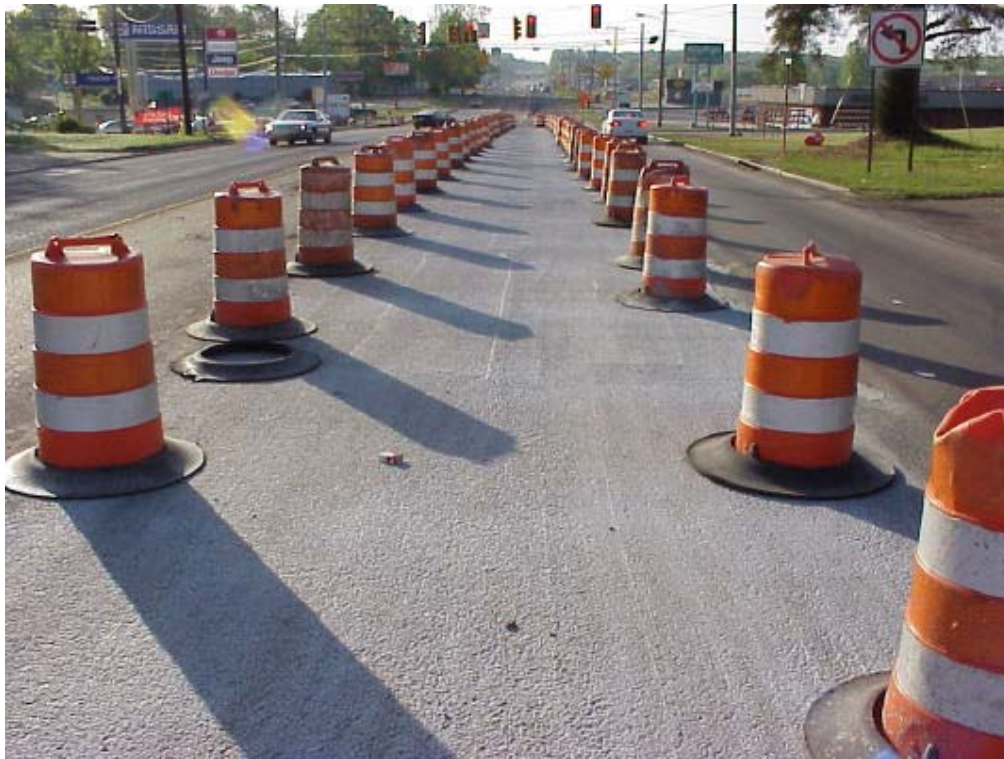
Figure 30 – Finished product the next morning (US 72 & Hinton St. looking east)

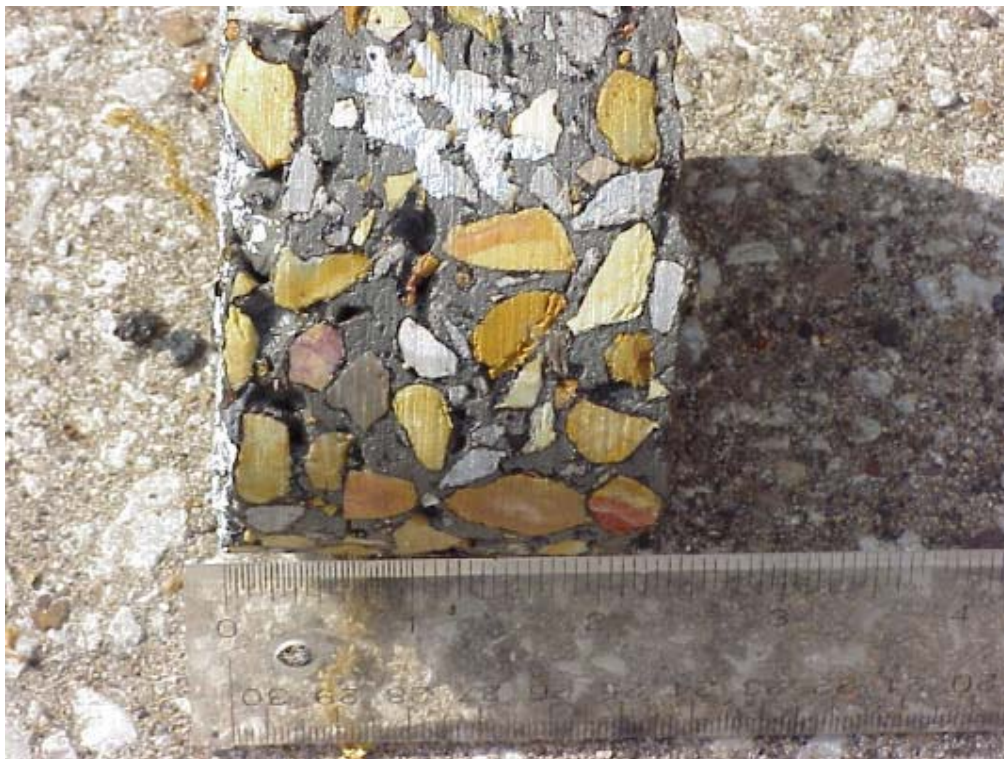
Figure 31 – Cores are taken to insure 95% saturation of grout

On April 30, the right thru lanes were cored to verify grout penetration. This time no capping of the material was discovered and both test sections were opened to traffic as built.

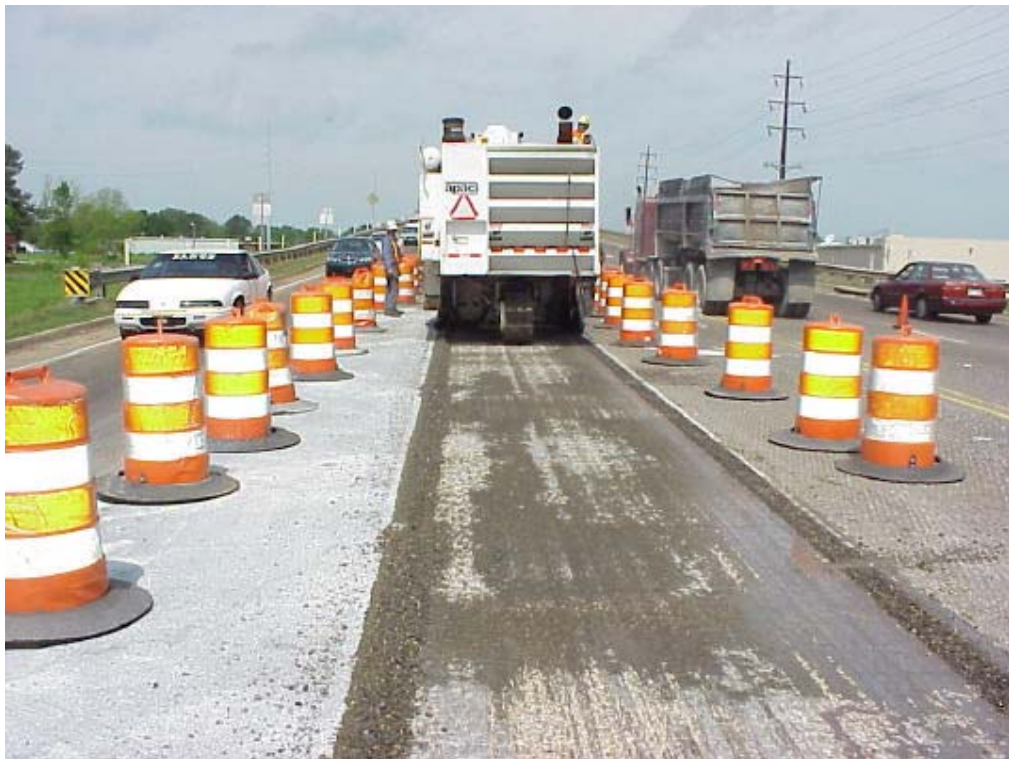
Figure 33 – Milling up of 75' x 12' area that failed to achieve full grout penetration

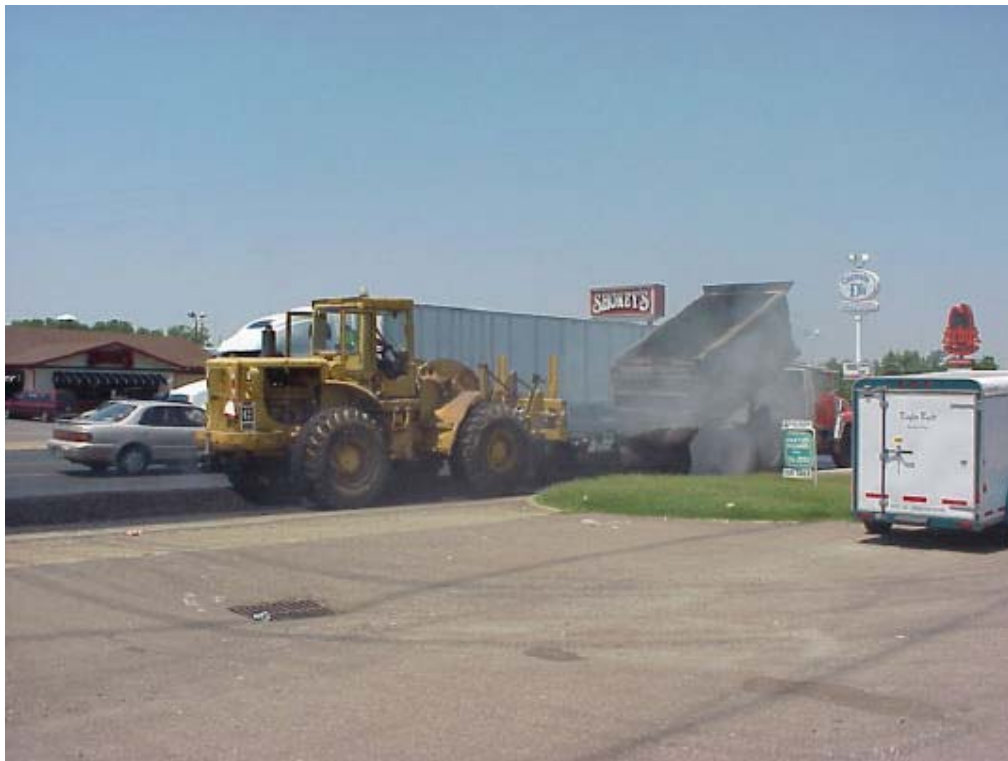
Figure 34 – PG 82-22 dense graded HMA being dumped ahead of Windrow device

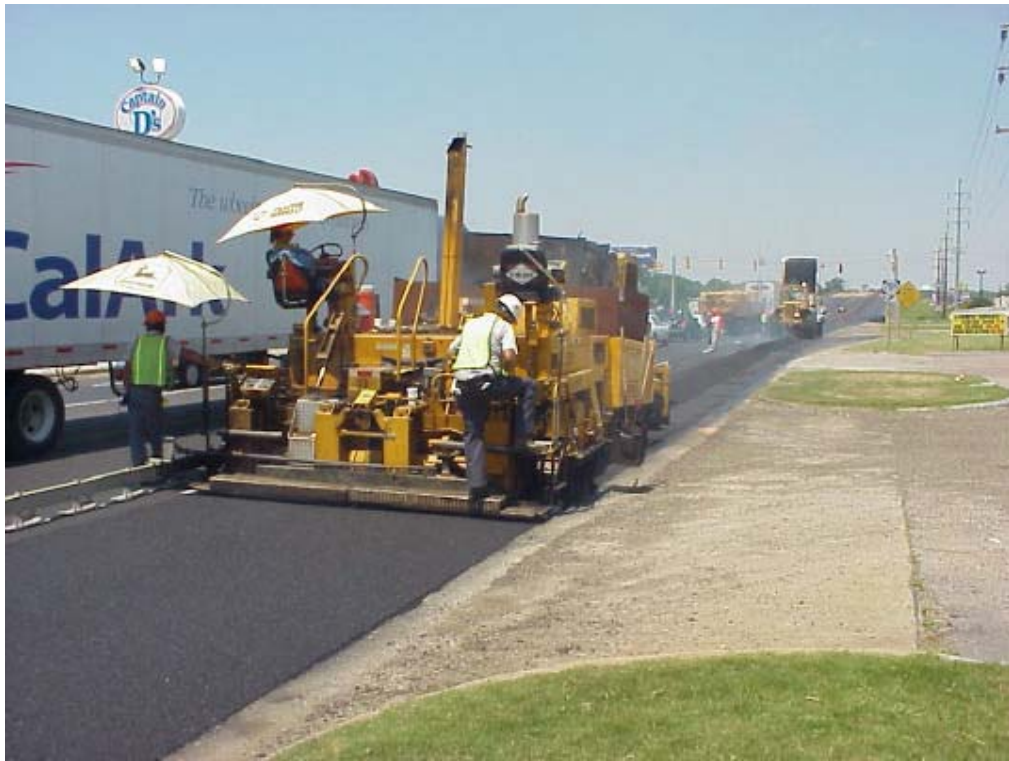
Figure 35 – Paver equipped with “shuttlebuggy” for PG 82-22 paving

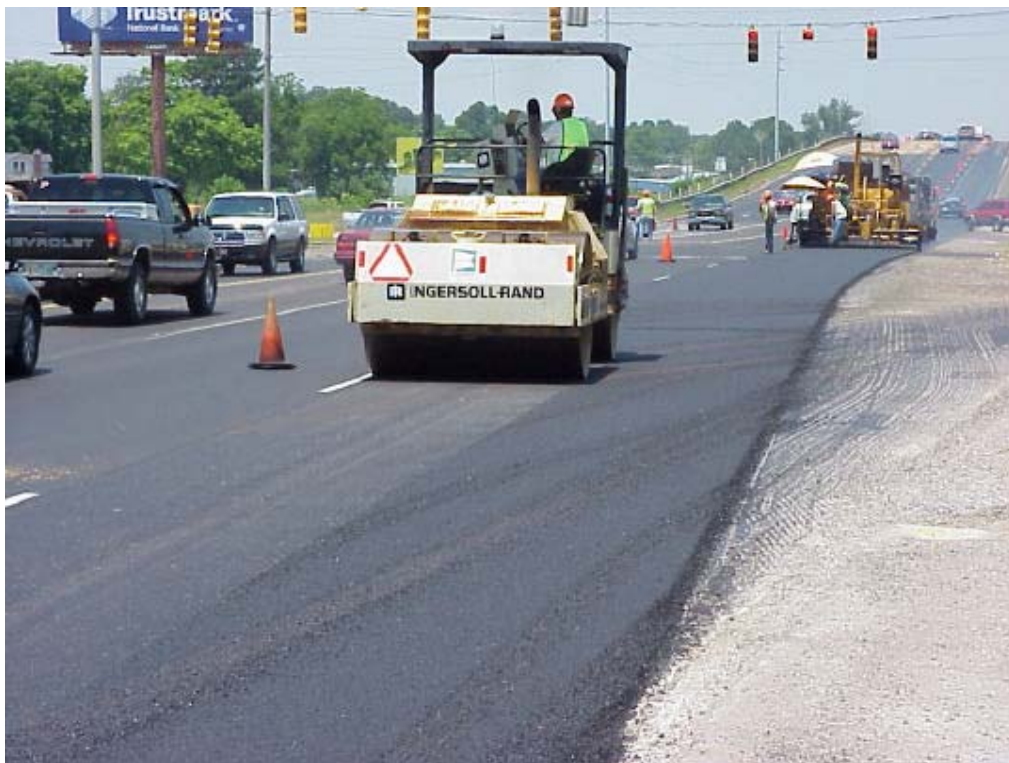
Figure 36 – Breakdown rolling (note scarring from traffic getting on the fresh mat)

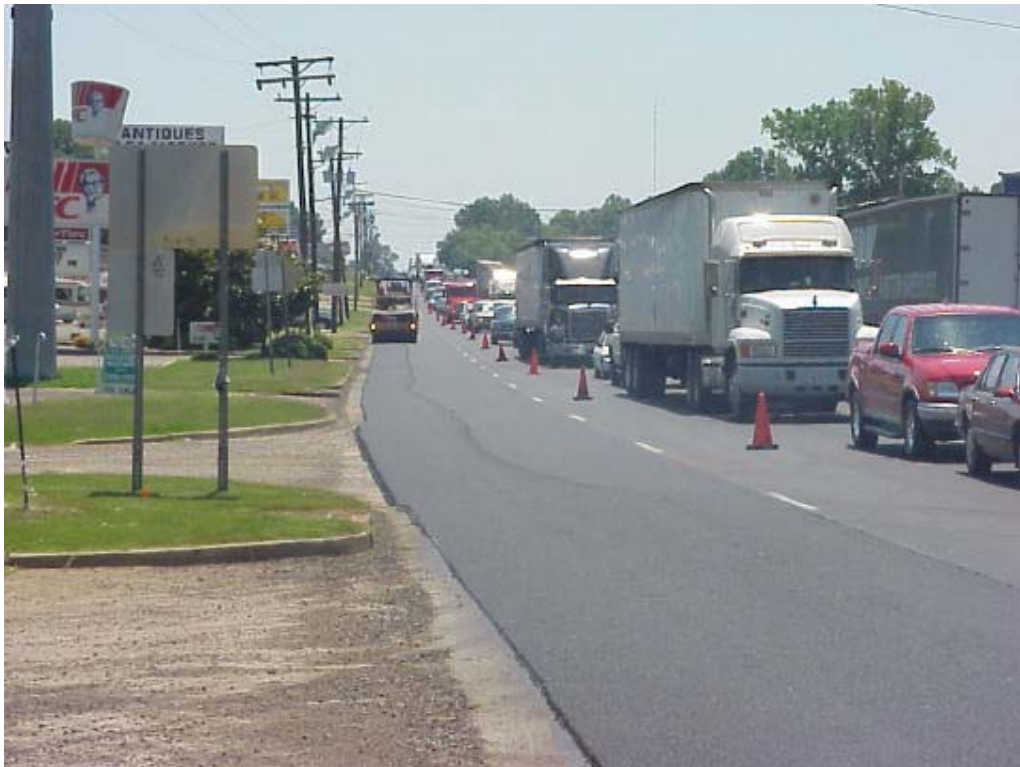
Figure 37 – Finish rolling

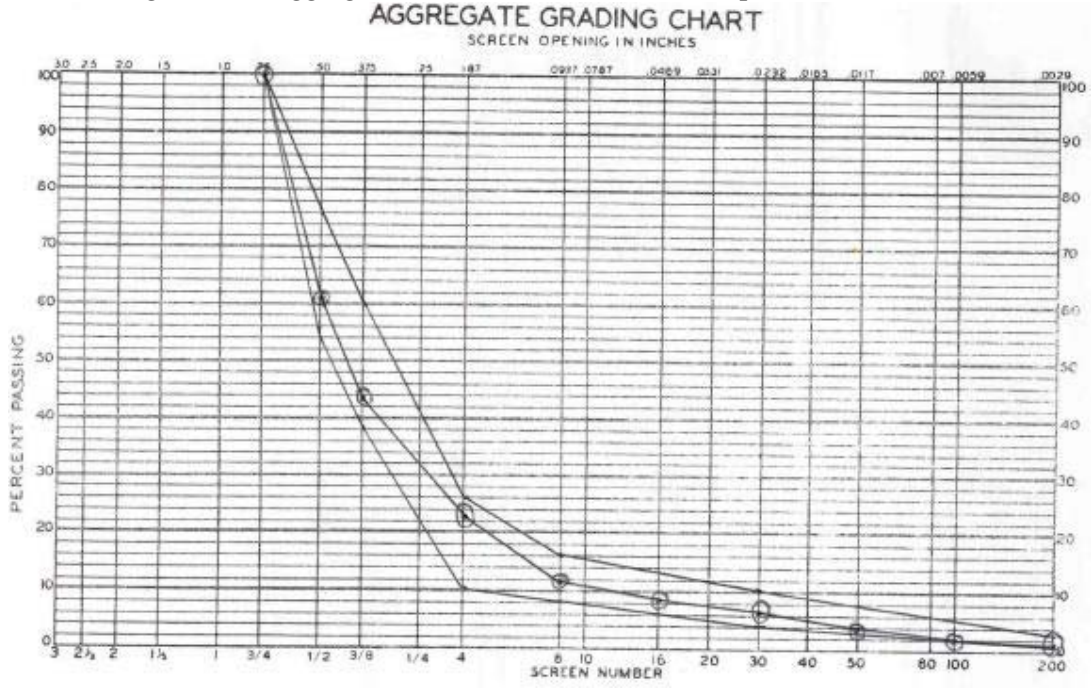
Figure F4 – Aggregate Gradation Chart for RMP Open Graded Mix

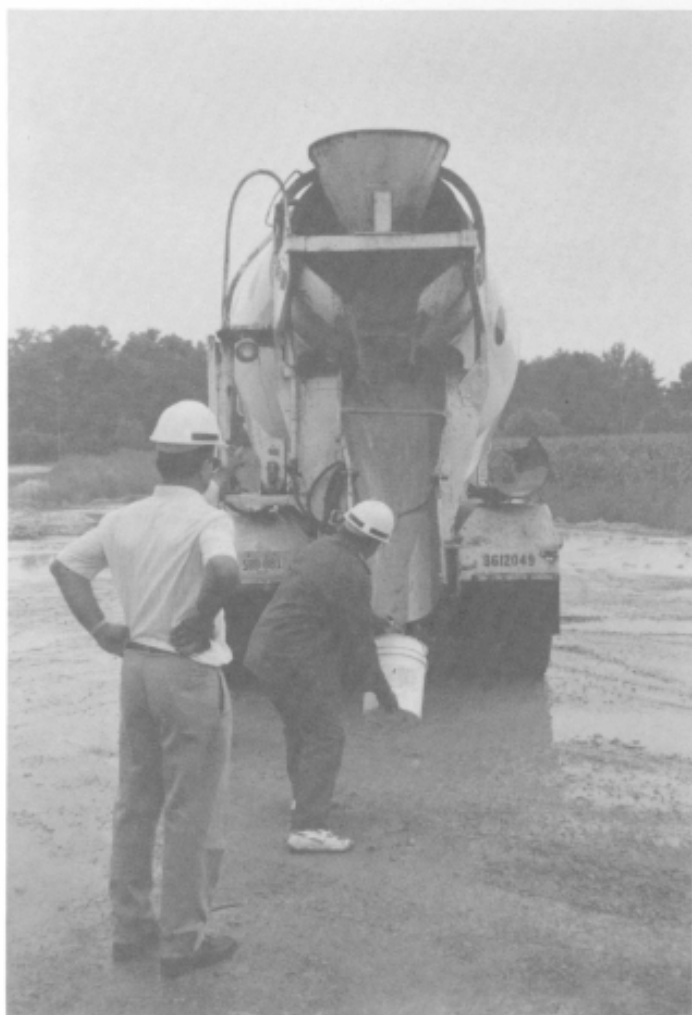
Once the slurry grout has passed the viscosity test, it is poured onto the surface of the open-graded asphalt material from the pivoting delivery chute of the transit mix truck (Figure 7). The slurry grout is applied until the area is
