Stream Channel Maintenance at Bridge Crossings in Ohio

Collaborative Approach Leads to Innovation and Implementation

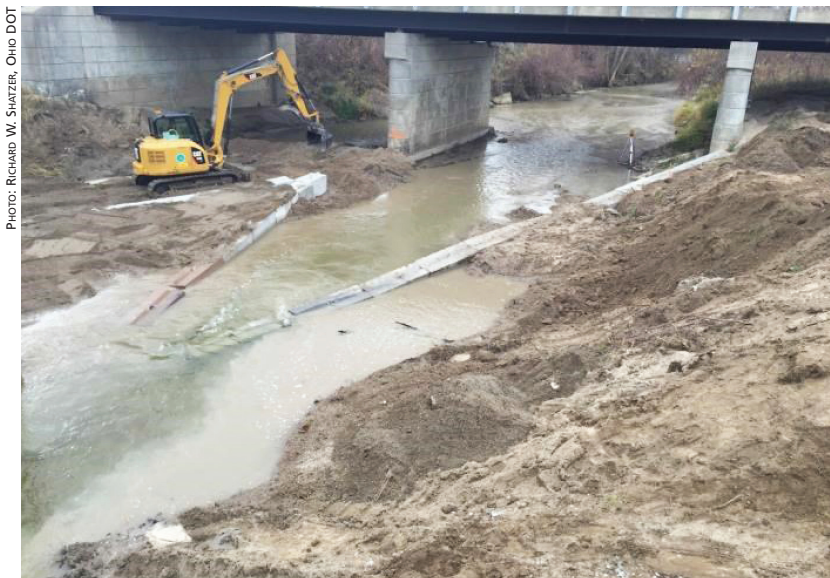
Stream vanes constructed of precast concrete block at the SR-20 bridge over Bean Creek in Fulton County, Ohio.

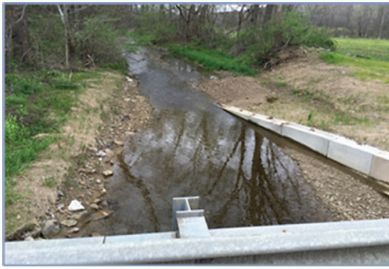
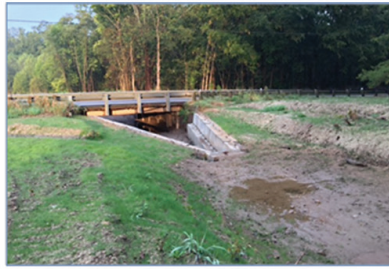
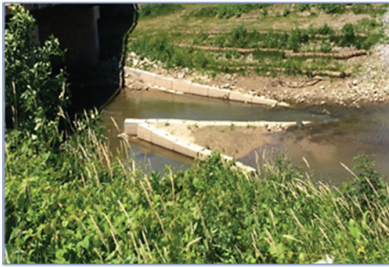
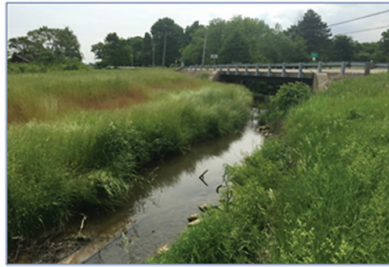
FIGURE 1 Examples of natural channel design practices explored by Ohio DOT researchers (clockwise from top left): single-arm vane, cross vane, W-weir, and two-stage channel.

The selected practices included single-arm vanes, cross vanes, W-weirs, and two-stage channels—all common in stream restoration. The team made minor modifications to adapt the practices for installation near bridges. Tests on alternative construction materials included tied concrete matting, concrete cloth for slope stabilization, and concrete blocks as a substitute for the irregularly shaped quarried limestone boulders typically used in vane structures.
